# Outer Rear View Mirror Image Vibration While Driving

YEAR(S)	MODEL(S)	ADDITIONAL INFORMATION
2019 - 2020	RAV4, RAV4 HV

## RAV4-Outer Mirrors Reflect Image Shaking/Vibrate When Driving

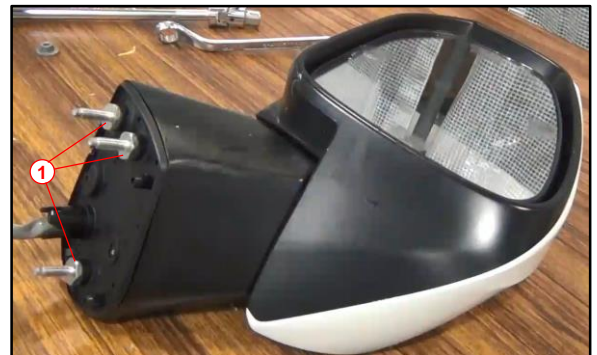
**Figure 1.**

- A. Remove the three original stud bolts from the mirror.

<b>1</b>	<b>Original Stud Bolts</b>
----------	----------------------------

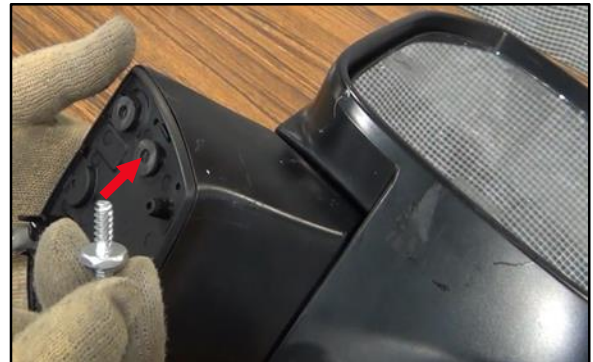
**Figure 3.**

- (1) Fasten the shorter side of the stud bolts to the mirror base.

BEFORE inserting the longer stud bolts, apply Loctite® type 242 to each bolt.

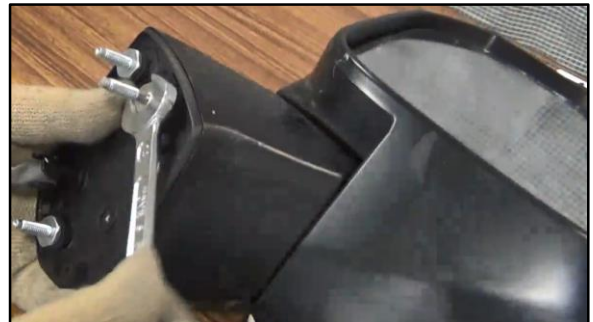
**Figure 4.**

- (2) Tighten ALL three bolts.

**Torque: 3.3 N\*m (33.65 kgf\*cm,  
29.2 in\*lbf / ft\*lbf)**

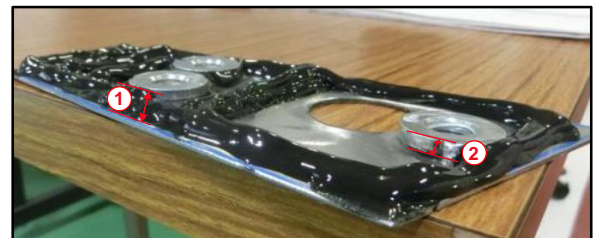
**Figure 7.**

1	Adhesive Thickness
2	Washer Thickness

- Scribe lines on the part are for adhesive application areas (bead width) and location as shown in Figure 6.
- Adhesive thickness (height) MUST be higher than the welded washer height to ensure proper bonding as shown in Figure 7.

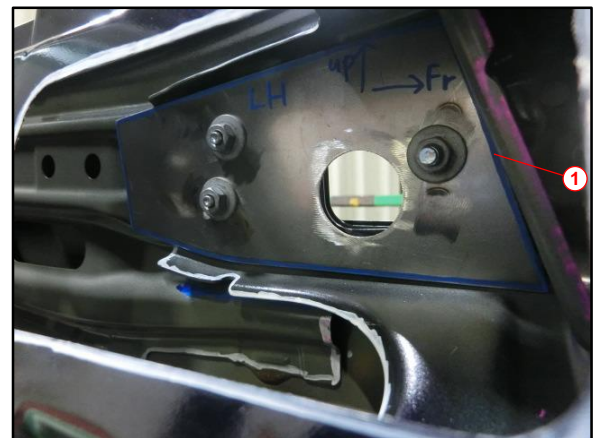
**Figure 8.**

- C. Install the mirror reinforcement bracket extension to the door panel.
- (1) Tighten to the torque requirement to secure the outer rear-view mirror to the reinforcement bracket extension.  
**Torque: 7 N\*m (71.38 kgf\*cm, 61.95 in\*lbf / ft\*lbf)**
  - (2) Adhesion cure time recommended by 3M™.
    - Work time: 90 Minutes.
    - Permanent set or fully cure: 24 hours.

Make sure to tighten nuts to the torque spec. (7.0 N/m)

1	New Reinforcement Bracket Extension
---	-------------------------------------

Figure 9 shows the adhesive application location for the door reinforcement assembly without the new mirror reinforcement bracket extension installed for enhance visualization of the area. When performing the repair, the mirror reinforcement bracket extension should already be installed, as shown in Figure 8.

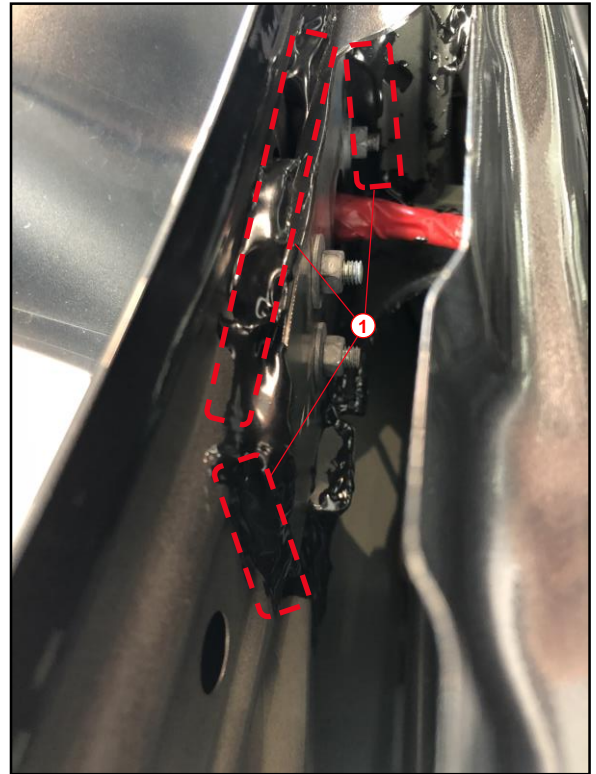
**Figure 10. Completed Assembly Condition**

Figure 10 shows an example of a completed assembly condition (with extension plate and applied adhesive).

<b>1</b>	<b>Applied Adhesive</b>
----------	-------------------------
