Technical Service Bulletin

Topic	Bentayga W12 - Bentley dynamic ride system fault displayed in Driver Instrument Par					
Market area	Bentley: worldwide (2WBE),Hongkong-Macau (5HK)					
Brand	Bentley					
Transaction No. 2051553/2						
Level	EH					
Status	Released for publishing					
Release date	Sep 28, 2020

Bentayga W12 - Bentley dynamic ride system fault displayed in Driver Instrument Panel

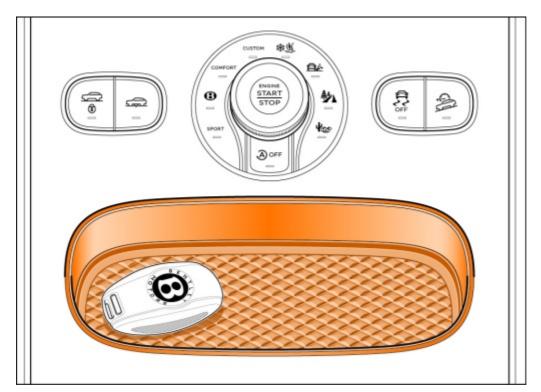
Figure 1

- 2. Ensure the ignition key is located in the remote control key reader and switch on the ignition (see Figure 1)
- 3. Connect the Bentley approved diagnostic tool to the vehicle On Board Diagnostic (OBD) socket. NOTE: The process is Initiated via Bentley diagnostic tool (VAS 6150C or similar) using a hard wire connection to the vehicle OBD socket, Bluetooth connections should not be used

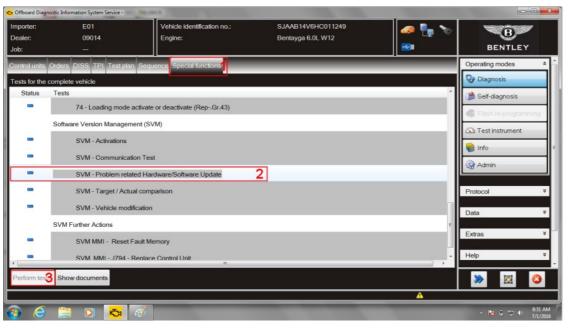
Figure 2

8. Referring to Figure 2, Select Special functions (1), Select SVM – Problem related Hardware/Software Update (2), Select Perform test (3)

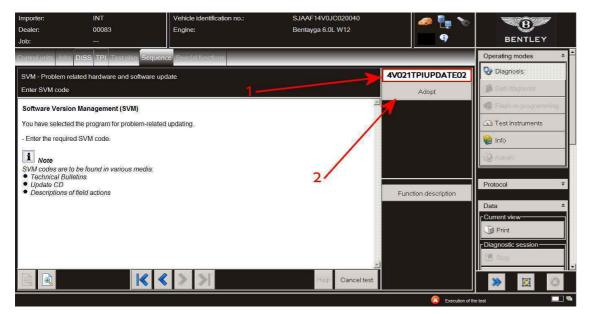
Figure 3

9. Referring to Figure 3, at the SVM screen (1) enter the specific SVM code 4V021TPIUPDATE02 and then select Adopt (2)

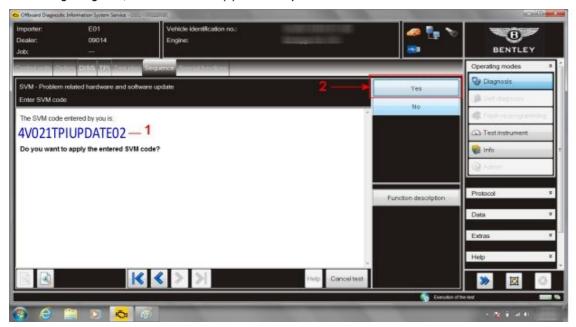
- 10. Referring to Figure 4, Check you have entered the correct SVM code (1) and select Yes (2)
- 11. When prompted enter your global user ID and password
- 12. Follow the on screen prompts to continue through the procedure, identification data will be transferred
- 13. Once software that requires changing is detected select Done/Continue Follow all onscreen prompts, the online connection will deliver the required software to the tester

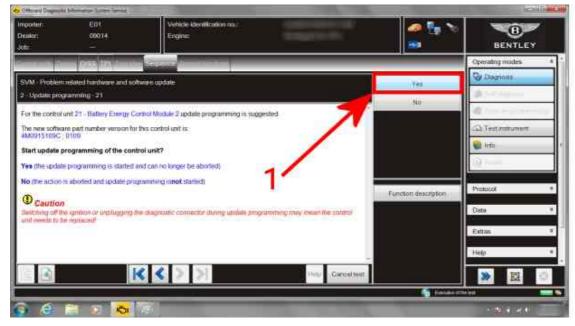
- 14. Select Yes at Update programming 21 to update 21 Battery Energy Control Module 2 (see Figure 4 point 1)
- 15. During update a progress bar will be displayed
- 16. Once the battery energy control module 2 is updated an automatic SVM will take place

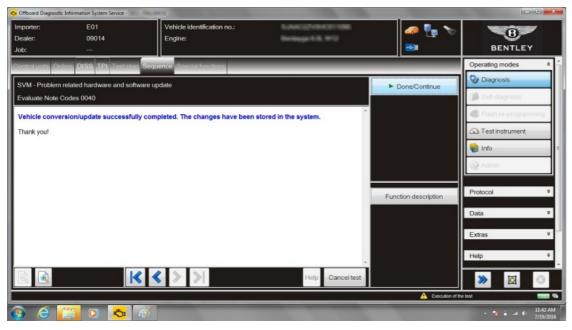
Figure 5

- 17. Select Done/Continue at successfully complete to finalise the update (see Figure 5)
- 18. Select Guided fault finding to check and clear the vehicle of any fault codes generated as a result of performing this campaign
- Make a Target/Actual comparison Follow all on screen prompts
