Engine does not start, left engine mount bolt deformed or broken

Topic number LI22.10-N-071666

Function group 22.10 Engine mounts, engine brackets

Validity Model 906, 907 with engine 651, 642

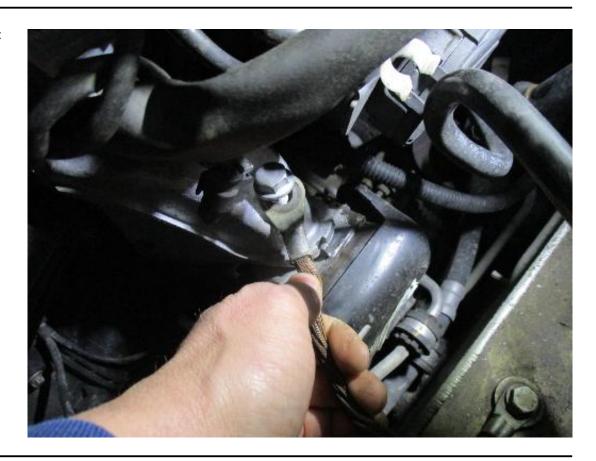
Motorlager lose.JPG:

Mounting bolt for left engine mount (engine carrier to engine mount) loose, deformed or broken.

As a result, there is a break in the ground connection to the engine and the engine does not start.

Replace mounting bolt for left engine mount. Fasten bolt and ground line (tightening torque 58 Nm).

If necessary, replace left engine mount, if engine mount has consequential damage.
