**DTC B14C0, B14C1 Present on Vehicles without Seat Heaters**

2021 Tacoma

**CONDITION**

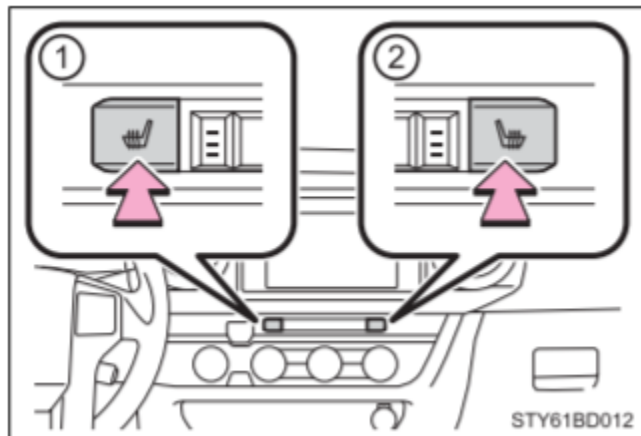
Check for seat heater switches (located below the radio).

Confirm if switches are present:

**Yes – Troubleshoot DTC per RM:**

- SEAT: SEAT HEATER SYSTEM: B14C0; Front Right Seat Heat Sensor Circuit; 2016 - 2021 MY Tacoma [08/2015 - ]
- SEAT: SEAT HEATER SYSTEM: B14C1; Front Left Seat Heat Sensor Circuit; 2020 - 2021 MY Tacoma [09/2019 - ]

**No – No Further Diagnosis or Repair Required.** This vehicle does not have seat heaters and these DTCs do not indicate a concern with the vehicle.
