AT19-013a

NTB19-076a

# 2018 ALTIMA AND 2018-2019 ROGUE; DTC P17F0, P17F1, P0776, P2813, P1715, AND/OR P0841 STORED

APPLIED VEHICLES:	2018 Altima (L33)
	2018-2019 Rogue (T32)

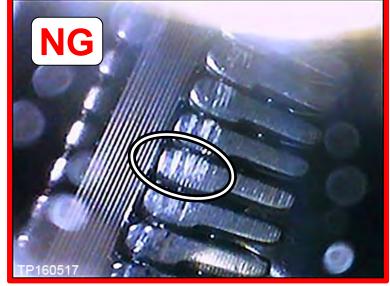
Figure 22: Example of NG belt

Pictures in Figure 22-Figure 24 were taken with borescope J-51951.

- > If the inspection result is **OK**, inspect the other side of the belt in step 8.
- If the inspection result is NG, replace the CVT sub-assembly (page 18), control valve (page 76) and, if applicable, reprogram the TCM (page 83).

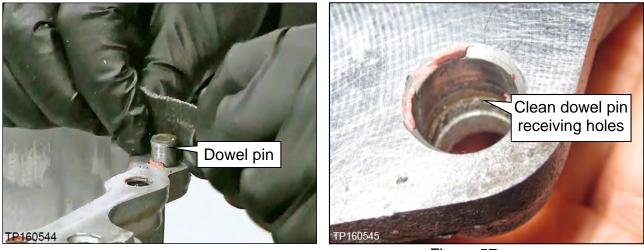
Figure 56

- DO NOT use sanding discs, similar abrasive tools, or metal blades.
- Use brake cleaner or equivalent solvent and lint free towel only.
- Make sure rust and debris have been cleaned off of dowel pins and receiving holes (Figure 56 and Figure 57).
- 35. Clean the dowel pins and dowel pin receiving holes of any rust and debris (Figure 56 and Figure 57).

**HINT:** Use a small wire brush or similar tool at the inside surface of the dowel pin holes. DO NOT SCRAPE THE CVT CASE mating surfaces.

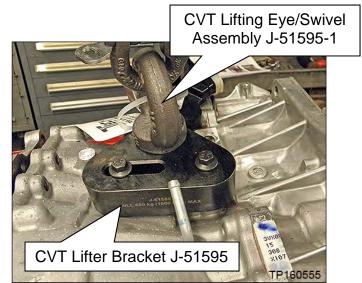
Figure 73

- 54. Rotate the CVT case so that the converter housing faces down and side-cover faces up.
  - CVT lifter bracket J-51595 and CVT Lifting Eye/Swivel Assembly J-51595-1 can be used for this step. See Figure 73.

- Attach Lifting Fixture J-51909 (Figure 81) with eyelet from J-51595 (Figure 73) to the side cover at point shown in Figure 82.
  - Lifting Fixture bolt torque (Max.): 45 N•m (4.6 kg-m, 33 ft-lb)

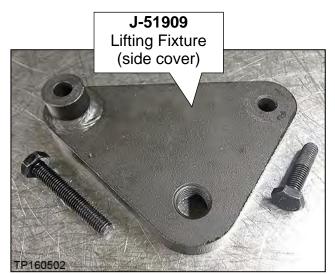
Figure 81

• Eyelet bolt torque: Hand tight.

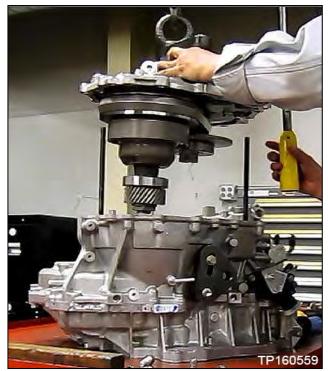
Figure 91

66. Raise the Lifting Fixture to remove the "side cover with pulleys and belt subassembly" (sub-assembly) from the CVT case (Figure 91).

To avoid damage to the primary speed sensor, make sure it is removed from the sub-assembly.

- The speed sensor <u>will</u> be reused.
- **<u>DO NOT</u>** discard the speed sensor.
- This sub-assembly <u>will not</u> be reused.

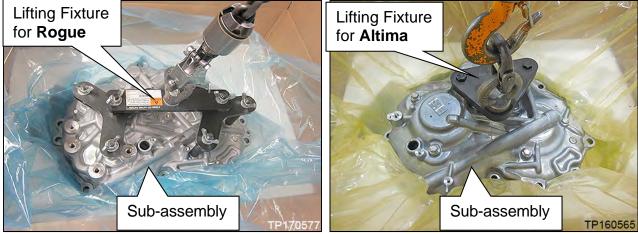
Figure 97

**HINT:** Do not cross thread the side cover holes when installing the Lifting Fixture. Always start the bolts by hand.

• Refer to Altima (page 40) or Rogue (page 42) Lifting Fixture procedures for correct Lifting Fixture installation.

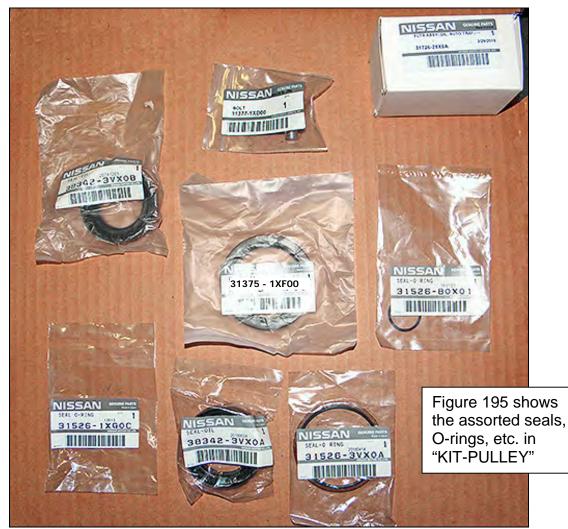
Figure 195

- The following Figures show the smaller components of KIT-PULLEY.
- KIT- CONTROL VALVE is not shown.
