**Complaint - Creases on Seat Surface/Side Bolster of Front Seat and Ridge Formation on Seat Surface of Rear Seat: Replacing Cover and Padding (119/20)**

Model Line: **Cayenne (9YA/9YB)**

Model Year: **As of 2018 up to 2020**

Subject: **Front and rear seat**

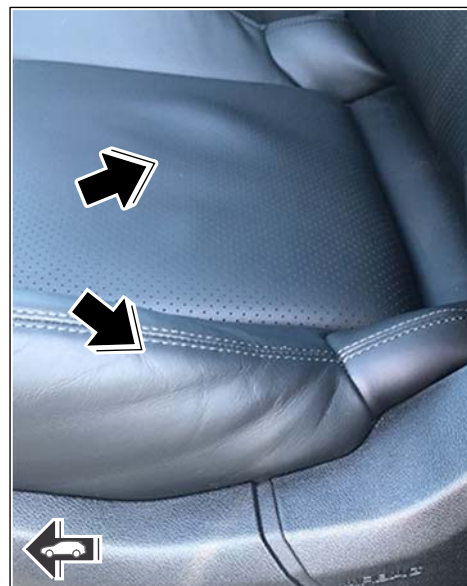
*Wrinkling on front seat*

Information: Leather stretching and compression in conjunction with an entry height typical for SUVs results in permanent creases in the seat covers and side bolsters of the front seats ⇒ *Wrinkling on front seat -Arrows-*.

Remedial Action: In the event of a customer complaint and on vehicles produced before the date of introduction specified below, replace padding and seat cover, see

- ⇒ Workshop Manual '741319 Removing and installing cover for front seat'
- ⇒ Workshop Manual '741055 Replacing padding for front seat'
- ⇒ Workshop Manual '742855 Replacing heating element for front seat'
- ⇒ Workshop Manual '74501901 Removing and installing cover for rear seat (2/3-split folding rear seat)'
- ⇒ Workshop Manual '74495501 Replacing padding for rear seat surface (2/3-split folding rear seat)'
- ⇒ Workshop Manual '74501902 Removing and installing cover for rear seat (1/3-split folding rear seat)'
- ⇒ Workshop Manual '74495502 Replacing padding for rear seat surface (1/3-split folding rear seat)'
- ⇒ Workshop Manual '743055 Replacing heating element for rear seat cushion'

In an effort to minimize the normal effect of leather stretching, Porsche has made a change to the seat cover. Based on the introduction dates below, optimized padding and seat covers, now also available for customer service, have been installed during production. This will provide additional support to the leather and should help the new look last for a much longer time.

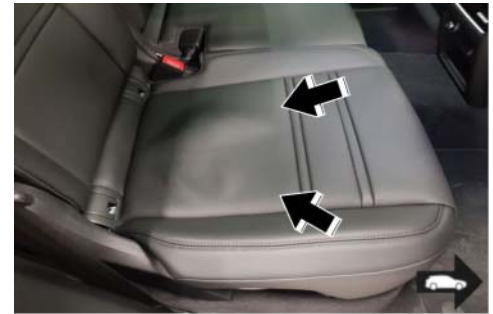
Ridge formation on rear seat

This also causes ridge formation on the seat surfaces of the rear seats ⇒ *Ridge formation on rear seat -Arrows-*.
