# Technical Service Bulletin

## 53 Cables visible in passenger compartment

53 20 04 2043016/2 December 17, 2020. Supersedes Technical Service Bulletin Group 53 number 16-03 dated March 29, 2016 for reasons listed below.

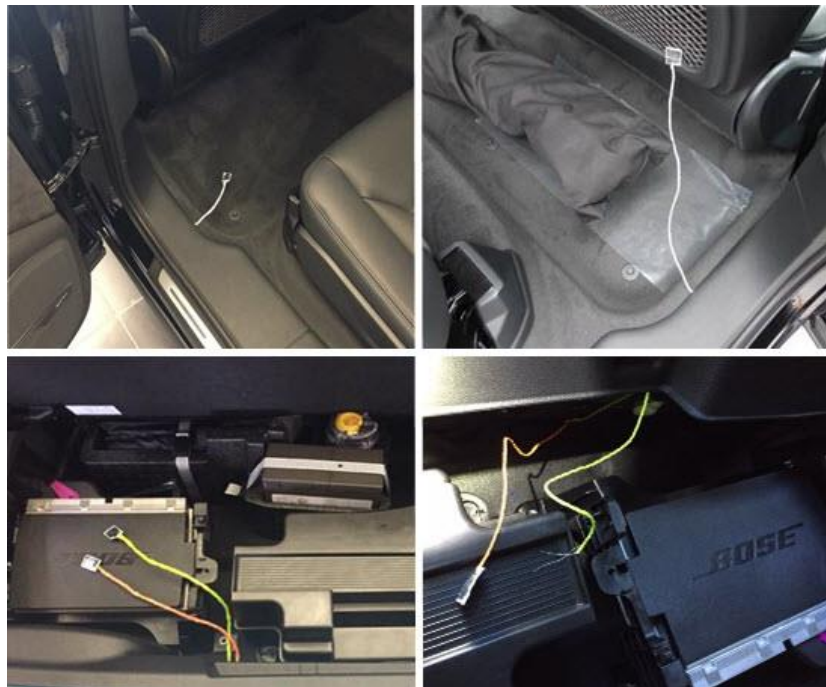
- Cables are visible in the front or rear footwells, or in the spare wheel wells (Figure 1).
- No DTCs are stored.

**Figure 1.** Examples of visible cables.

The visible cables are connected to sensors that are only used during the production process. These cables are not used during normal vehicle operation and are not connected to the vehicle electrics.

If the cables are visible and no DTCs are stored, simply push the cables under the trim. The cables are not connected to any circuits in the vehicle.
