# Technical Service Bulletin

## 68 Noises from the MMI screen

68 20 28 2061722/1 December 17, 2020.

Model(s)	Year	VIN Range	Vehicle-Specific Equipment
Q5, SQ5	2019 - 2020	All	Not Applicable

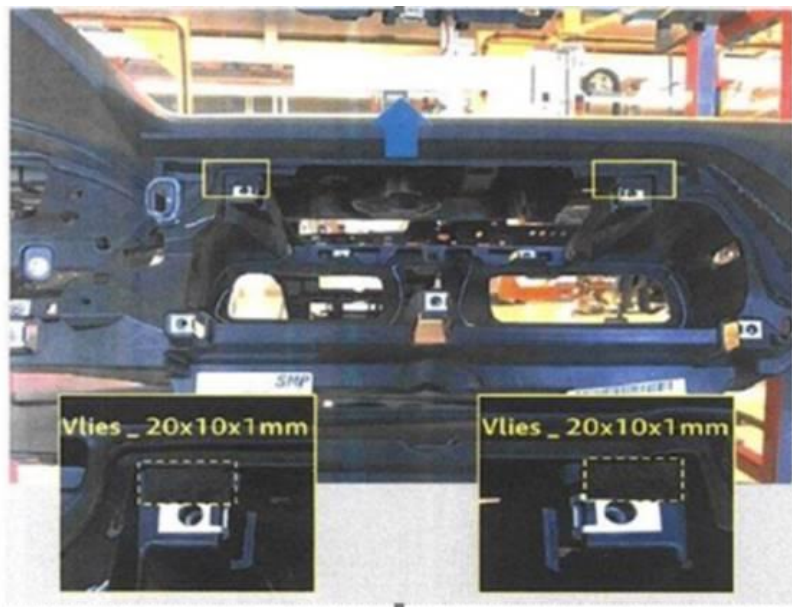
- The noises originate from the area of the MMI screen.

Relative movement between the MMI screen and its mounting surfaces in the dash panel.

**Figure 1.** Apply two pieces of felt tape to the dash panel in the area shown.

- Felt strips with part number 533867910A (dimensions: 20x10x1 mm).
1. Remove the MMI screen according to the Elsa repair manual.

2. Attach two pieces of felt tape to the MMI screen mounting surfaces in the dash panel (Figure 1).

3. Reinstall the MMI screen according to the Elsa repair manual.
4. Test drive vehicle to verify the repair.
