## 26-19-01 - AdBlue® Warning and or MIL ON - Ad Blue® Leakage at Reductant Injector

## Technical Background

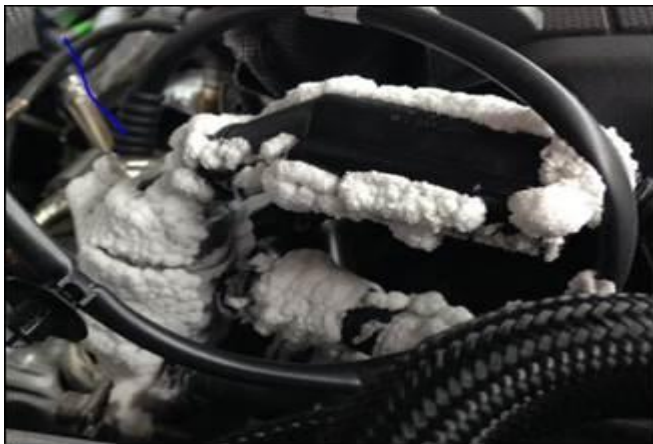
**Figure 1**

Welding process issues of the reductant line connector to the supply line may cause AdBlue® leakage at the reductant injector.

Inspect the connection of the reductant supply line connector at the reductant injector in the engine compartment. If white crystalized (dried) AdBlue® is found at the reductant injector (see Figure 1 & 2), it will be necessary to replace the reductant supply line.

- Thoroughly clean the area of the reductant supply line connection with water to remove the crystalized AdBlue®.
- Replace the reductant supply line.
- Refill reductant agent as required per part table quantity.

It is not necessary to replace the reductant injector.
