# SERVICE BULLETIN

**Bulletin No.....:** TS-U107

**Bulletin Name.....:** Filling Throat Of Fuel Tank

**Subject:** Preventing fuel leaking out

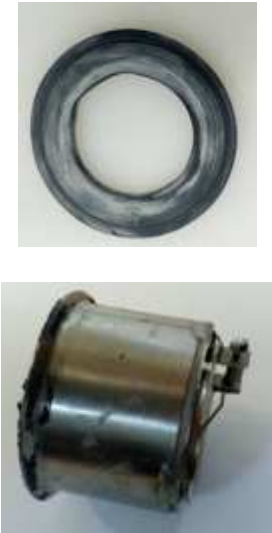
No	Part Number	Definition	Figure	Quantity	Unit
1	RP160120	CAP,FUEL TANK FILLER KIT AFTERSALES
