Sanimarin Toilet Controller Update

Bulletin Type:	TSB	Publication Date:	January 20, 2021
Bulletin #(s):	20-038	Make(s):	Entegra/Jayco
Job Code(s):	9803560	Model(s):	Embark, Reatta, Reatta XL, Aspire, Anthem, Cornerstone
Flat Rate(s):	.25 Inspection -per toilet .75 Install new control touchpad-per toilet	Model Year(s):	2021

Incident:	Saniflo macerator toilet does not clear bowl with single flush.
Affected Units:	All 2021 Embark, Reatta, Reatta XL, Aspire, Anthem, Cornerstone
Parts Kit:	Parts Kit #: 20-038JM
	Parts Kit Contents: Touchpad AC120147C
Misc. Tools & Supplies:	Putty knife, small straight screwdriver, #2 Philips head screwdriver #2 square bit, cordless screw driver, clear silicone, electrical tape, silicone gun
Parts Return Information:	NA

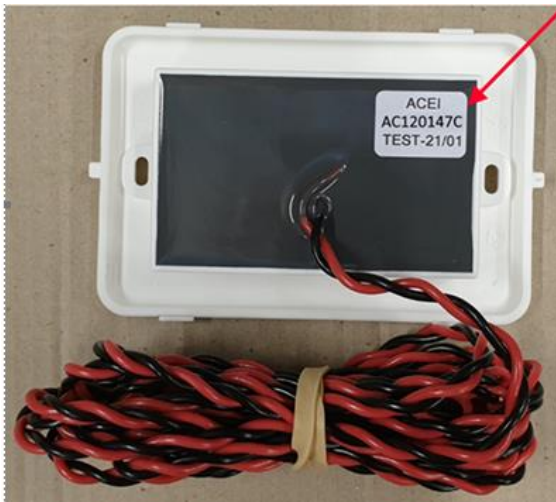
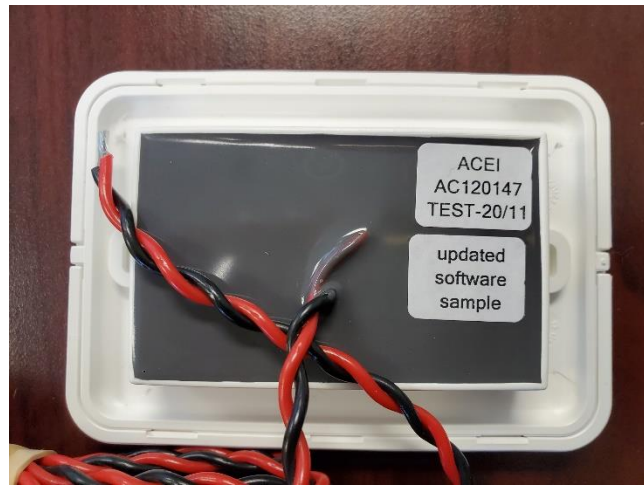
Verify brand of toilet installed in unit. If Sanimarin toilet is installed, remove touchpad to verify version of software (See step 1 of instructions). There is a label on the back of panel identifying revision. **Correct panel should show AC120147C or be labeled as "software update sample".**
