| <b>REFERENCE:</b> | Nova Bus Manuals |
| <b>SECTION:</b> | 02: Engine and Cooling |
| <b>RS N°:</b> | MQR 7621-1834 |

| <b>SUBJECT:</b> | Electric Cooling Package (ECP) power cable lugs and junction bus bar corrosion. |

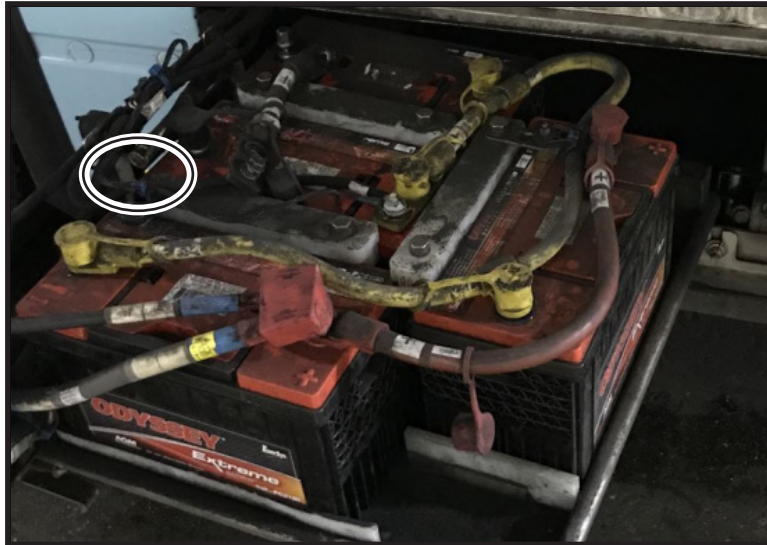
Figure 4 - Ground Cable Disconnected and Isolated

Make sure to disconnect the ground cable from the structure or batteries and ensure that the ground cable lug is isolated (see figure 4).

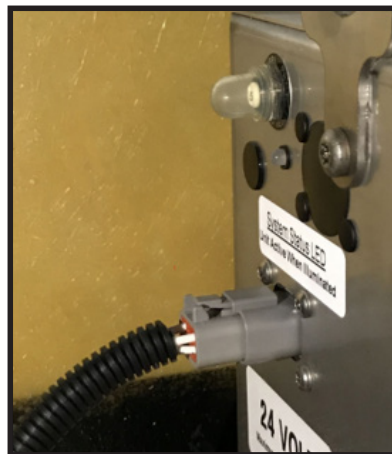
Figure 5 - View of the Super Capacitor Control Connector to Disconnect

Disconnect the super capacitor control connector and ensure 0V voltage at the bus bar near the engine box (see figure 5).

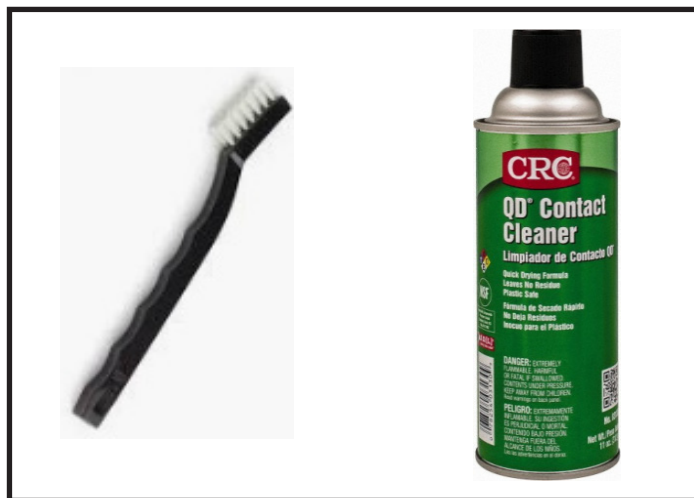
Figure 10 - Corrosion Cleaning Brush and Contact Cleaner Product

- 1.15. Using the CRC Citrus Degreaser remove the dirt (see figure 9) and the grease from both sides of each power cable lug, from the junction bus bar and from the hardware nuts.
- 1.16. Using a nylon bristle brush and the CRC QD Contact Cleaner product, remove the corrosion (see figures 9 & 10) from both sides of each power cable lug, from the junction bus bar and from the hardware nuts.

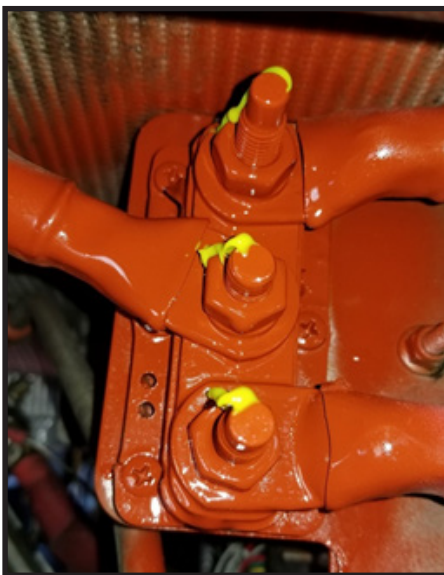
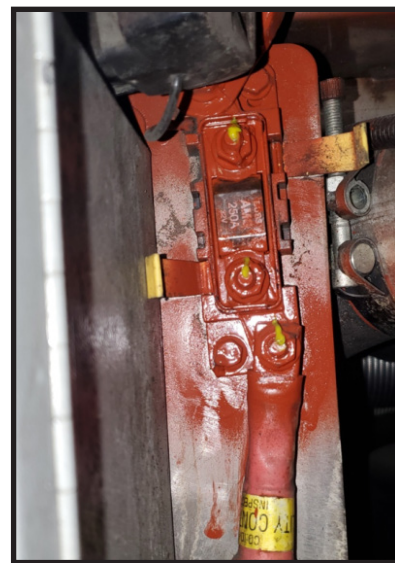
Figure 12 - Dolph ER-44 and Yellow Torque Seal Applied

- 1.23. Apply 3 thin coats of the Dolph ER-44 product over the exposed metal surfaces of the junction bus bar, power cable lugs, fuse terminals, fuse holder terminals and nuts (see figure 12).
- 1.24. After the last Dolph ER-44 coat has dried, apply the yellow torque seal on each nut. Then, reinstall the protective plastic caps over the junction bus bar and the fuse holder.
