Revised February 2021

Dealer Service Instructions for:

## Customer Satisfaction Notification W80 Oil Consumption Inspection

**2015 - 2018 (BU) Jeep® Renegade (FWD)  
2016 - 2018 (FB) Fiat 500X (FWD) , (AWD)  
2015 - 2018 (VM) Ram Promaster City**

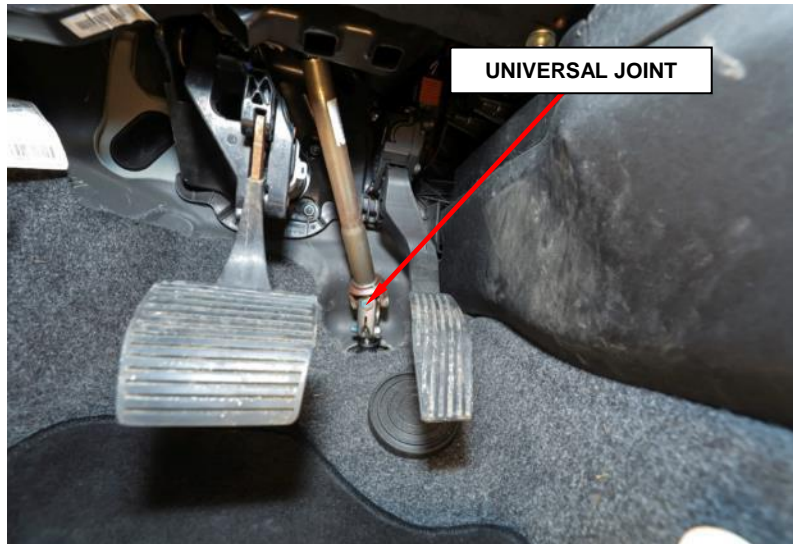
**Figure 13 – Steering Shaft Joint**

23. From inside the vehicle remove the bolt and separate the universal joint (Figure 13).

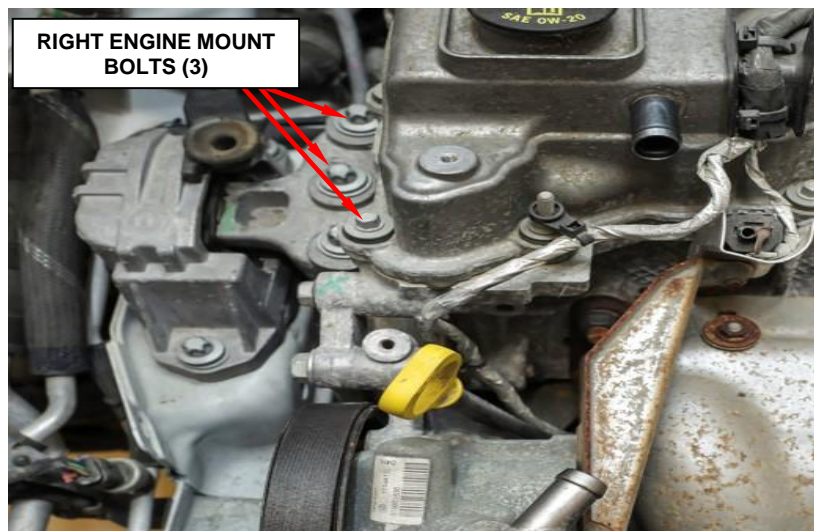
84. Remove the 3 left engine mount insulator bolts (Figure 40).
85. Remove the 3 right engine mount insulator bolts (Figure 41).
