**IMPORTANT ORIGINAL EQUIPMENT MANUFACTURER
RECALL**

CSR 510

Cummins C2302 - Fuel Heater Module

***** IMPORTANT SAFETY RECALL *****
NHTSA Recall No. 20E-018
Cummins Campaign #C2302

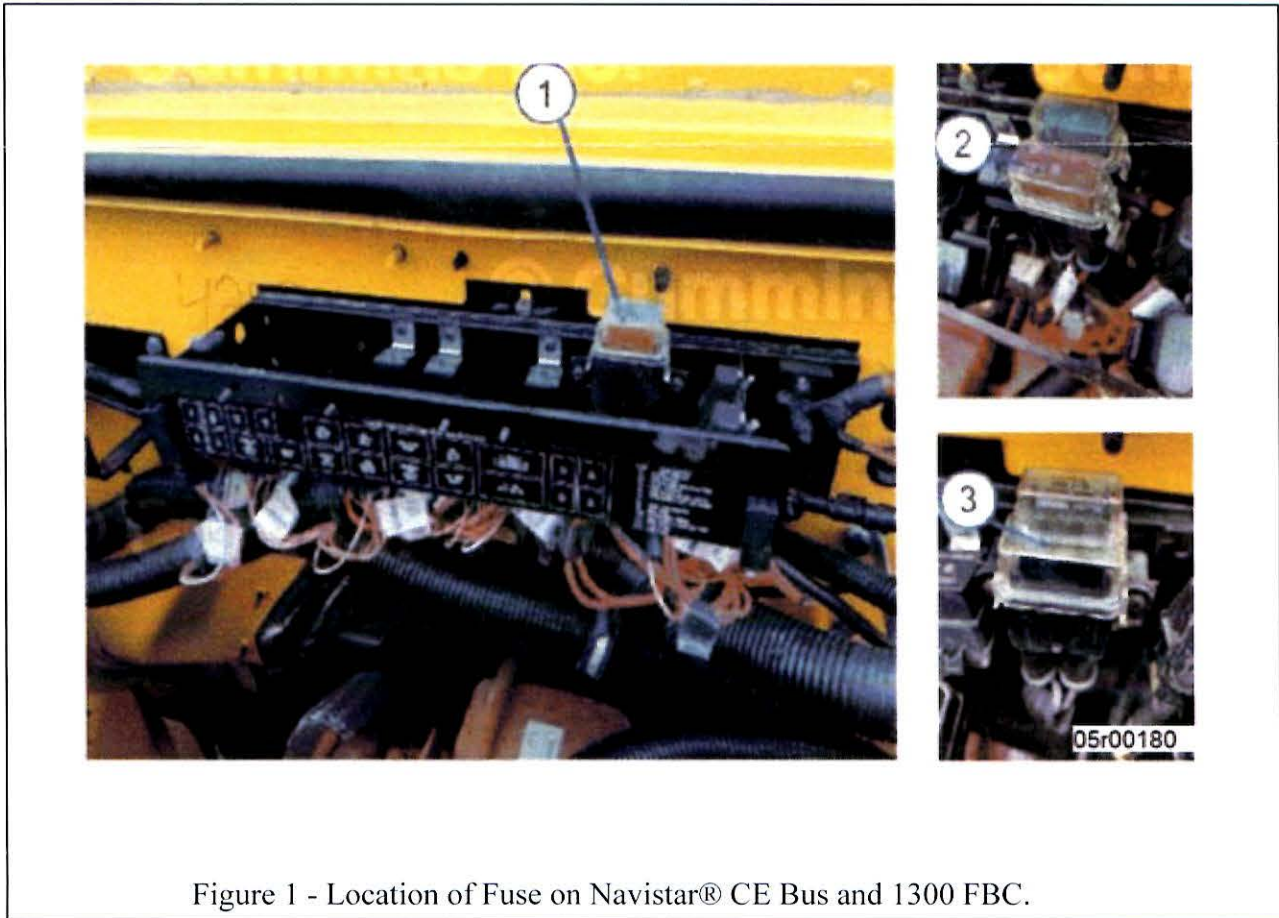
Navistar® CE Bus and 1300 FBC Fuse Removal Instructions (Reference Figure 1 below)

1. Disconnect vehicle battery.
2. Locate red 50 Amp or green 30 Amp Maxi Fuse on under hood fuse panel.
3. Remove fuse cap and discard red or green Maxi Fuse.
4. Reinstall fuse cap. Do **not** replace fuse.
5. Reconnect vehicle battery.

In the meantime, to mitigate the safety risk, Cummins advises you to remove the fuel heater fuse as shown in Figures 1, 2 or 3 below (based on the vehicle).

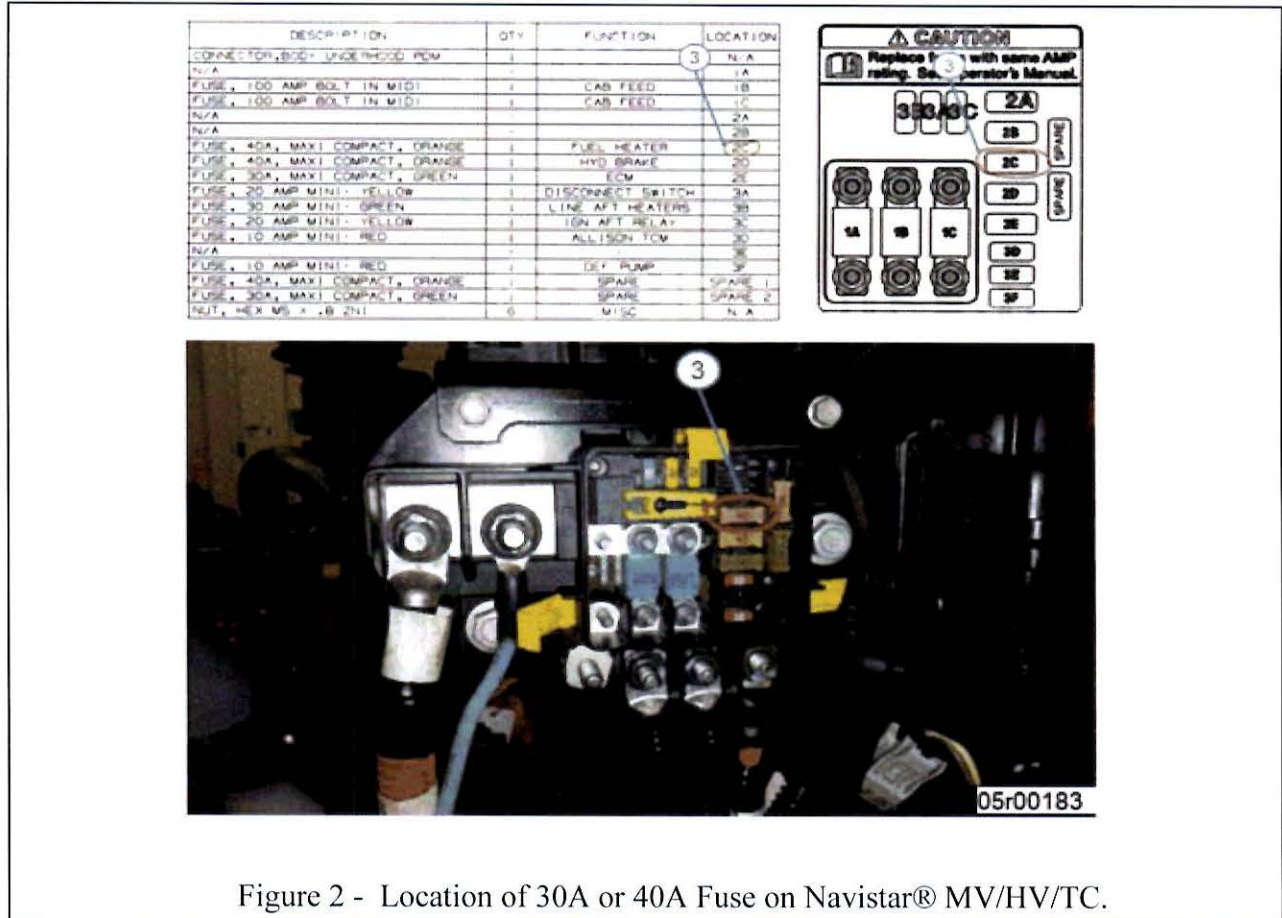
Figure 2 - Location of 30A or 40A Fuse on Navistar® MV/HV/TC.

Navistar® MV, HV and TC Commercial Bus (some DuraStar (4300)/WorkStar (7300)) Fuse Removal Instructions (Reference Figure 2 below)

1. Disconnect vehicle battery.
2. Remove 30 or 40 amp fuse located at 2C cavity.
3. Reconnect vehicle battery.

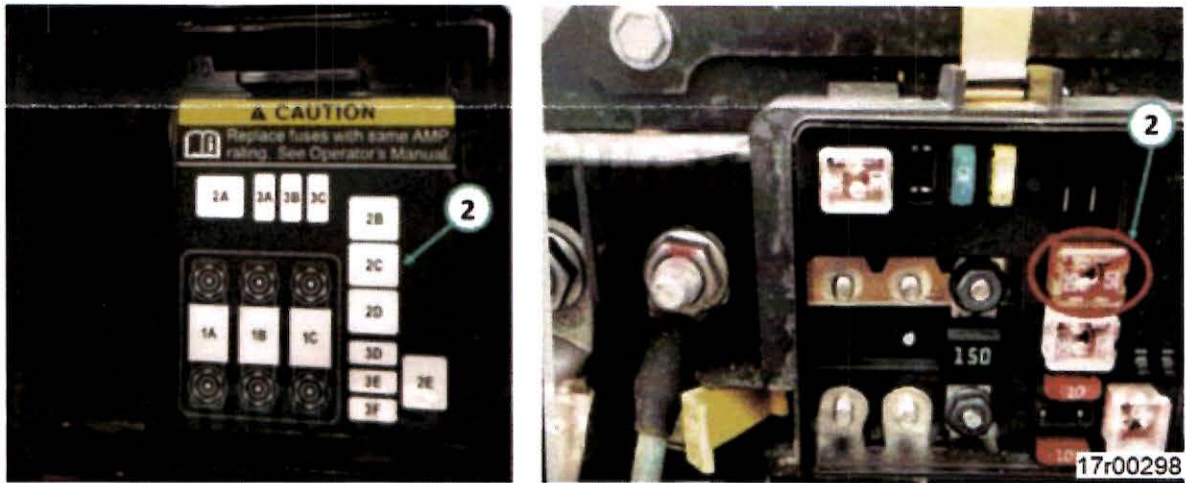
Figure 3 - , Location of Fuse on Navistar® DuraStar (4300) / WorkStar (7300) / HC Commercial Bus

Navistar® DuraStar (4300) / WorkStar (7300) / HC Commercial Bus Fuse Removal Instructions (Reference Figure 3 below)

1. Disconnect vehicle battery.
2. Remove Power Distribution Module (PDM) cover, located under the hood on the driver side of the vehicle.
3. Remove fuse located at cavity 2C.
4. Reconnect vehicle battery.
