# HYUNDAI

## Technical Service Bulletin

GROUP <b>CAMPAIGN</b>	NUMBER <b>21-01-024H</b>
DATE <b>MARCH 2021</b>	MODEL(S) <b>APPLICABLE VEHICLES BELOW</b>

**SUBJECT:** DTC P1326 - ENGINE INSPECTION / REPLACEMENT  
(SERVICE CAMPAIGN T6G)

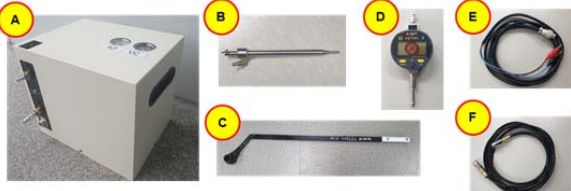
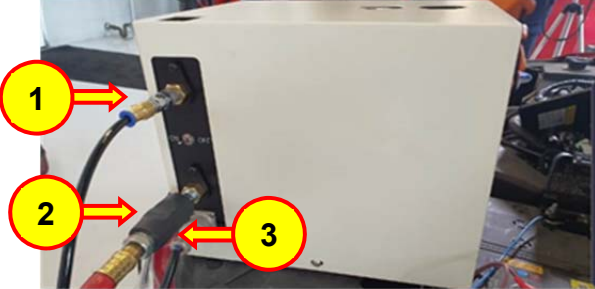
Part Name	Part Number / Figure	Note
<p>BEARING CLEARANCE TESTER SET (BEARING TOOL)</p>

<p>(1) TEST HOSE (2) MAIN HOSE (3) POWER SUPPLY CABLE</p> <p>One BEARING CLEARANCE TESTER SET provided to dealers. (Additional units can be ordered.)</p>	<p>Confirm the following pressures meet requirements. The correct ranges for AP/VC air pressures are also indicated with red/blue decals on the gauges:</p> <p><b>Shop air supply:</b> <b>50 psi minimum</b></p> <p><b>AP: 0.1 ~ 0.11MPa</b> <b>VC: -73 ~ -83Kpa</b> (Refer to TSB 20-GI-009H or later for calibration procedure)</p>

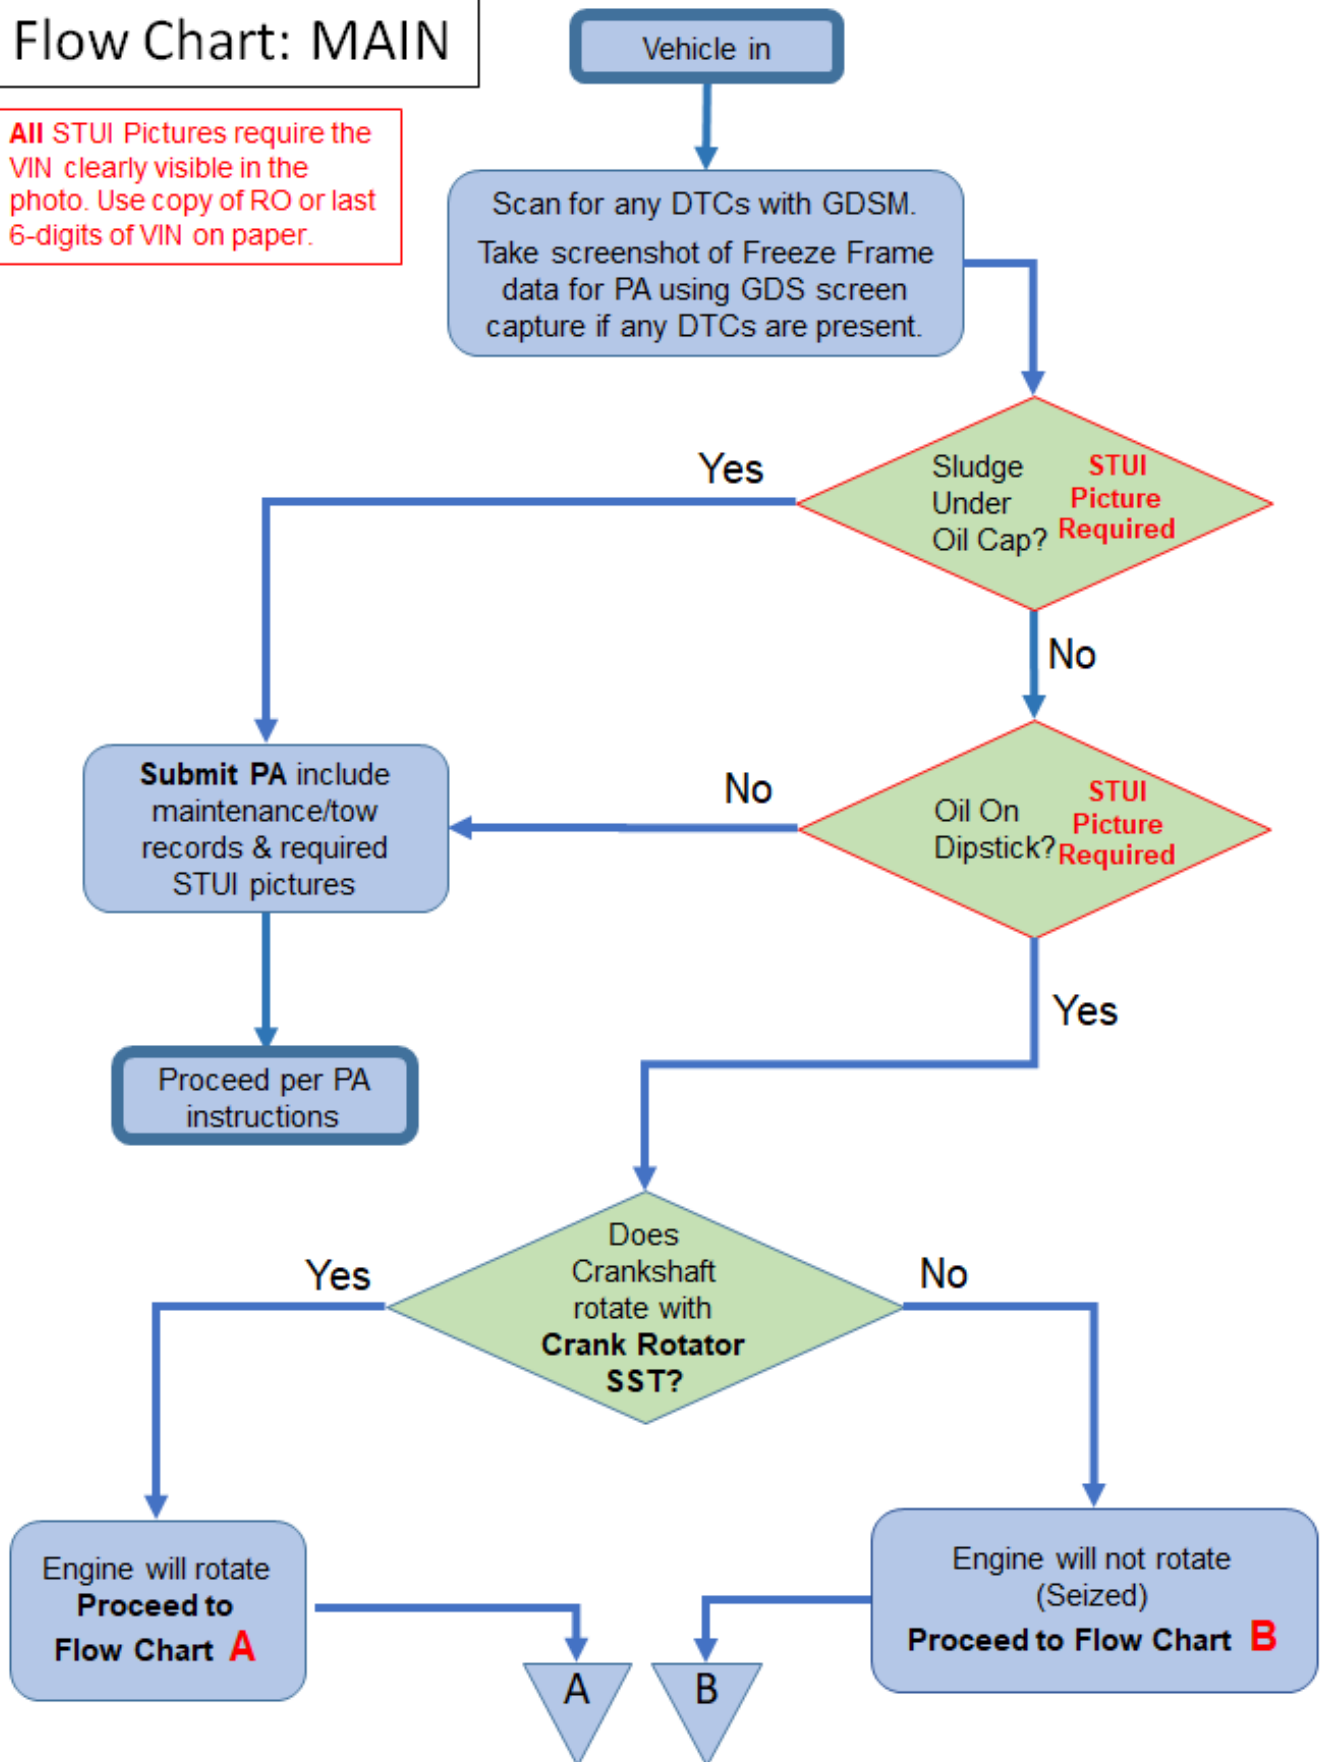
**Flow Chart: MAIN**

**All STUI Pictures require the VIN clearly visible in the photo. Use copy of RO or last 6-digits of VIN on paper.**

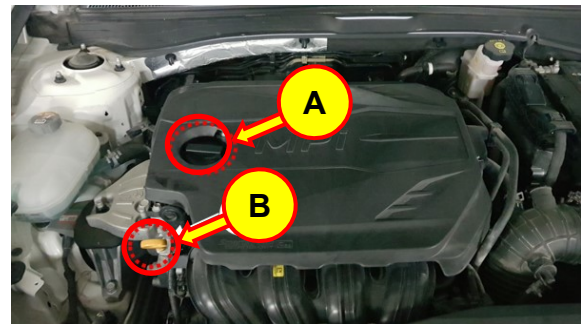
1. Remove the engine oil filler cap (A) and engine oil level gauge (B).

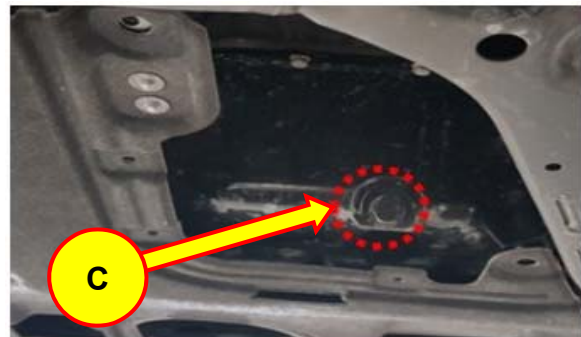
2. Lift up the vehicle and remove the oil drain plug (C).

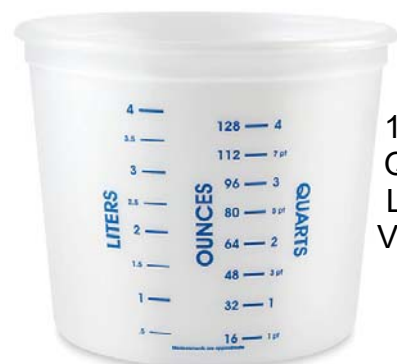
1 to 4  
Quart  
Level  
Visible

3. Drain the engine oil into a container. The 1-4 quart level should be clearly marked and visible on the container. Using STUI in the GDS, take and submit a picture of the oil container with the drained oil level clearly visible and the VIN in the background of the photo (RO or last 6 digits written on paper) for records, if needed. **VIN must be legible.**

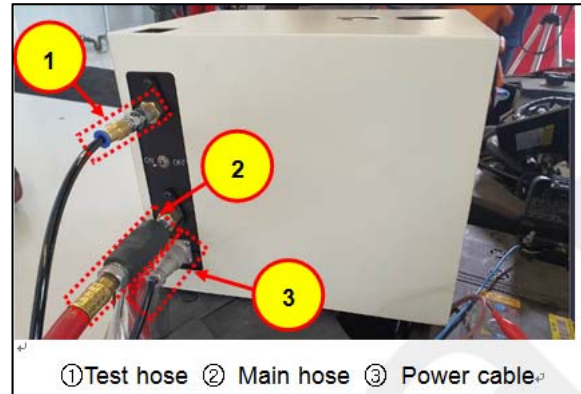
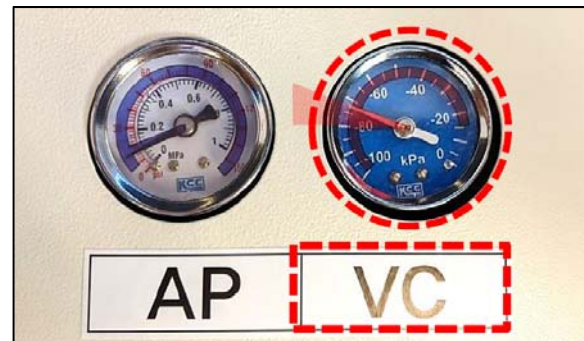
- a) Connect the main air compressor hose.
- b) Connect the test hose. (The other end of the test hose should be left disconnected from the spark plug rod.)
- c) Confirm that the AP/VC toggle switch at top is in the middle position.
- d) Inspect the AP/C gauge indicators and compare to the specification range:
  - **AP:** 0.1 ~ 0.11MPa
  - **VC:** -73 ~ -83Kpa

**Do not continue if any of the above readings are out of specification range.**

- **Adjust shop air to consistently provide at least 50 PSI of air pressure or greater.**
- **Do not use a portable air compressor to perform the bearing clearance testing.**
- **Be sure to check that the shop air water separator is functioning correctly.**
- **If any of the AP/VC air pressure indications are out of the specified range, recalibration of the Bearing Clearance Tester is required.**
  - **Refer to latest instructions outlined in the Engine Bearing Clearance Tester Calibration Procedure TSB 20-GI-009H or later for calibration procedure.**

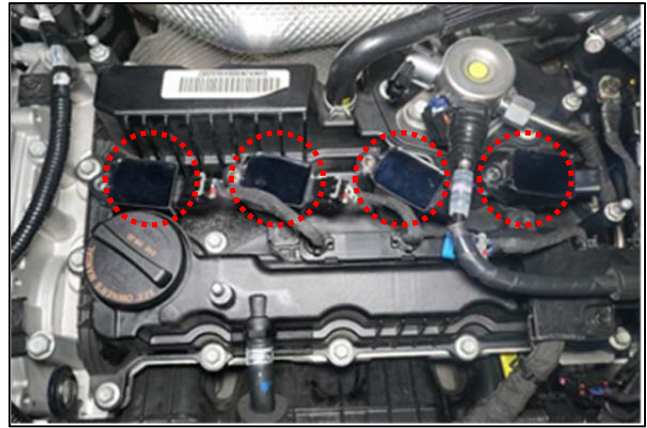
2. Remove the engine cover and the 4 ignition coils.

**Tightening Torque (ignition coils):**  
**9.8 - 11.8 N·m**  
**(1.0 - 1.2 kgf·m, 7.2 - 8.7 lb·ft)**

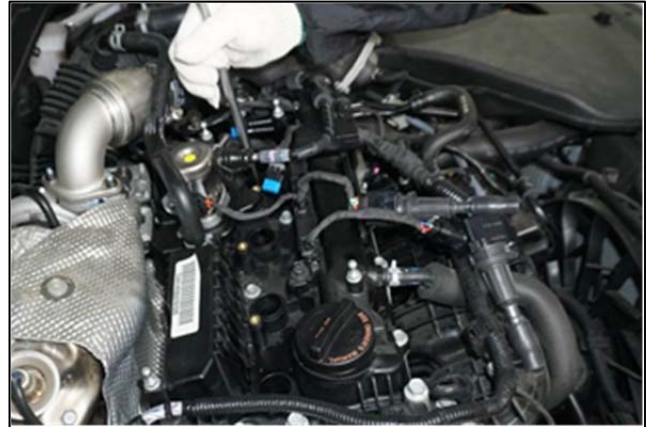
3. Remove the 4 spark plugs.

**Tightening Torque:**  
**14.7 - 24.5 N·m**  
**(1.5 - 2.5 kgf·m, 10.9 - 18.0 lb·ft)**

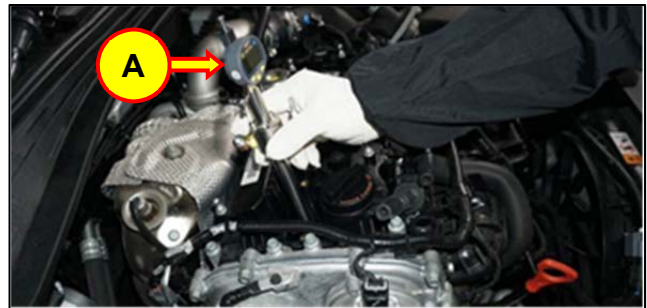
4. Insert the appropriate (use **M12 for GDI and Theta MPI Hybrid** engines or **M14 for all other MPI** engines) spark plug rod SST (A) into Cylinder #1 spark plug hole and turn until hand tight. Insert the clearance gauge SST into the spark plug rod and tighten using the thumb screw.

**DO NOT connect the test air hose to the clearance gauge at this time.**

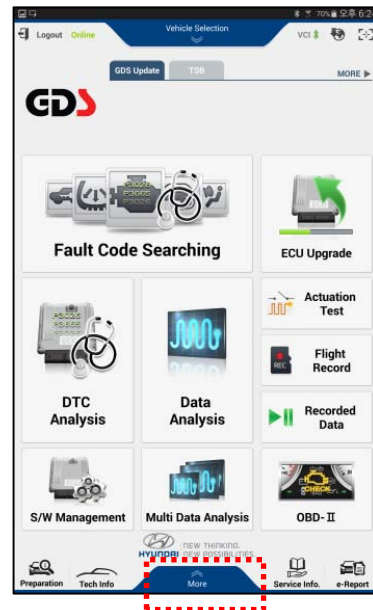
6. Swipe up on the 'More' tab at the bottom of the GDS home screen. Select the 'Special Inspection' function.

7. Enter the vehicle info into the GDS as prompted then select 'Next'.

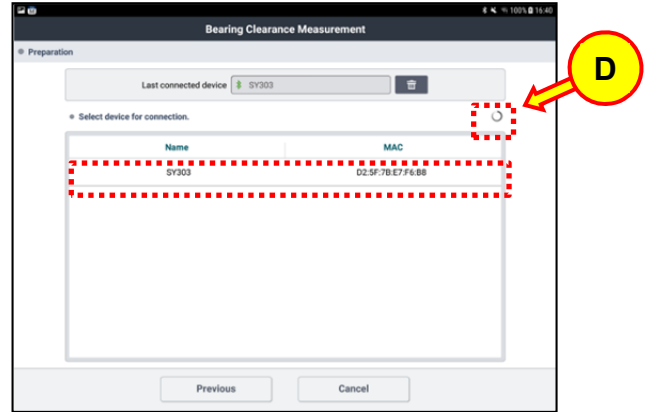
- Press the “Set” button (B) on the gauge to turn it on.
- Press the “Set” (B) and “Mode” (C) buttons at the same time for about 4 sec until the “reset” message is displayed.
- Select the gauge in the list of devices on the GDS. Select the ‘Refresh’ icon (D) if the gauge doesn’t appear automatically.

If more than one device appears in the list of devices, there is another device in range. Move away from the other device to pair the gauge.

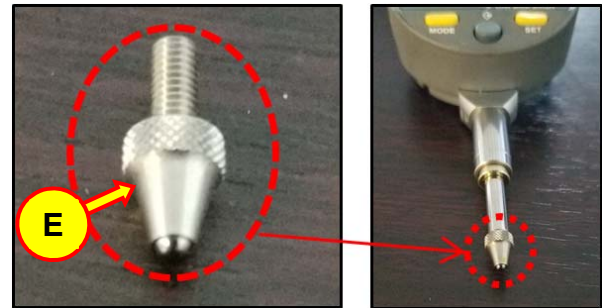
- Check that the ball point tip (E) of the clearance gauge SST is securely installed to the tool as shown. **Do not continue if ball point tip (E) is loose or missing.**

If loose, apply Blue Loctite (or equivalent) to the tip thread and retighten securely to the gauge plunger.

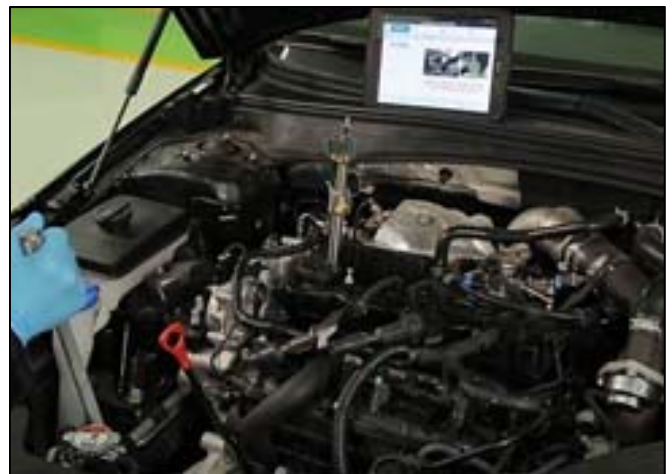
- ❖ Monitor the piston height value on GDS screen or the clearance gauge SST while rotating the engine clockwise using the Crank Rotator Tool.
  - Rotate the engine **SLOWLY** as the value increases towards a MAX value. (BTDC → TDC)
  - When the value changes direction (increasing/BTDC → TDC → decreasing/ATDC), stop rotating the crank when the piston height is at MAX value minus 0.03mm.

The testing point is slightly towards ATDC from TDC when the piston has moved down 0.03mm from its highest position.

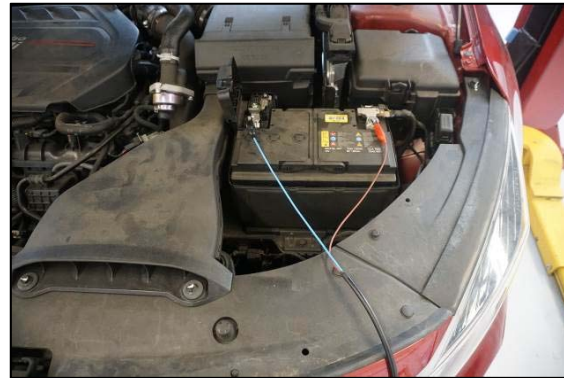
15. Connect the SST power cables to a fully charged 12V battery or to an external AC/DC power supply.

- Turn the bearing tool SST power switch 'ON'.

- Supply 12 volts (or an alternate external AC/DC 13.8 volt power supply with at least ~2 amp output) to the power cable (3) connected to the bearing tool SST.
- Turn power switch to ON.
- Toggle AP/VC transfer switch between AP <> VC.
  - ❖ The solenoids should “click” while switching between AP/VC when the unit is ON.
  - ❖ If the solenoids are not switching, then check the power cable or the power supply.

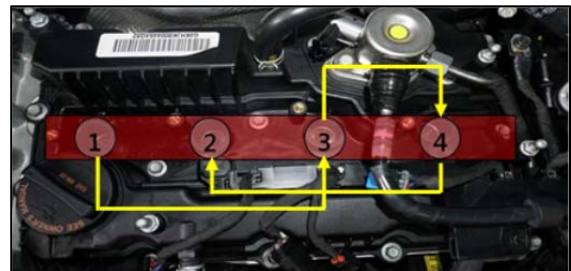
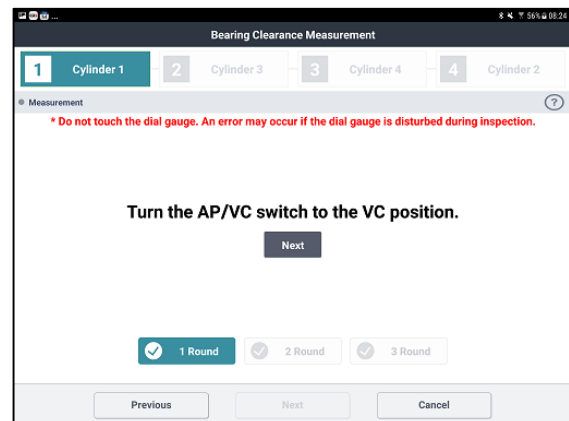
18. On the bearing tool SST, change the AP/VC switch to the VC position when instructed by the GDS.

If the bearing measurement value does not change when the AP/VC is switched or the “Unable to measure” message appears on the GDS, rotate the crankshaft further as the exhaust valves could be open. Set the crankshaft to TDC again (Step 11).

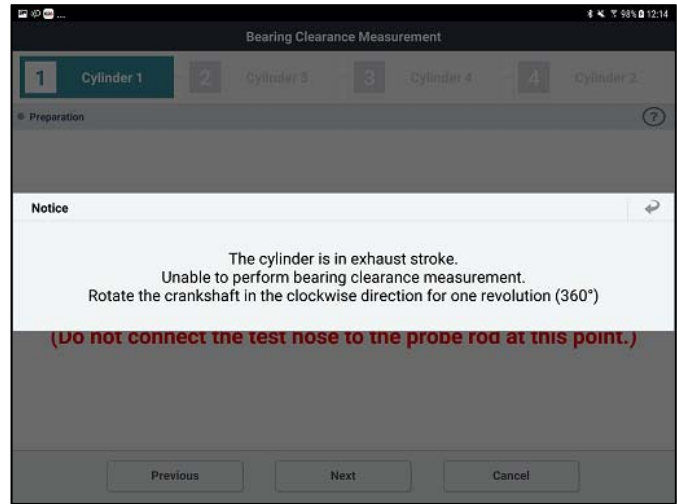
Ensure the test hose is disconnected from the clearance gauge SST when finding TDC.

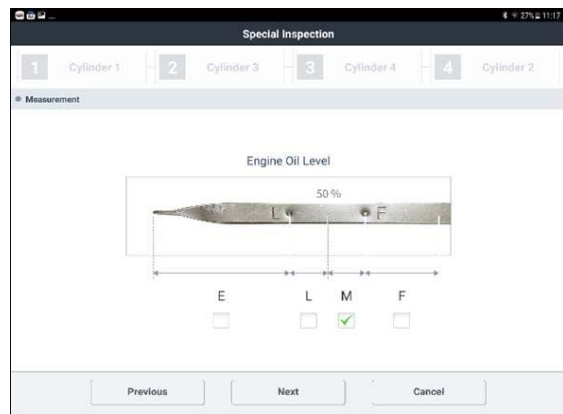
19. Continue following the instructions on the GDS to complete the bearing inspection. Check the engine oil level and select the level in the GDS.

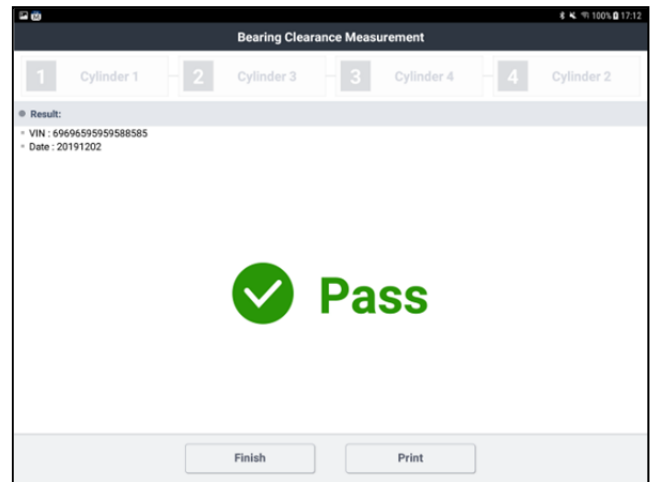
20. If the test result is “PASS”:

- a) Save a screenshot of the results screen.
  - ❖ If there is audible engine noise:
    - Refer to HTSS "Fix it Right" under symptom: “Engine Noise-Undetermined”
    - Using STUI on the GDS, record and submit a video of the engine noise 1-2 ft above the valve cover. Include the VIN Plate (at windshield or on door jamb) in the beginning of the video.
    - Follow remainder of Flow Chart A to complete the procedure.
  - ❖ If there is no audible engine noise:
    - Follow remainder of Flow Chart A to complete the procedure.
- b) Reinstall all components in the reverse order of removal.
- c) Check for DTCs and perform the appropriate diagnostic service. Ensure no warning lights are present to complete the procedure.

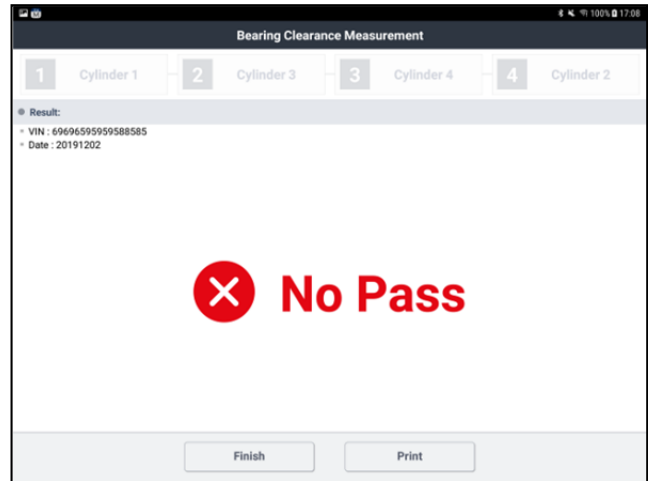
**If the test result is “NO PASS”:**

- a) Save a screenshot of the results screen.
- b) Submit PA for engine replacement approval.
- c) Follow remainder of Flow Chart A and Engine Replacement section of this TSB to complete the service procedure.
- d) Check for DTCs and perform the appropriate diagnostic service. Ensure no warning lights are present to complete the procedure.

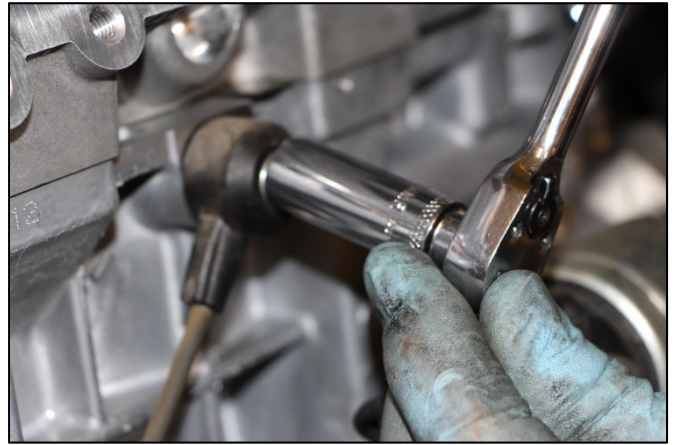
4. Remove and reinstall the engine knock sensor from the old engine to the new engine.

**Knock Sensor Fastener Tightening torque:**  
21Nm (15.5lb-ft)

Ensure the knock sensor is torqued to specification using a torque wrench.

- ❖ Improper installation can result in DTC codes.

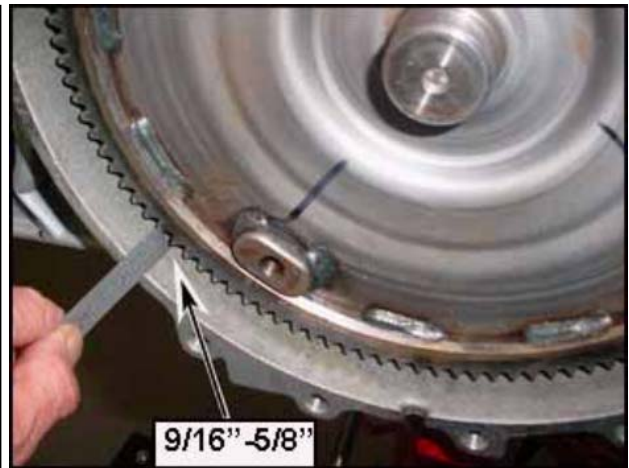
(For Automatic Transmissions equipped w/ torque converters only) If the torque converter has moved from the fully inserted position, carefully push inward and rotate the torque converter until the converter is recessed approximately 5/16" - 9/16" (8 -14 mm) into the transaxle case when reinstalling the automatic transaxle.

Check the depth of the torque converter to confirm it's fully installed in the transmission otherwise the oil pump may be damaged resulting in transmission failure.

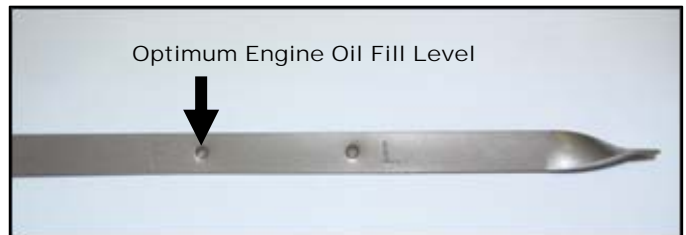
- Check for any leaks during this time.
- After the engine has warmed up to normal operating temperature, turn the engine off, wait a few minutes, and then **adjust the engine oil level to near the "F" mark as shown.**
