Classification:  
DA17-028BReference:  
ITB18-006BCOPYRIGHT© NISSAN NORTH AMERICA, INC.  
Date:  
March 24, 2021

## 2013 JX35 AND 2014-2017 QX60; VDC WARNING LAMP ON WITH DTC C1116 STORED

**APPLIED VEHICLES:** 2013 JX35 (L50)  
2014-2017 QX60 (L50)  
**APPLIED SYSTEM:** Without Intelligent Cruise Control ONLY

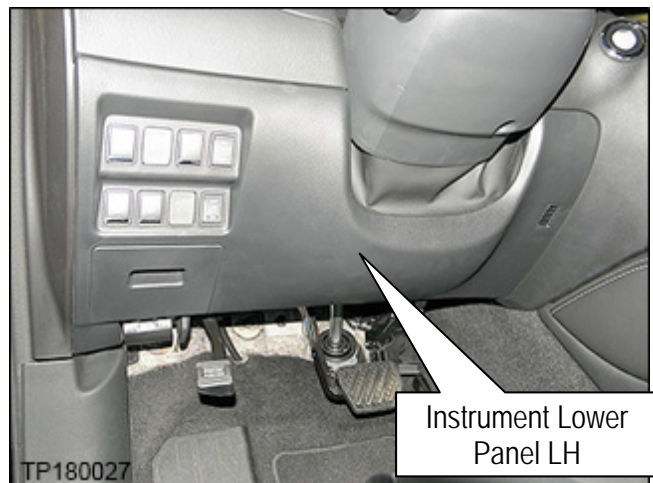
Figure 1

4. Remove the Instrument Lower Panel LH.
  - For the procedure to remove the Instrument Lower Panel LH, refer to the ESM section, **BODY INTERIOR > INSTRUMENT PANEL > REMOVAL AND INSTALLATION > INSTRUMENT LOWER PANEL LH > Removal and Installation.**

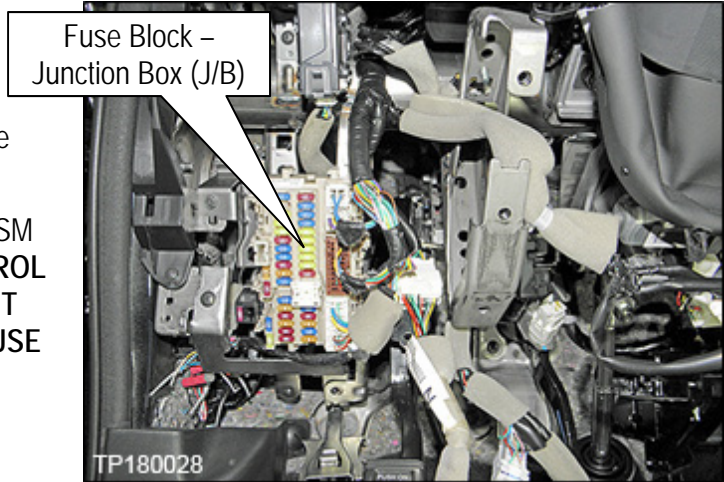
Figure 2

5. Completely disconnect and remove the Fuse Block – Junction Box (J/B).
  - For additional information refer to the ESM section, **ELECTRICAL POWER CONTROL > POWER SUPPLY, GROUND CIRCUIT ELEMENTS > WIRING DIAGRAM > FUSE BLOCK – JUNCTION BOX (J/B)**.

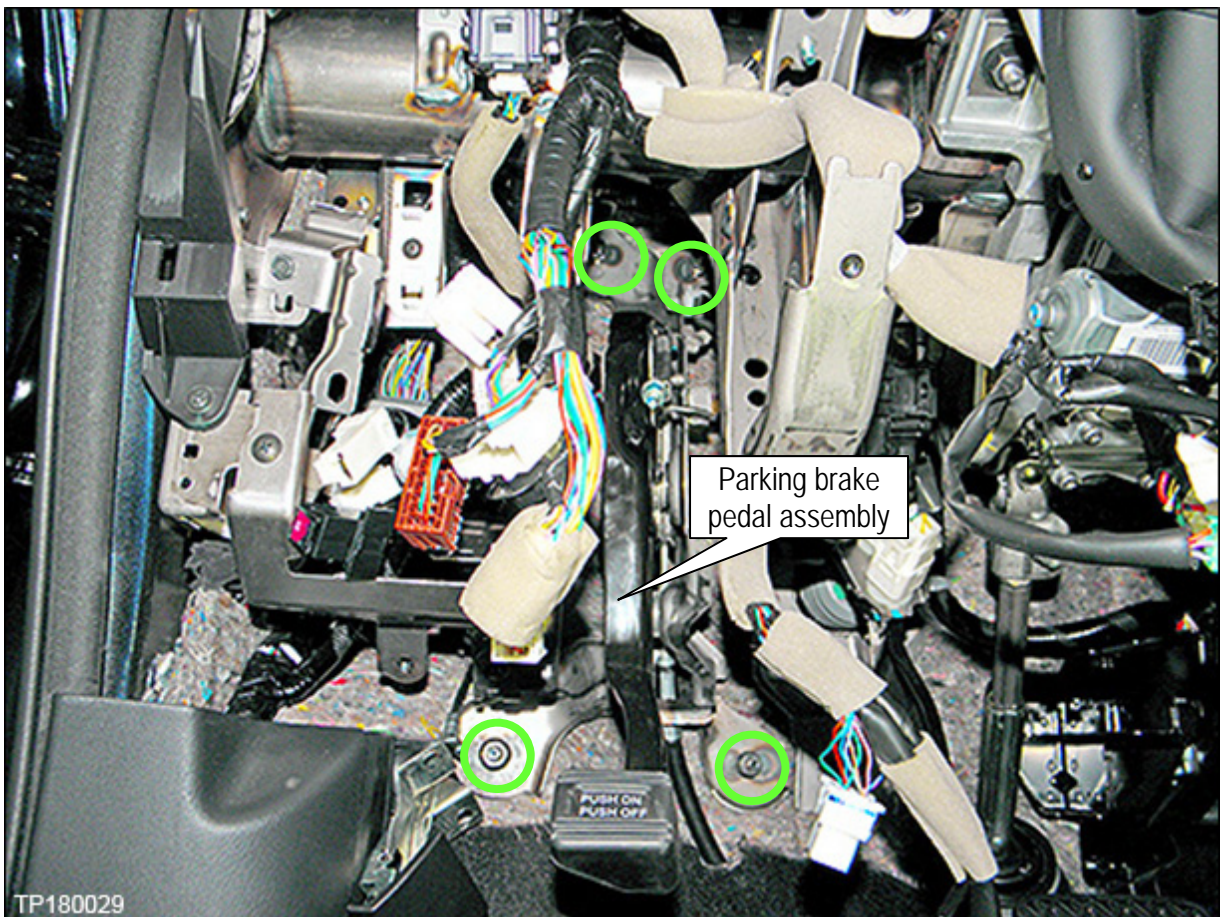
Figure 3

6. Unbolt the parking brake pedal assembly.
  - Remove four (4) bolts shown in Figure 3.

**NOTE:** Do not disconnect the parking brake cable.

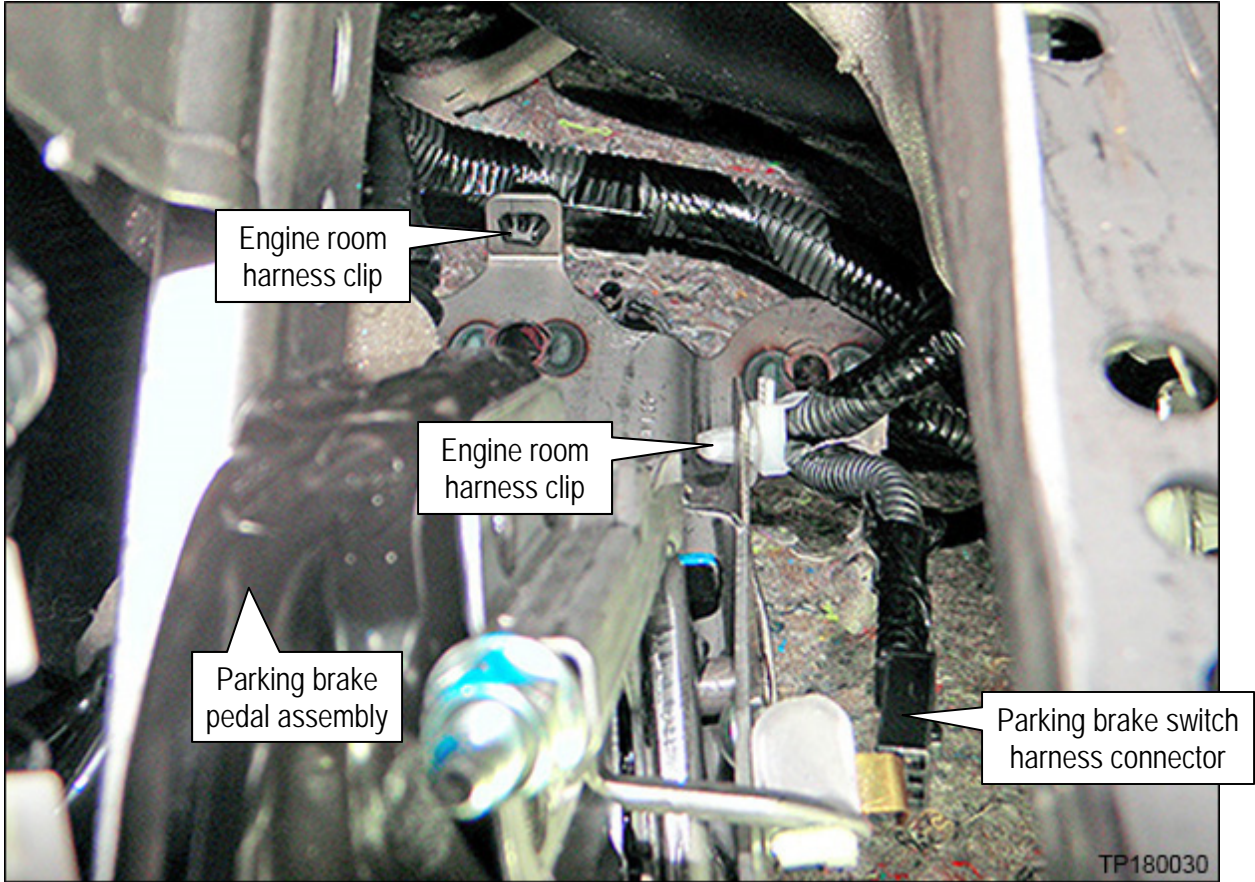
- Unclip the engine room harness from the parking brake pedal assembly in the two locations shown in Figure 4 and unplug the parking brake switch harness connector.

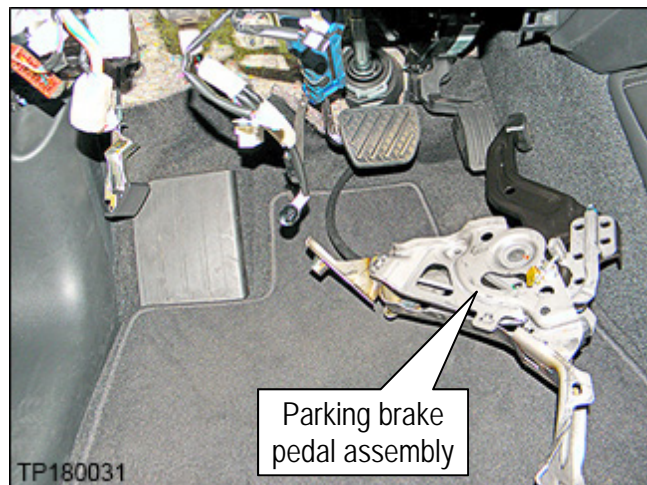
Figure 5

- Remove the parking brake pedal assembly from under the Instrument Panel and lay it on the floor as shown in Figure 5.

**NOTE:** Do not disconnect the parking brake cable.

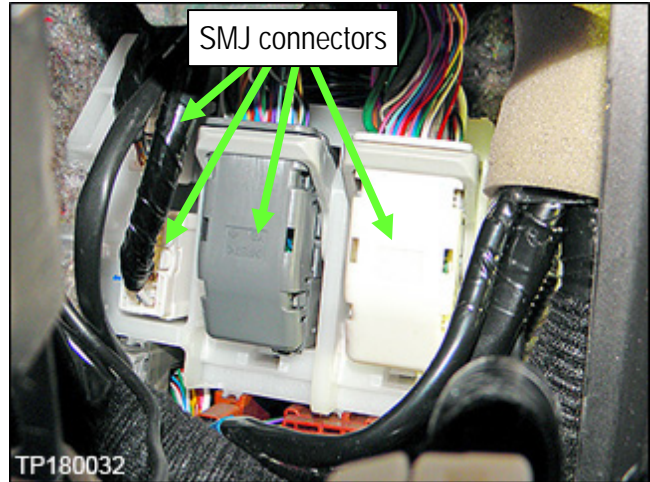
Figure 6

9. Disconnect the Super Multiple Junction (SMJ) connectors.

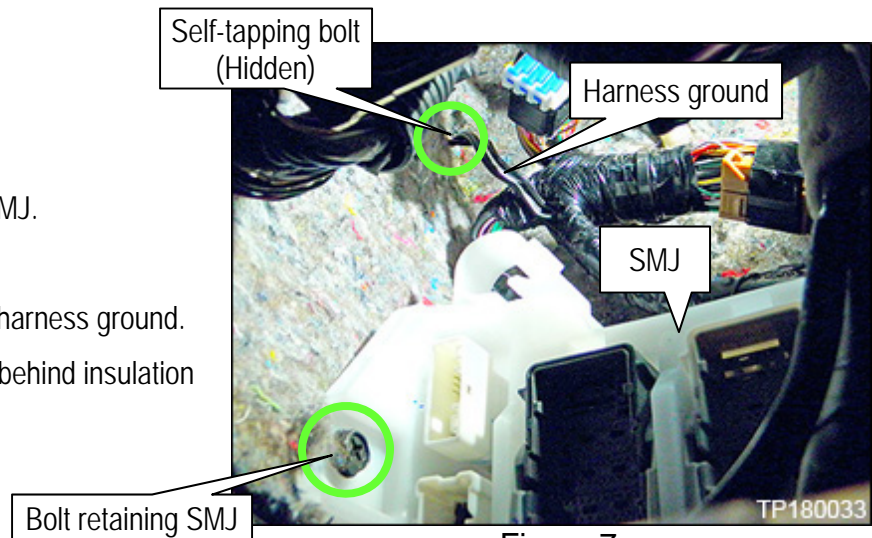
10. Remove bolt that is retaining SMJ.
11. Remove self-tapping bolt from harness ground.  
**NOTE:** Bolt hidden in Figure 7 behind insulation material.

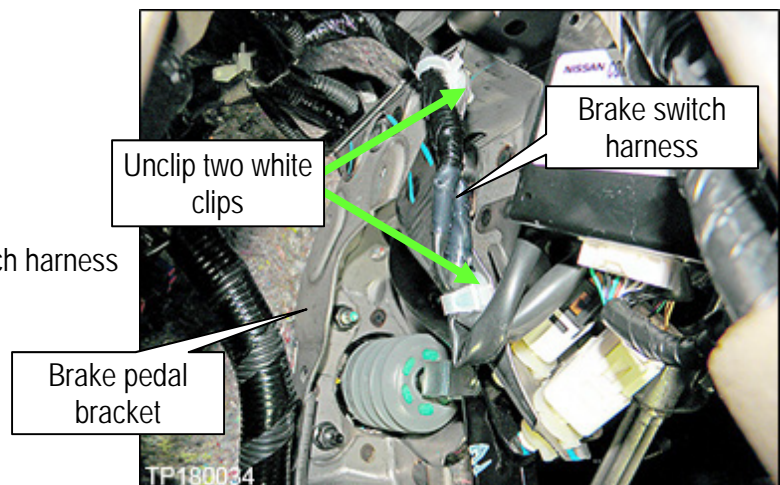
Figure 8

12. Unclip two (2) white clips of brake switch harness from brake pedal bracket.

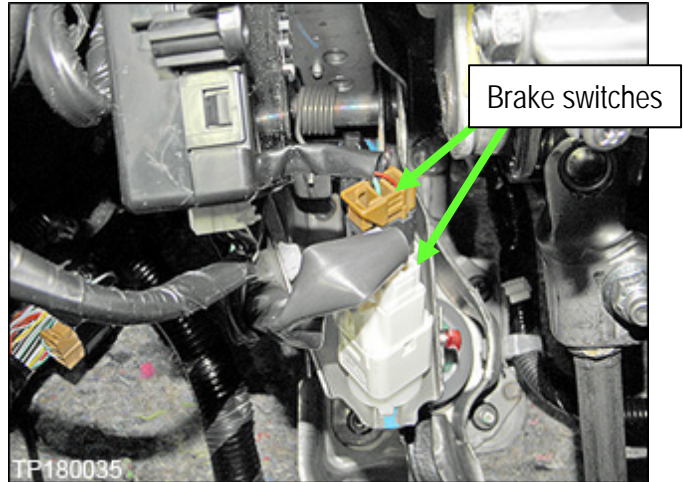
Figure 9

13. Disconnect both brake switch harness connectors from the brake switches.

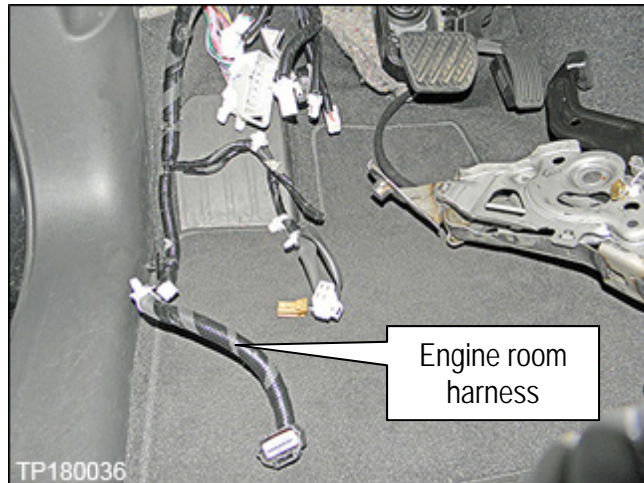
Figure 10

14. Remove the engine room harness completely from the Instrument panel and lay it on the floor.

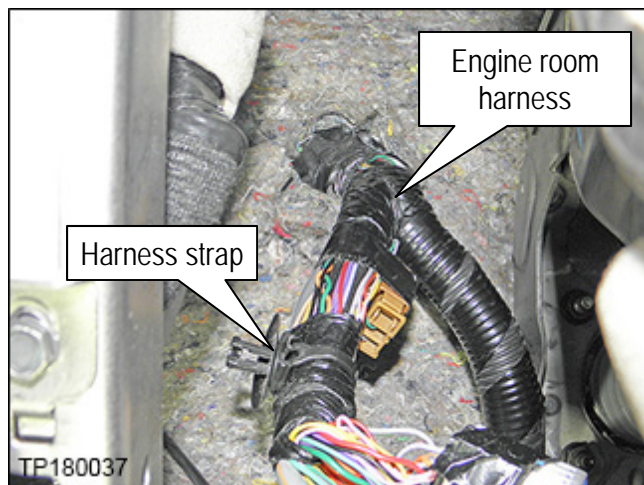
Figure 11

15. Detach harness strap from threaded stud, if not already detached.

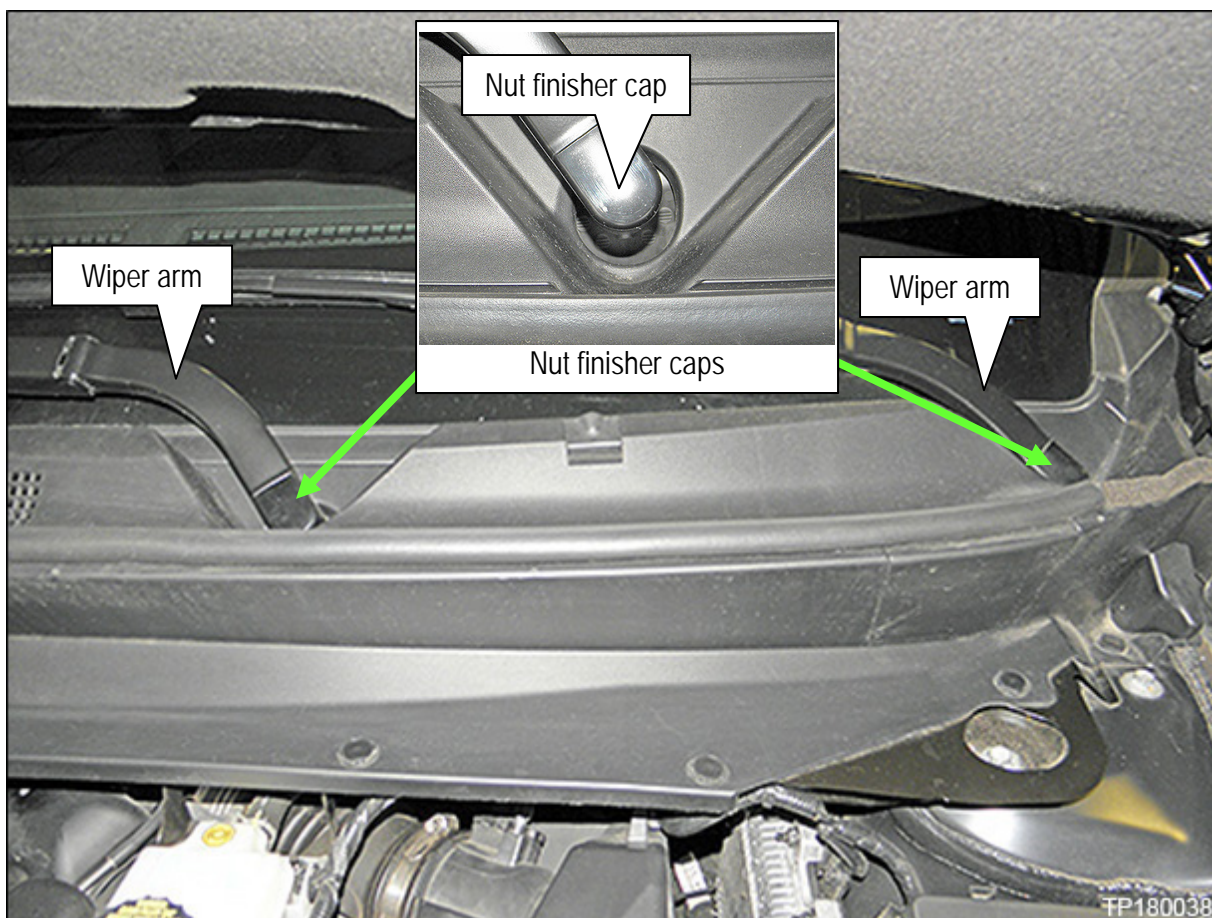
16. Remove the wiper arms as follows:

- a. Remove the nut finisher caps.

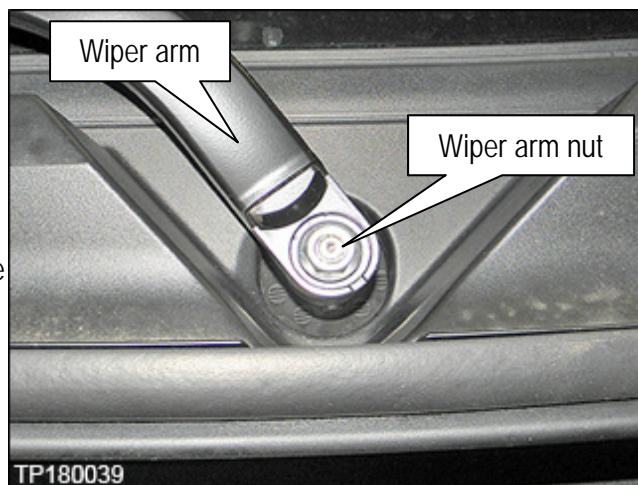
- d. Remove both wiper arms.

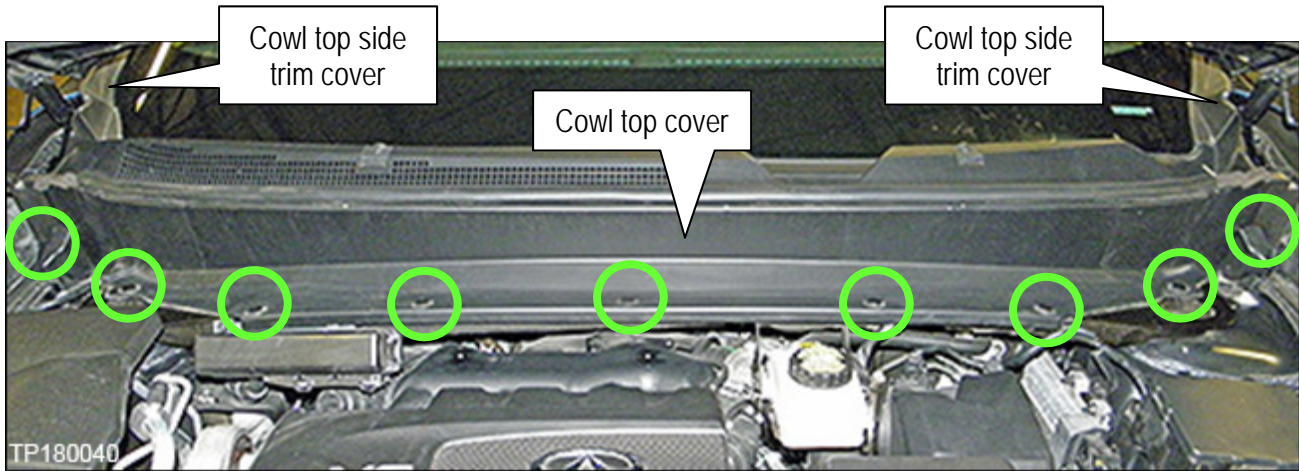
Figure 14

18. Remove the 9 clips that attach the cowl top cover (Figure 14).

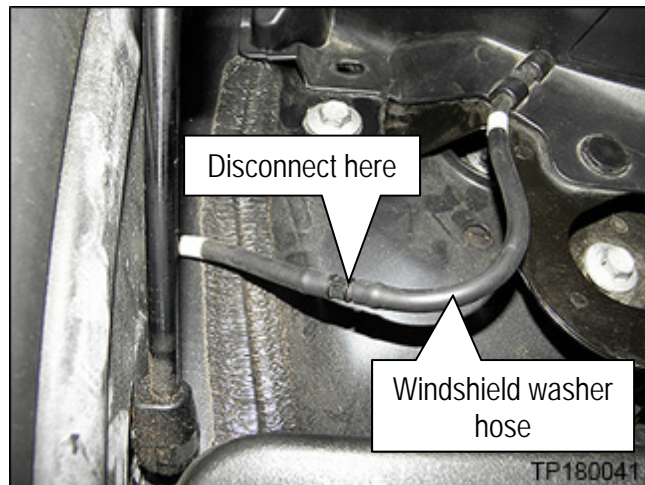
Figure 15

19. Disconnect the windshield washer hose.

- Located on the passenger side of the cowl top cover.

20. Remove the cowl top cover.

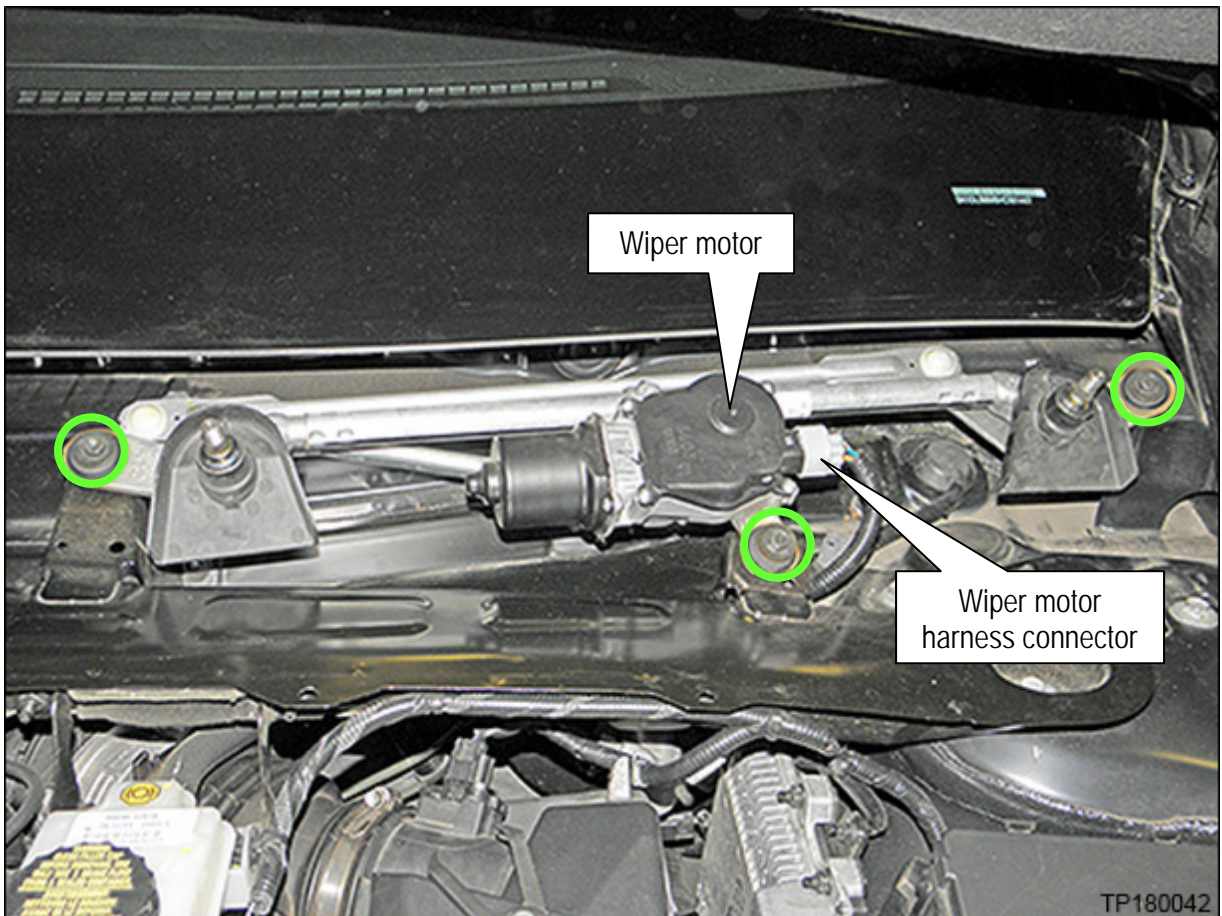
Figure 16

21. Remove the three nuts retaining the wiper motor.

22. Disconnect the wiper motor harness connector.

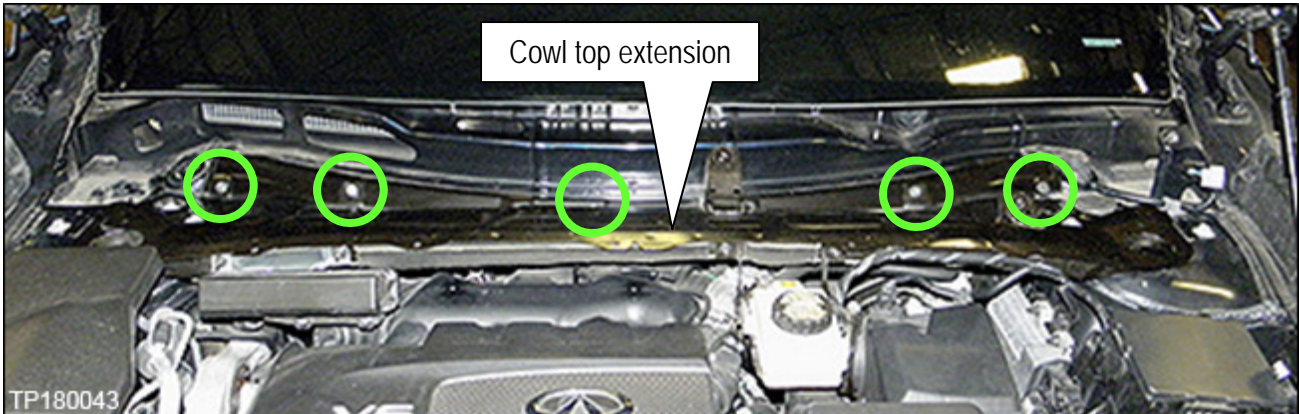
Figure 17

- a. Remove four (4) bolts and one (1) nut along the rear edge of the cowl top extension.

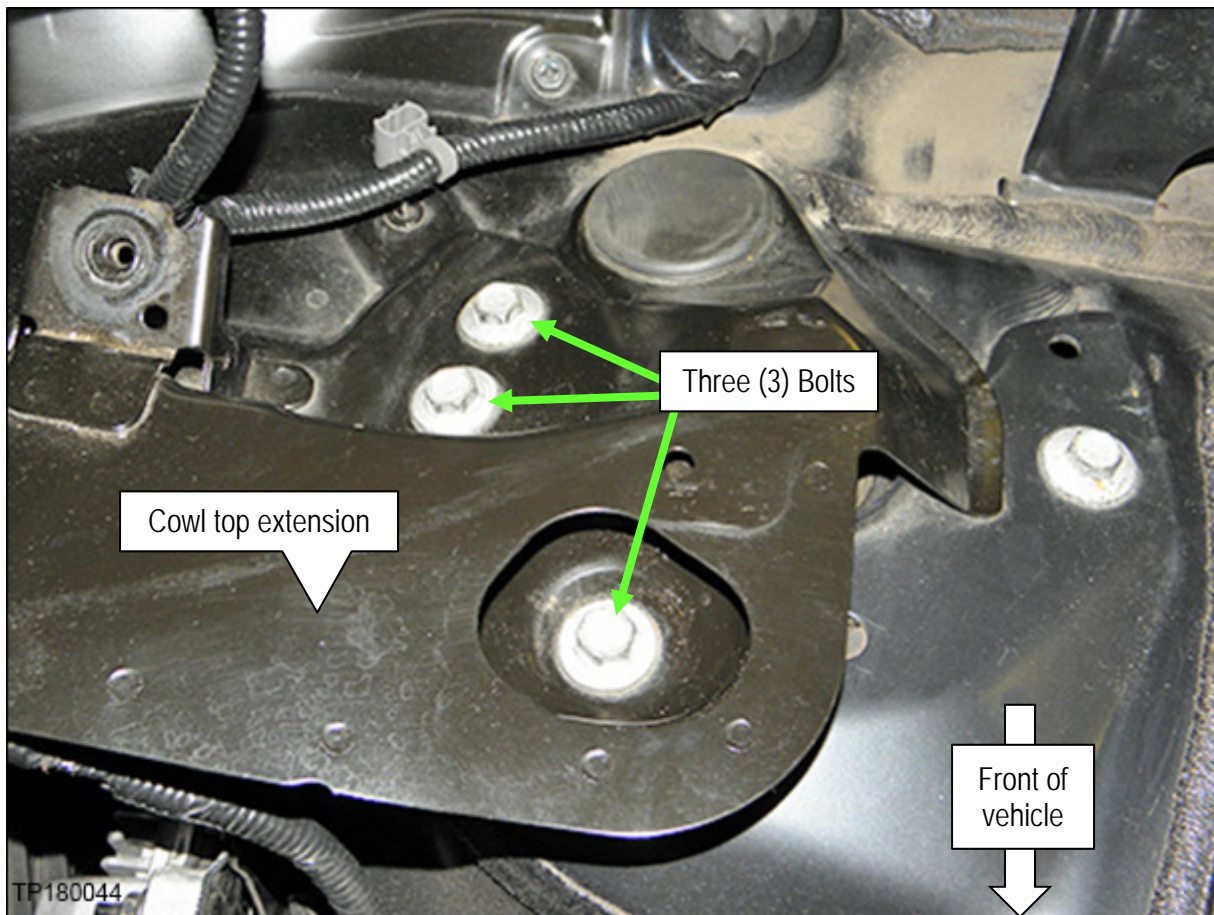
- b. Remove the six (6) bolts that attach the cowl top extension; three (3) at each end.
  - Three (3) bolts shown in Figure 18 are on the driver's side. Three (3) bolts for passenger side are similar, but not shown.

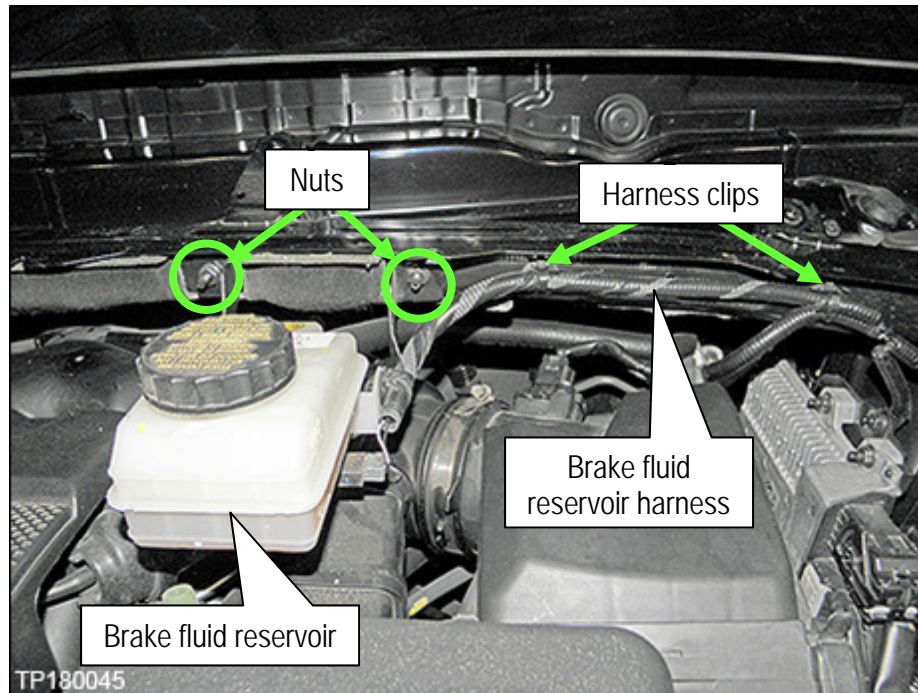
Figure 19

- c. Remove two (2) nuts that attach the brake fluid reservoir to the cowl top extension.
- d. Disconnect brake fluid reservoir harness clips from the cowl top extension.

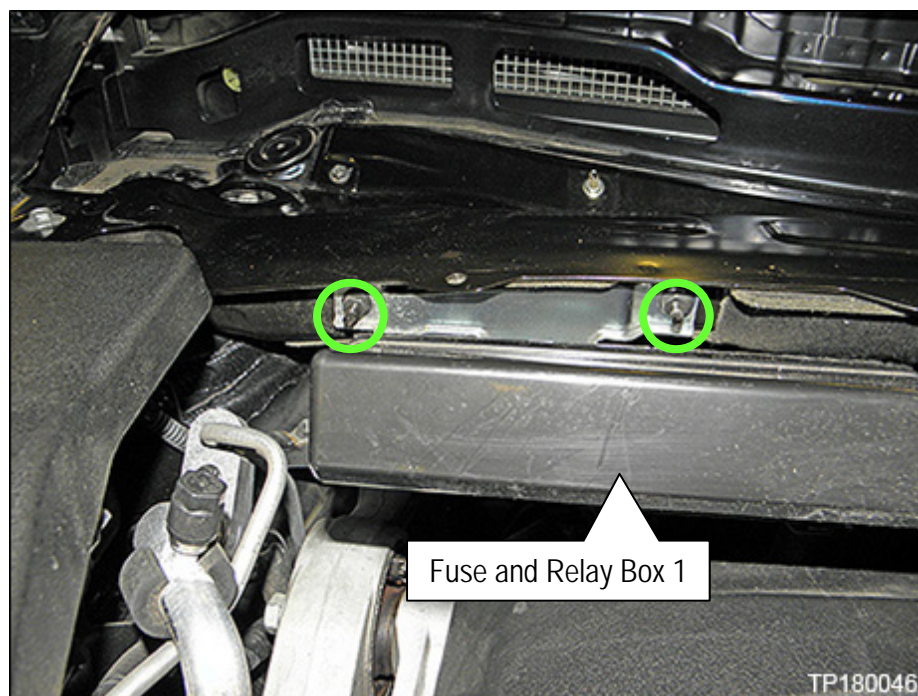
Figure 20

- e. Remove two (2) nuts that attach the Fuse and Relay Box 1 to the cowl top extension.

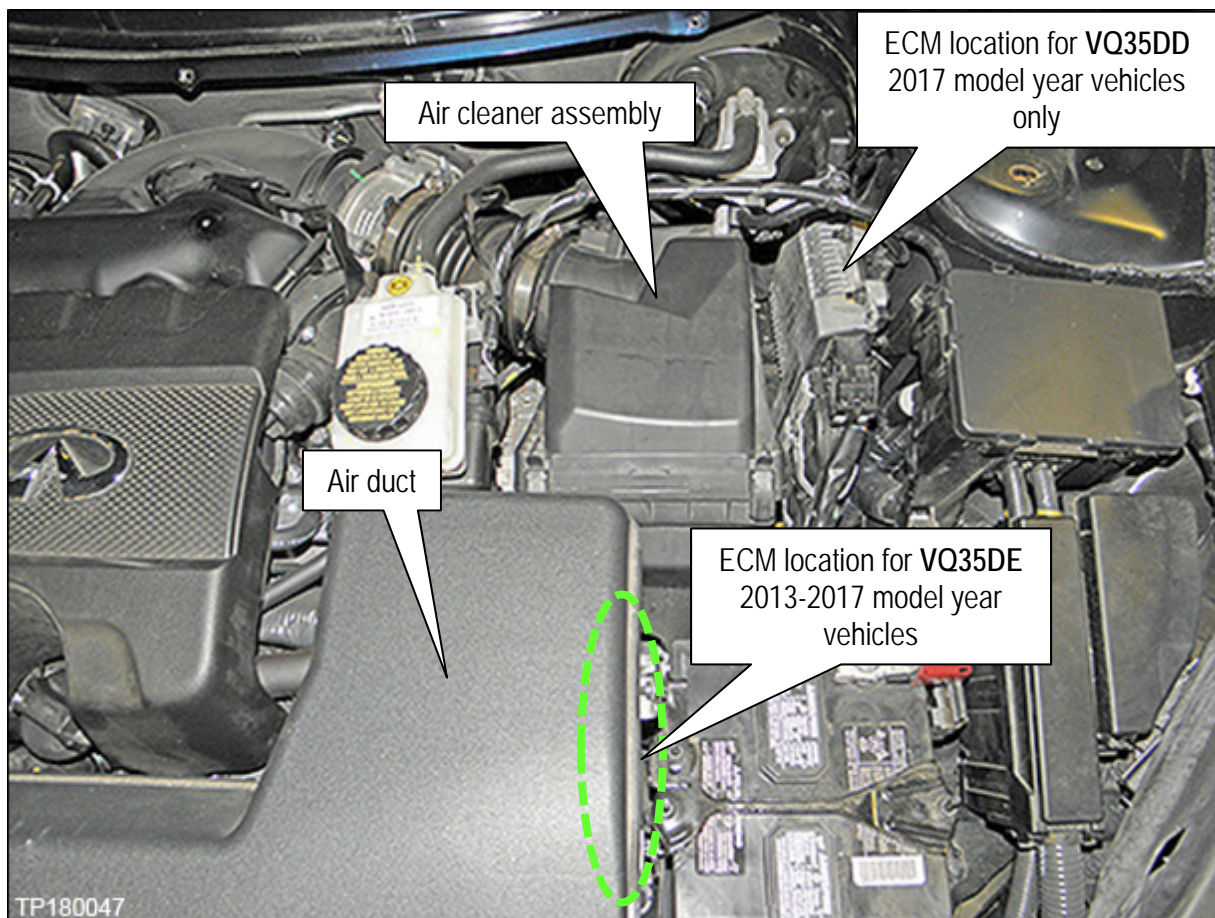
Figure 21

24. Remove the front air duct and the air cleaner assembly (Figure 21).

25. For 2017 model year vehicles with VQ35DD engine, disconnect and remove the ECM shown in Figure 21.

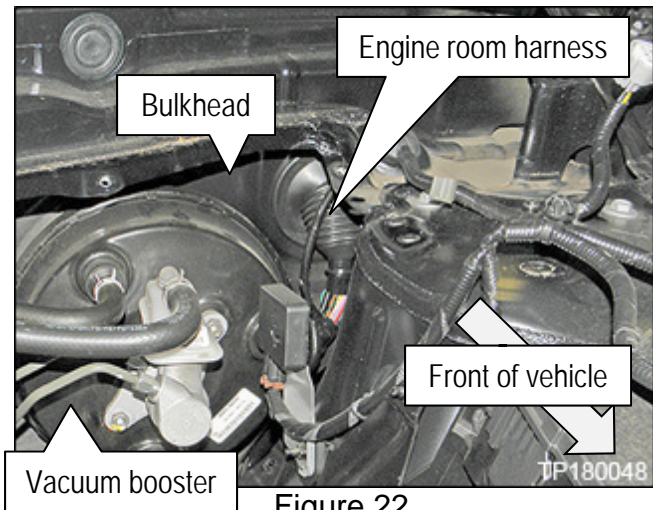
26. Pull the right side engine room harness completely through the Lower Dash Assembly (bulkhead) and into engine room.

**IMPORTANT:** Take care to not damage the harness or harness connectors on the sharp edges of the bulkhead as it is pulled through.

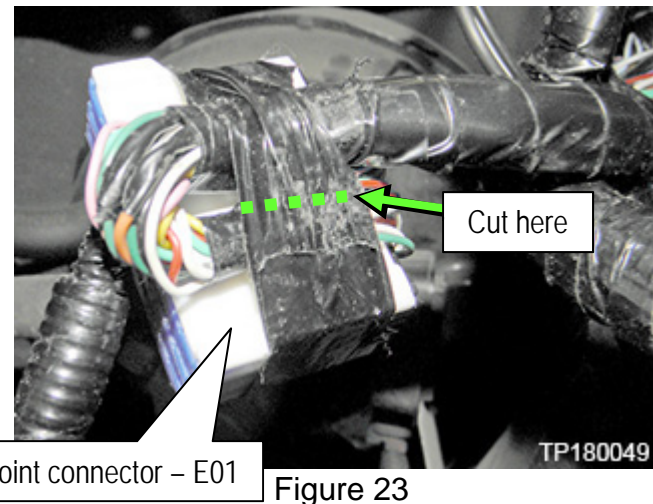
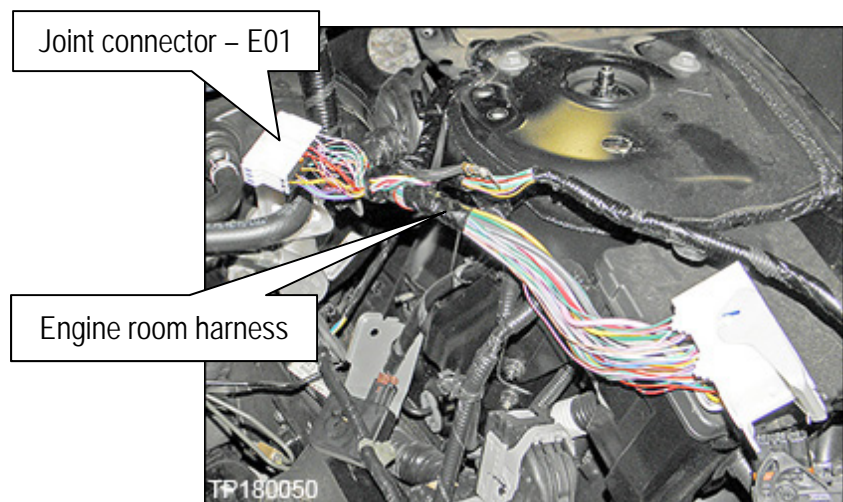
27. Locate "Joint connector – E01" that is attached to the engine room harness.

- This harness connector has blue "shunts" plugged into its terminals.

28. Cut the black tape that is attaching Joint connector – E01 to the engine room harness, and remove the black tape from Joint connector – E01.

- Figure 24 shown with Joint connector – E01 black tape removed.

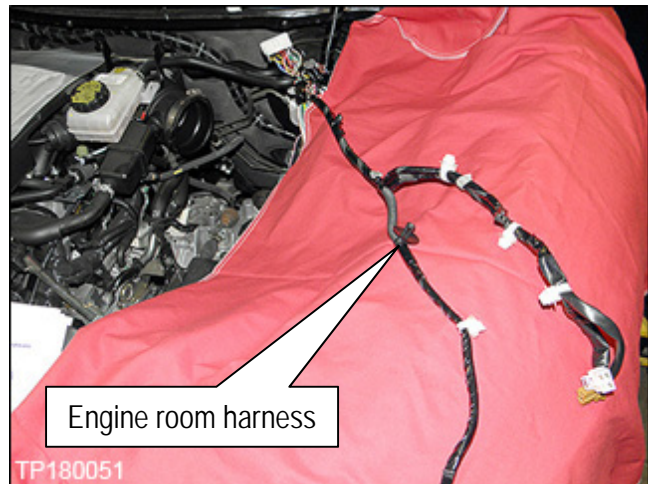
Figure 25

29. Place a fender cover over the driver's side fender and lay out the engine room harness.

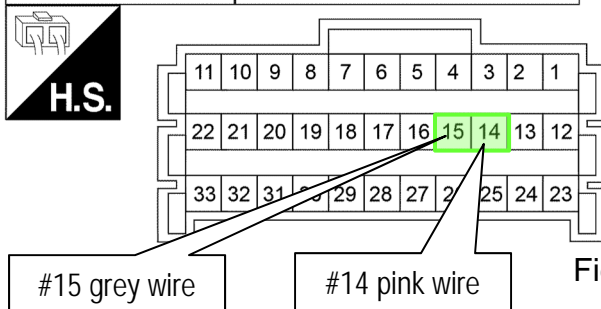
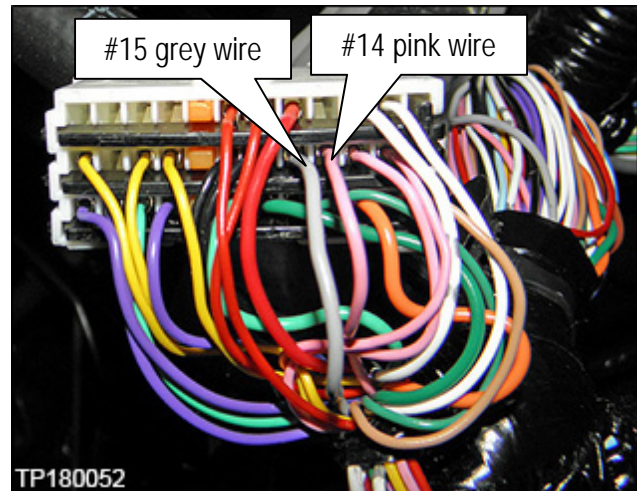
30. Locate the grey and pink wires shown in Figure 26 in Joint connector – E01 (connector number E44).

- Grey wire in position #15 as viewed from the harness side.
- Pink wire in position #14 as viewed from the harness side.

Connector No.	E44
Connector Name	JOINT CONNECTOR-E01
Connector Type	BJ30FW
Connector Color	WHITE

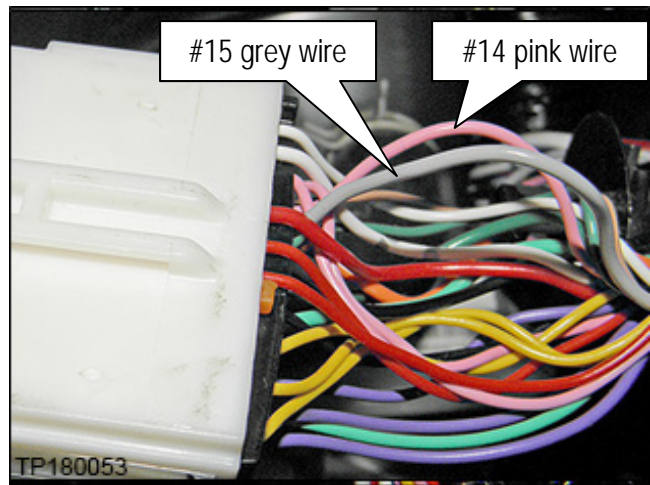
Figure 27

31. Separate the grey and pink wires that have been located from the other wires as shown in Figure 27.

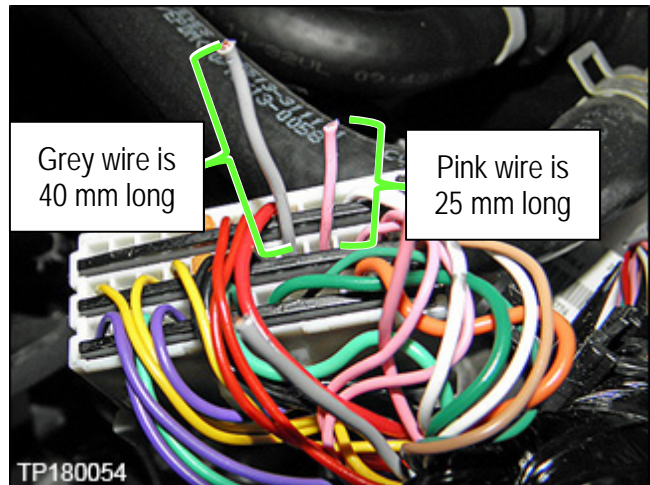
Figure 28

32. Cut the grey wire that was located in steps 30 and 31.
- Measure approximately 40 mm from Joint connector – E01 to point where grey wire is cut.
33. Cut the pink wire that was located in steps 30 and 31.
- Measure approximately 25 mm from Joint connector – E01 to point where pink wire is cut.

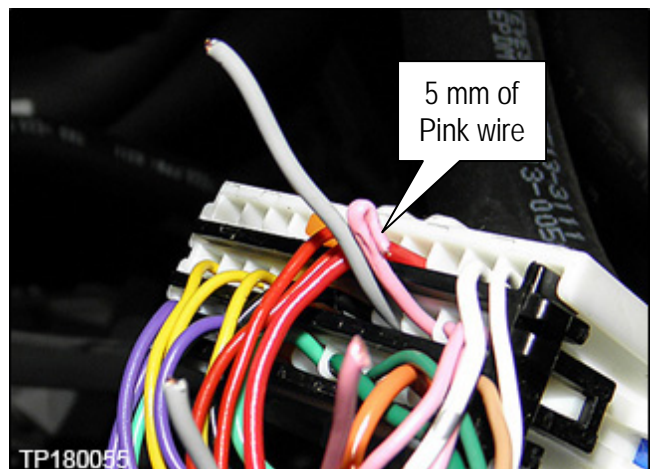
Figure 29

34. Fold over approximately 5 mm of the pink wire that is extending from Joint connector – E01 as shown in Figure 29.

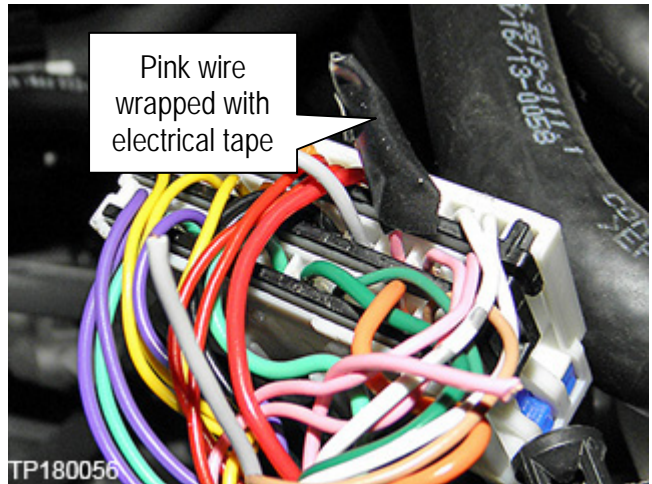
Figure 30

35. Wrap pink wire that was folded over in step 34 with black electrical tape.
- Use 3M/Scotch Professional Grade Vinyl Super 88 Electrical Tape (3/4 inch wide) or equivalent.

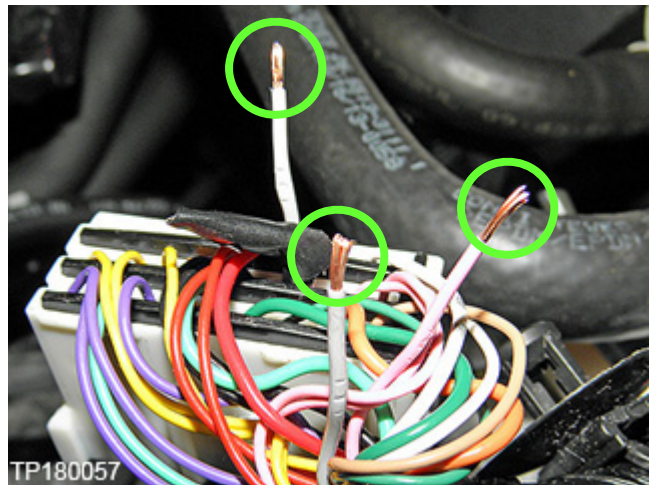
Figure 31

36. Strip approximately 10 mm from the remaining pink wire and the two grey wires.

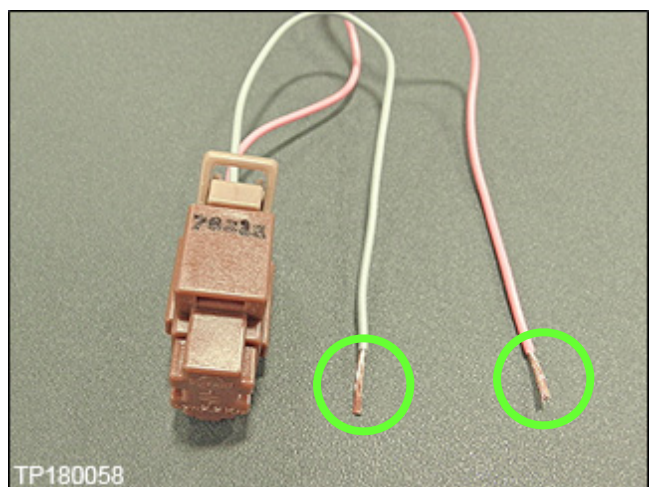
Figure 32

37. Strip approximately 10 mm from the pink and grey wires of the jumper harness.
- Listed in the **PARTS INFORMATION** on page 26.

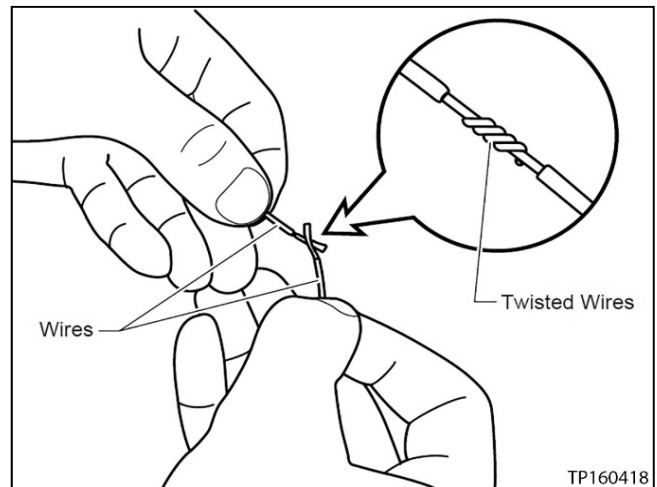
Figure 33

39. Twist together the pink wire of the jumper harness with the remaining pink wire stripped in step 36. (See Figures 33 and 34.)

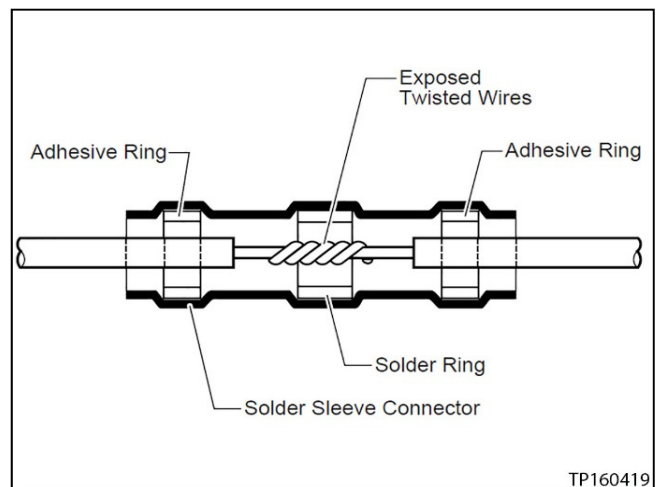
Figure 34

40. Position the solder ring in relation to the twisted wires as shown in Figure 34.

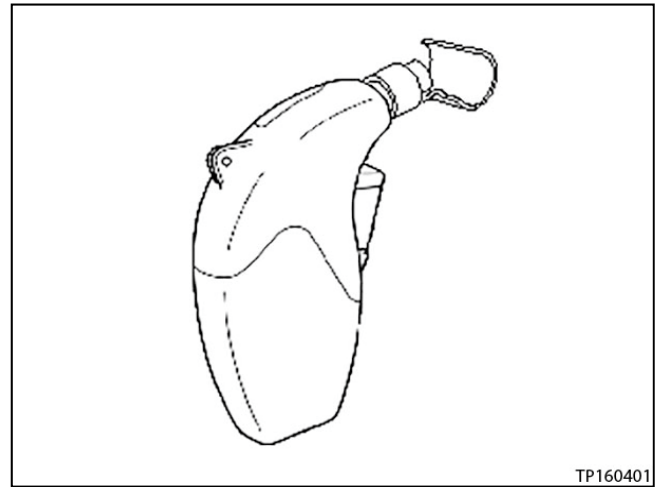
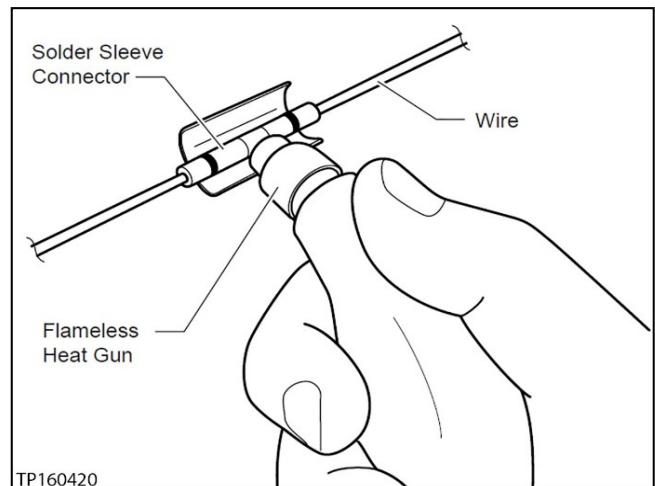
41. "Install" the solder sleeve connector by shrinking it to the wire with essential tool Flameless Heat Gun J-46538 or similar flameless heating tool (see Figures 35 and 36).

- Melt the solder (silver ring inside the solder sleeve connector) into the exposed twisted wire area,
- Melt the sealant (red rings inside the solder sleeve connector) onto the wires, and
- Shrink the remainder of the solder sleeve connector to the wire.

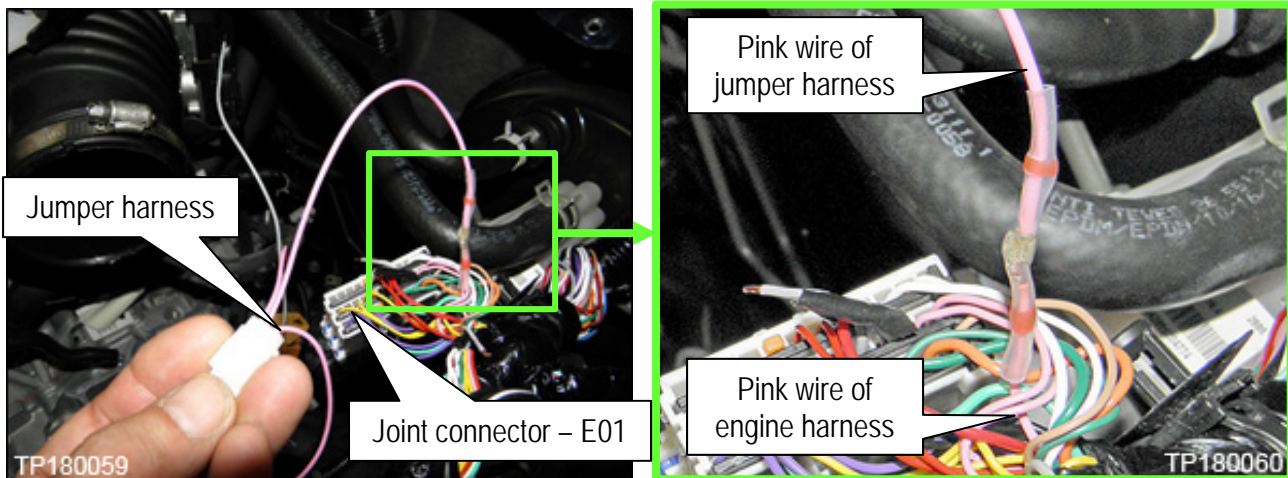
- Figure 37 shown with solder connection of pink wire of jumper harness and pink wire of Joint connector – E01 completed.

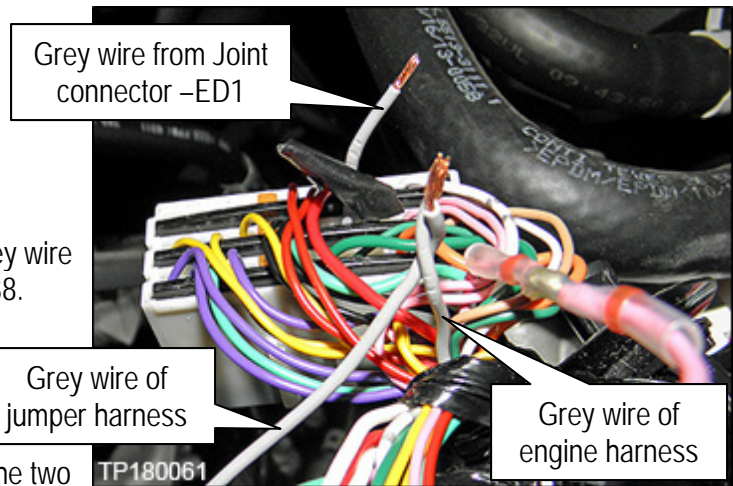
Figure 38

42. Twist together the grey wire of the engine harness that was cut in step 32 with the grey wire of the jumper harness as shown in Figure 38.

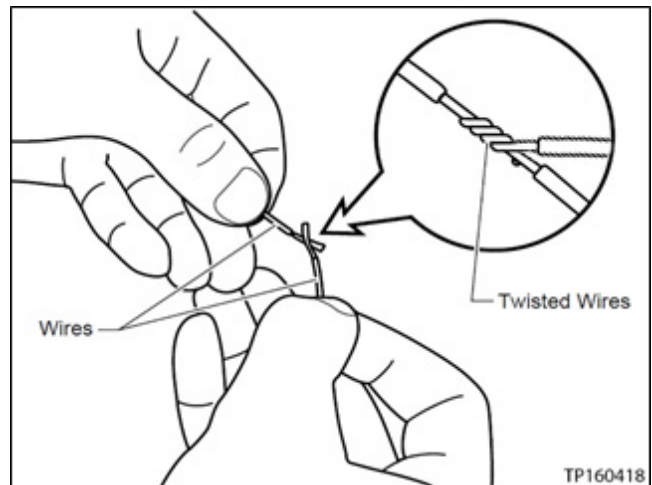
Figure 39

44. Now twist the third grey wire from Joint connector – E01 (Figure 39) that was cut through in step 32 to form a three way connection.

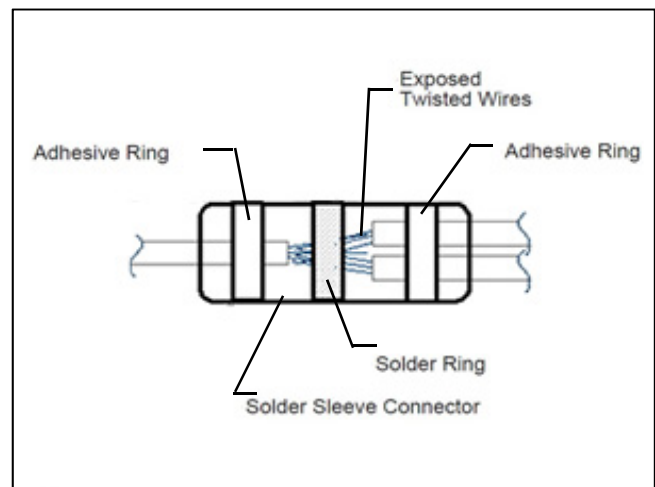
Figure 40

45. Position the blue solder sleeve connector so that the solder ring is in relation to the three twisted wires as shown in Figure 40.

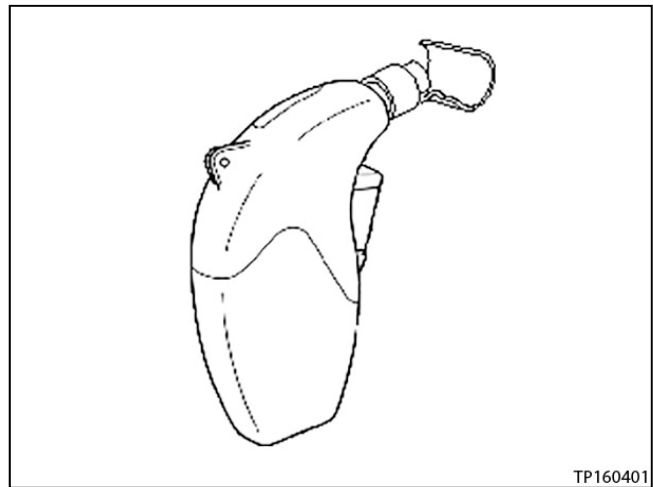
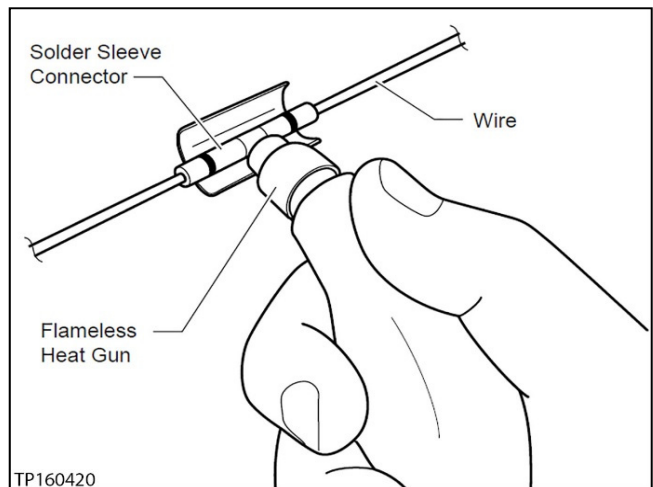
46. "Install" the solder sleeve connector by shrinking it to the wire with essential tool Flameless Heat Gun J-46538 or similar flameless heating tool (see Figures 41 and 42).

- Melt the solder (silver ring inside the solder sleeve connector) into the exposed twisted wire area,
- Melt the sealant (blue rings inside the solder sleeve connector) onto the wires, and
- Shrink the remainder of the solder sleeve connector to the wire.

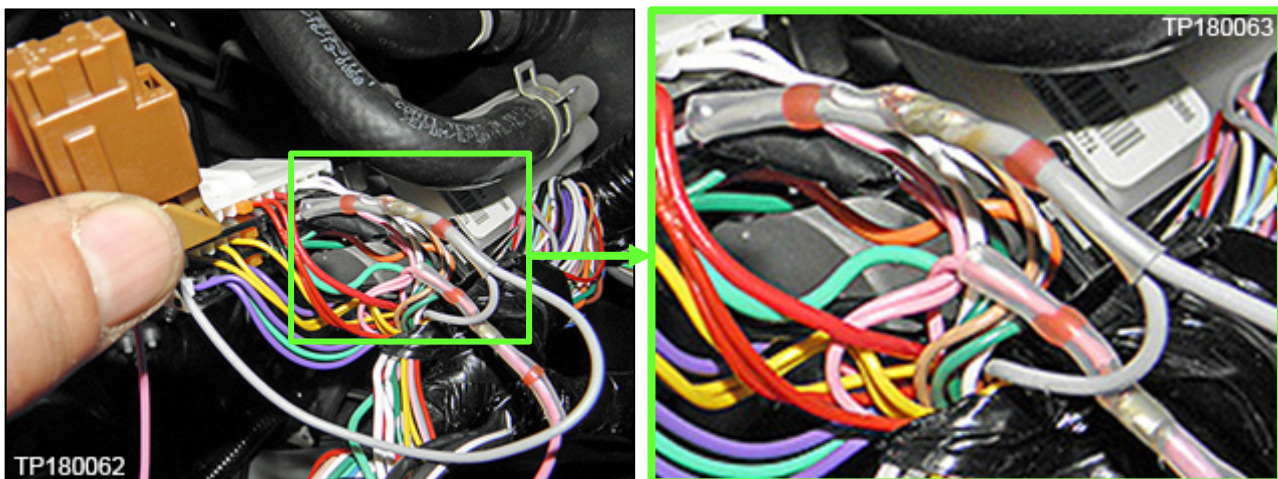
- Figure 43 shown with three way solder connections completed.

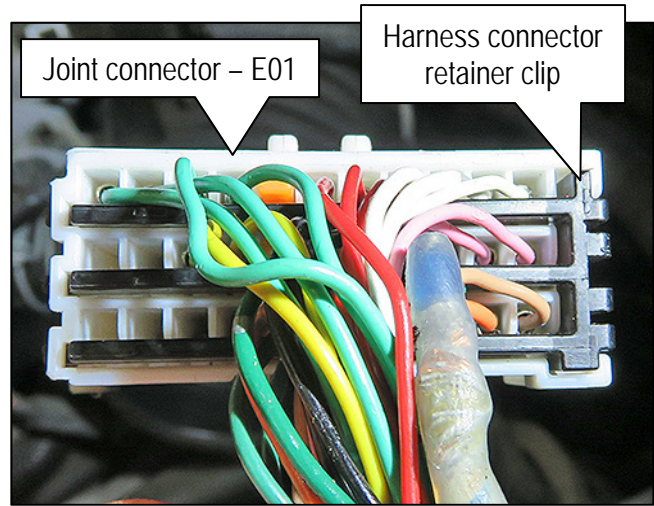
Figure 44

48. Remove the black harness connector retainer clip from the back of Joint connector – E01.
49. Remove the plastic harness connector protector from the end of the yellow jumper harness shown in Figure 45.
  - See the **PARTS INFORMATION** on page 26 for 2013 JX35 and 2014-2015 QX60 VDC RESISTOR JUMPER kit.
