Classification:  
DA17-028BReference:  
ITB18-006BCOPYRIGHT© NISSAN NORTH AMERICA, INC.  
Date:  
March 24, 2021

## 2013 JX35 AND 2014-2017 QX60; VDC WARNING LAMP ON WITH DTC C1116 STORED

**APPLIED VEHICLES:** 2013 JX35 (L50)  
2014-2017 QX60 (L50)  
**APPLIED SYSTEM:** Without Intelligent Cruise Control ONLY

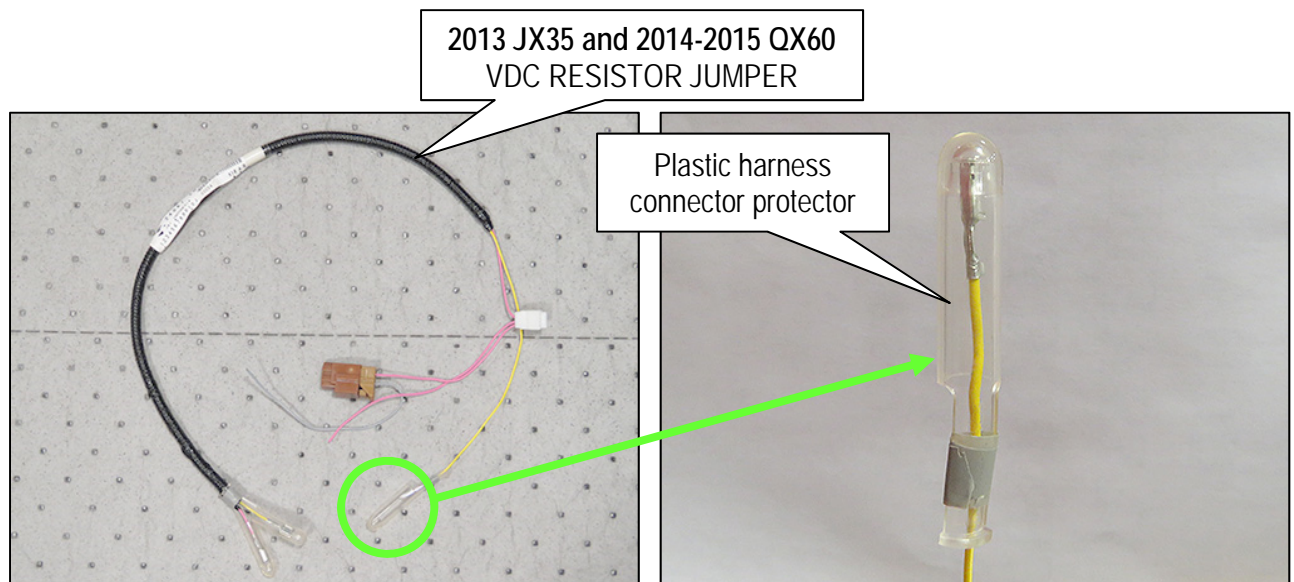
Figure 45

48. Remove the black harness connector retainer clip from the back of Joint connector – E01.
49. Remove the plastic harness connector protector from the end of the yellow jumper harness shown in Figure 45.
  - See the **PARTS INFORMATION** on page 26 for 2013 JX35 and 2014-2015 QX60 VDC RESISTOR JUMPER kit.

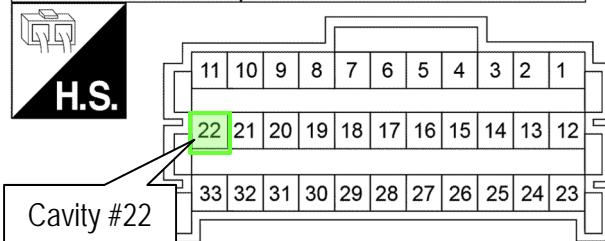
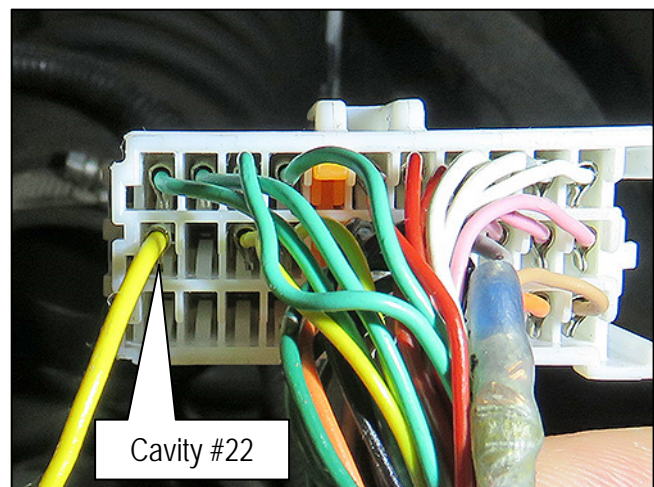
Figure 46

50. Insert the end of the yellow jumper harness into Joint connector – E01, cavity #22.

Connector No.	E44
Connector Name	JOINT CONNECTOR-E01
Connector Type	BJ30FW
Connector Color	WHITE

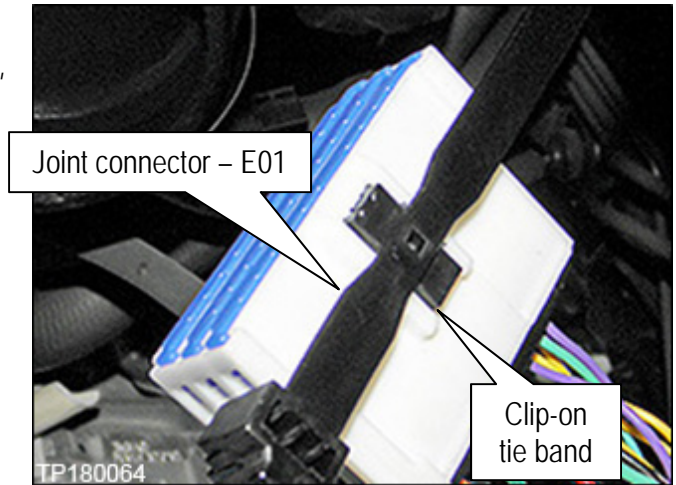
Figure 47

53. Install a new band (clip-on tie band) from the **PARTS INFORMATION** on page 26 to Joint connector – E01.

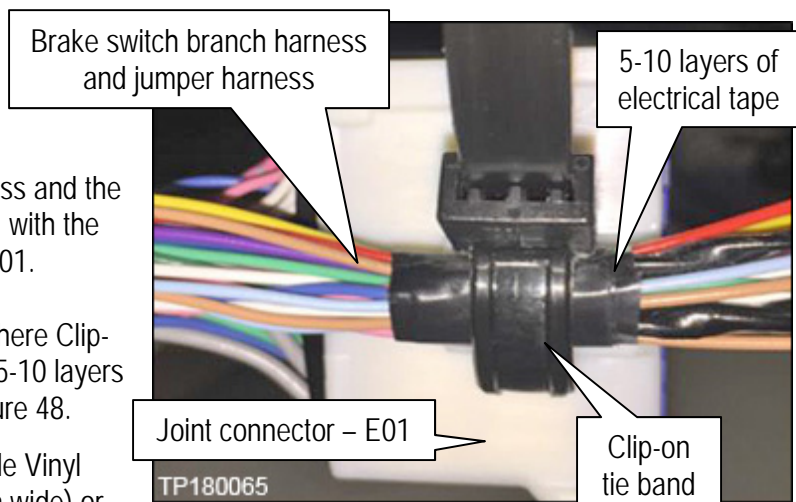
Figure 48

54. Bundle the brake switch branch harness and the jumper harness and then secure them with the clip-on tie band of Joint connector – E01.

**IMPORTANT:** If tape is not present where Clip-on tie band will be located, wrap with 5-10 layers of electrical tape first as shown in Figure 48.

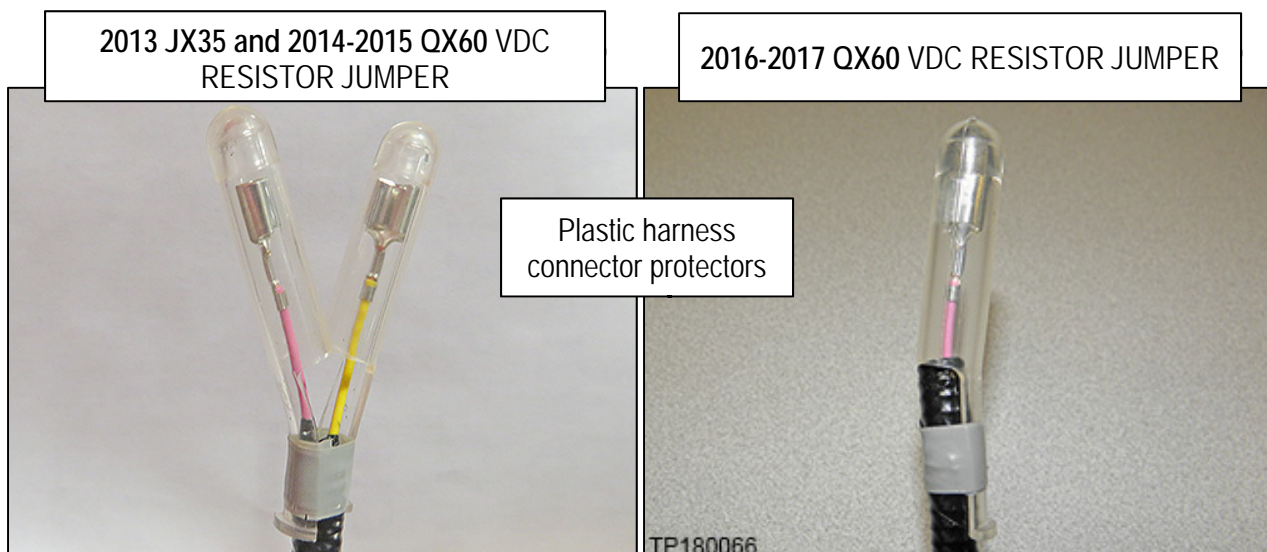
Figure 49

55. Remove any remaining plastic harness connector protector(s) from the jumper harness (Figure 49).

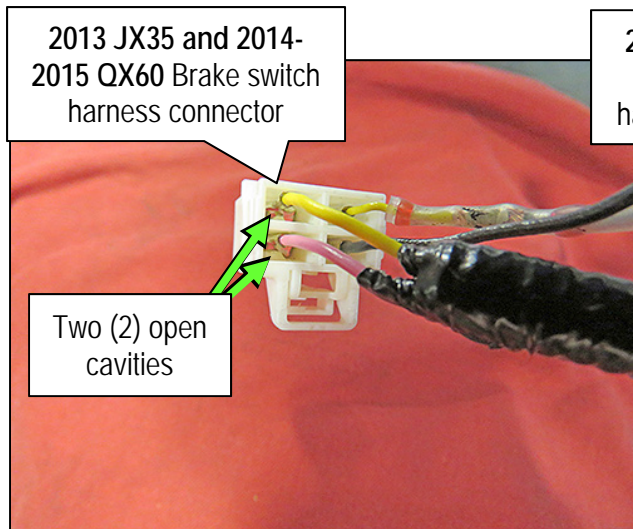
Figure 50

- For 2013 JX35 and 2014-2015 QX60: Insert the pink and yellow jumper wire connectors into the open cavities of the harness side of the brake switch harness connector as shown in Figure 50.
- For 2016-2017 QX60: Insert the single pink jumper wire connector into the open cavity of the harness side of the brake switch harness connector as shown in Figure 51.

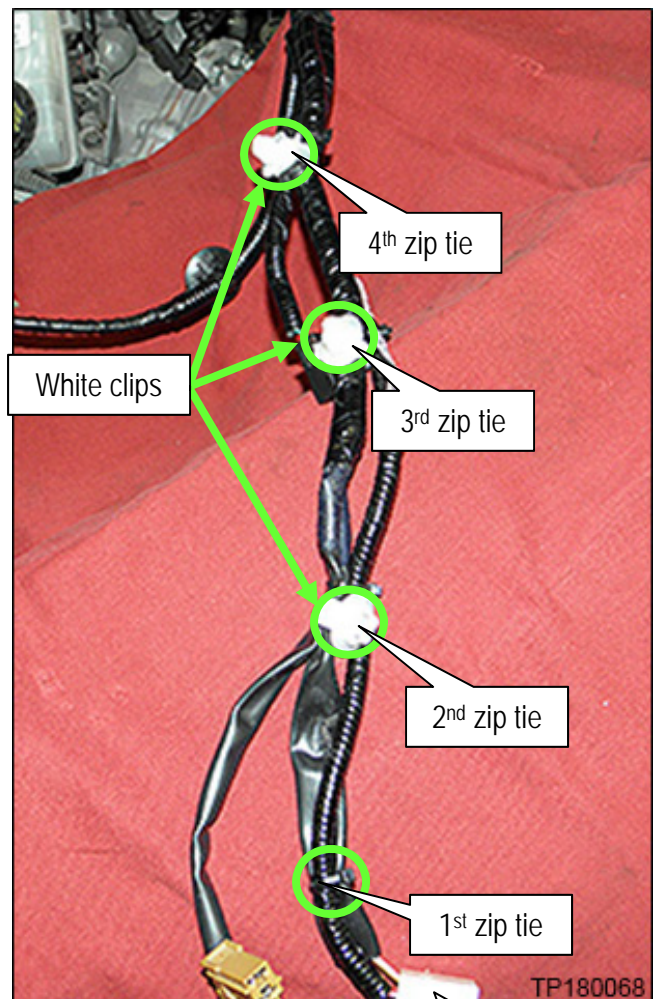
Figure 52

- a. Lay the new jumper harness next to the brake switch branch harness so that there is no slack at the harness plug end.
- b. Place the first (1<sup>st</sup>) zip tie approximately 25 mm (1 inch) from the brake switch branch harness connector.
- c. Place the second (2<sup>nd</sup>) zip tie next to the first white clip.
- d. Place the third (3<sup>rd</sup>) zip tie next to the second white clip.
- e. Place the fourth (4<sup>th</sup>) zip tie next to the third white clip.

Harness plug end

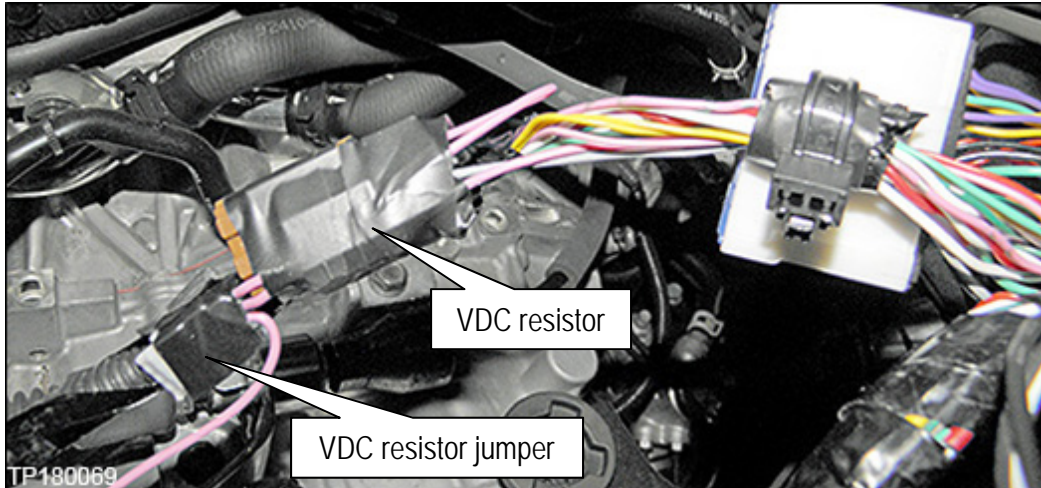
Figure 53

58. Secure the VDC resistor and VDC resistor jumper (both part of jumper harness) to the brake switch branch harness with black electrical tape.

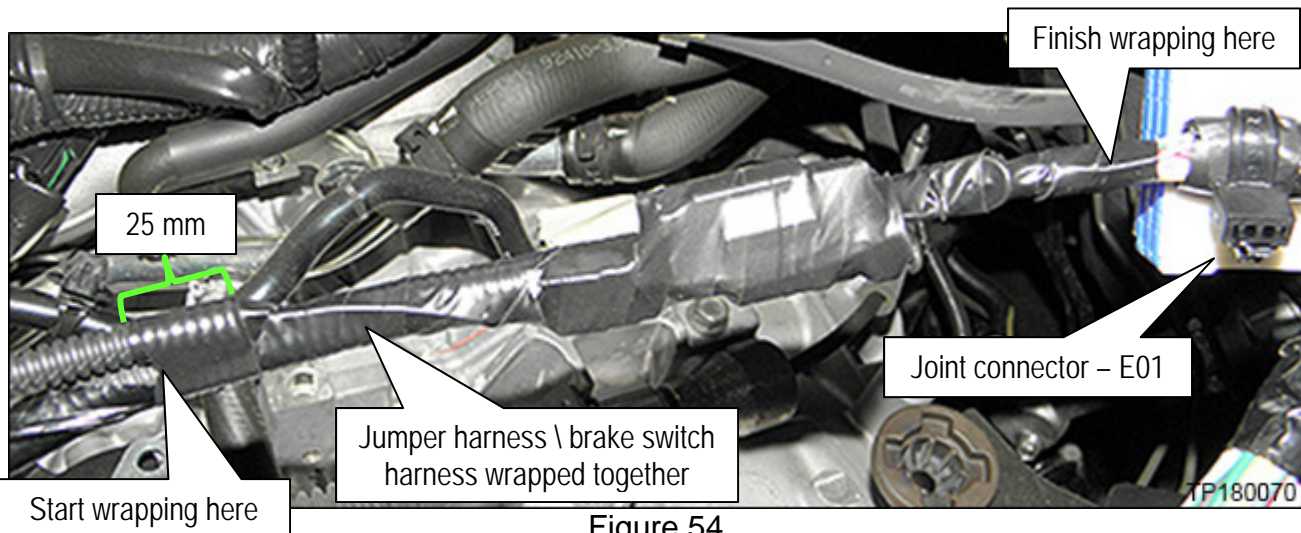
59. Starting at the point shown in Figure 54 wrap the jumper harness and brake switch harness together with black electrical tape as follows:

- Use 3M/Scotch Professional Grade Vinyl Super 88 Electrical Tape (3/4 inch wide) or equivalent.
  - a. Start the wrap approximately 25 mm (1 inch) below where the two (2) corrugated harness protectors of the jumper harness and brake switch harness come together.
    - Wrap only the jumper harness and brake switch harness together.
  - b. Wrap over the VDC resistor and VDC resistor jumper.

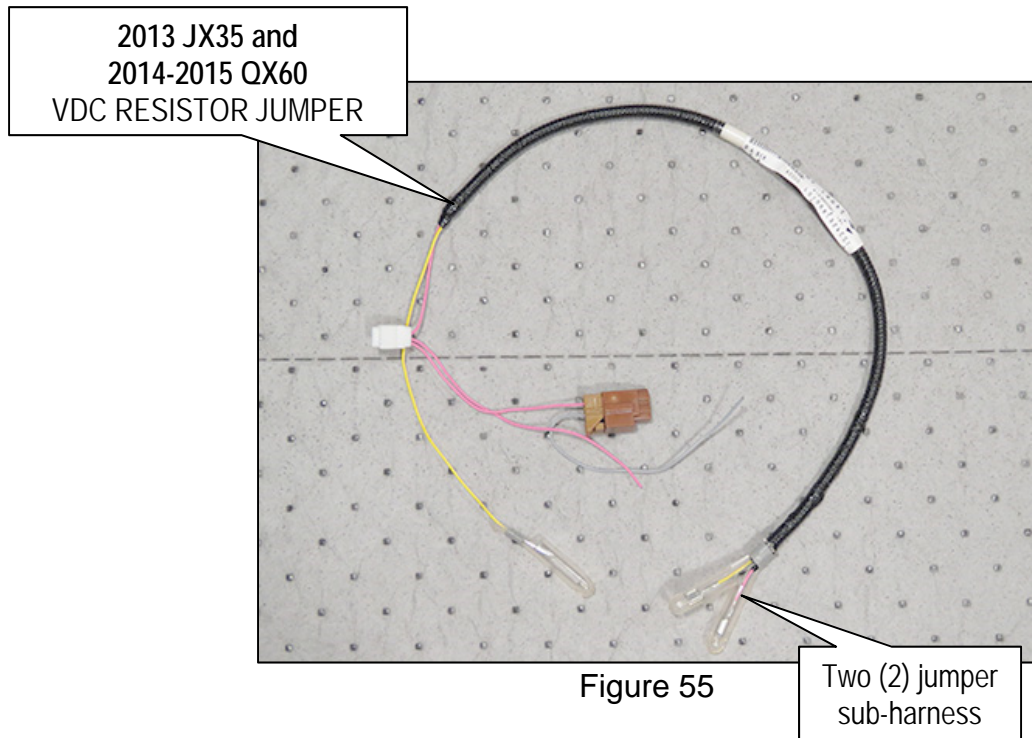
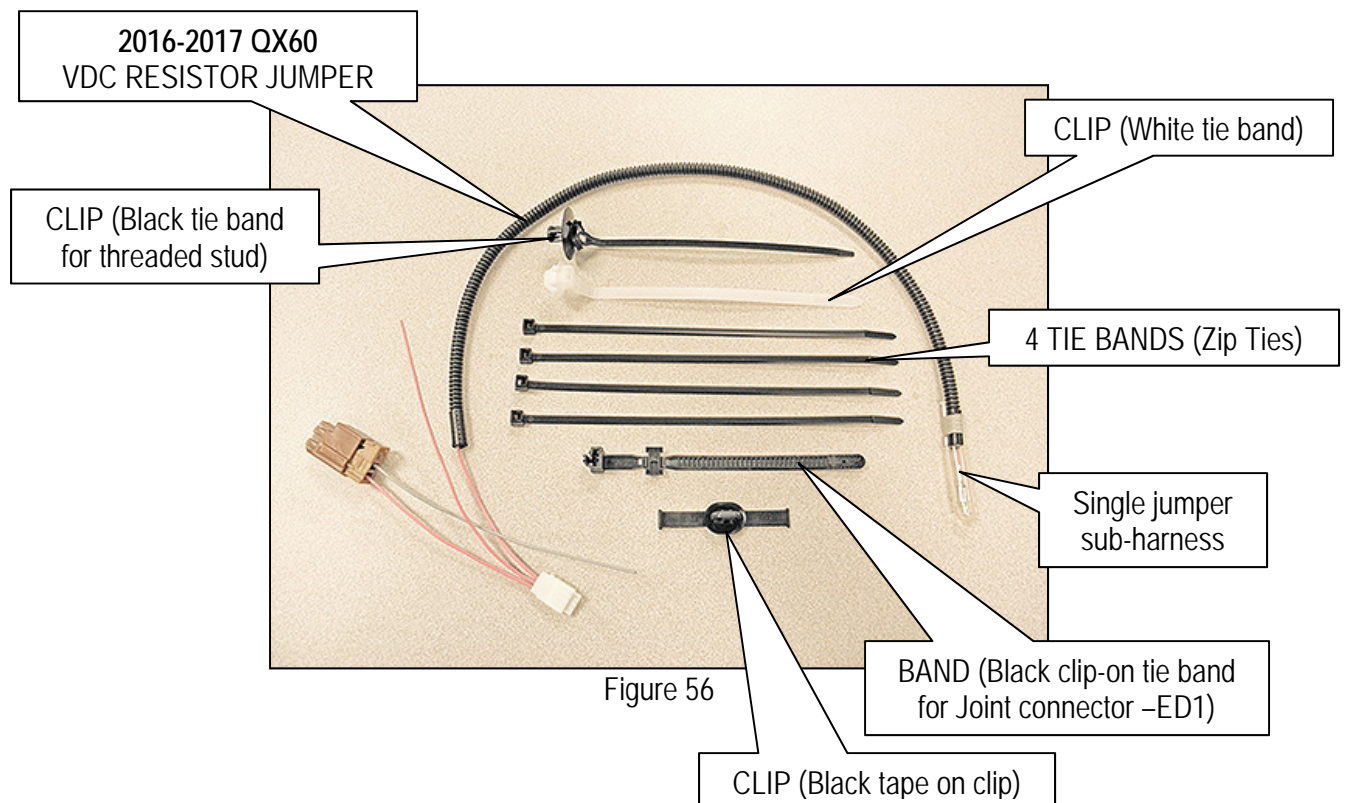
## HARNESS IDENTIFICATION

**NOTE:** Figure 56 shows all components that are included in both kits. Figure 55 only shows the differences between the two harnesses.
