KS16-014C

ITB16-012C

INTELLIGENT KEY BUTTONS INOPERATIVE BUT REQUEST SWITCHES WORK

2015-2019 Q50 (V37)

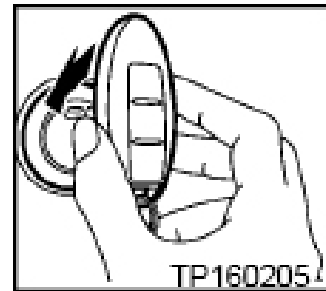
9. **Without pressing the ignition button**, place the Intelligent Key in front of the ignition button, as shown in Figure 3 (upper back of the key aligns with center of the ignition button), and listen for two short tones.

- If two short tones are heard: The Intelligent Key is now re-synchronized and should function normally again. Proceed to step 10 on the next page.
- If no tones are heard, and the Intelligent Key buttons still do not work: Refer to ASIST or the applicable Electronic Service Manual for further diagnosis.
