SERVICE BULLETIN

Classification: EC14-003	Reference: NTB14-044	Date: May 16, 2014
-----------------------------	-------------------------	-----------------------

2013 – 2014 SENTRA; MIL ON WITH DTC P0448

APPLIED VEHICLES: 2013 – 2014 Sentra (B17)

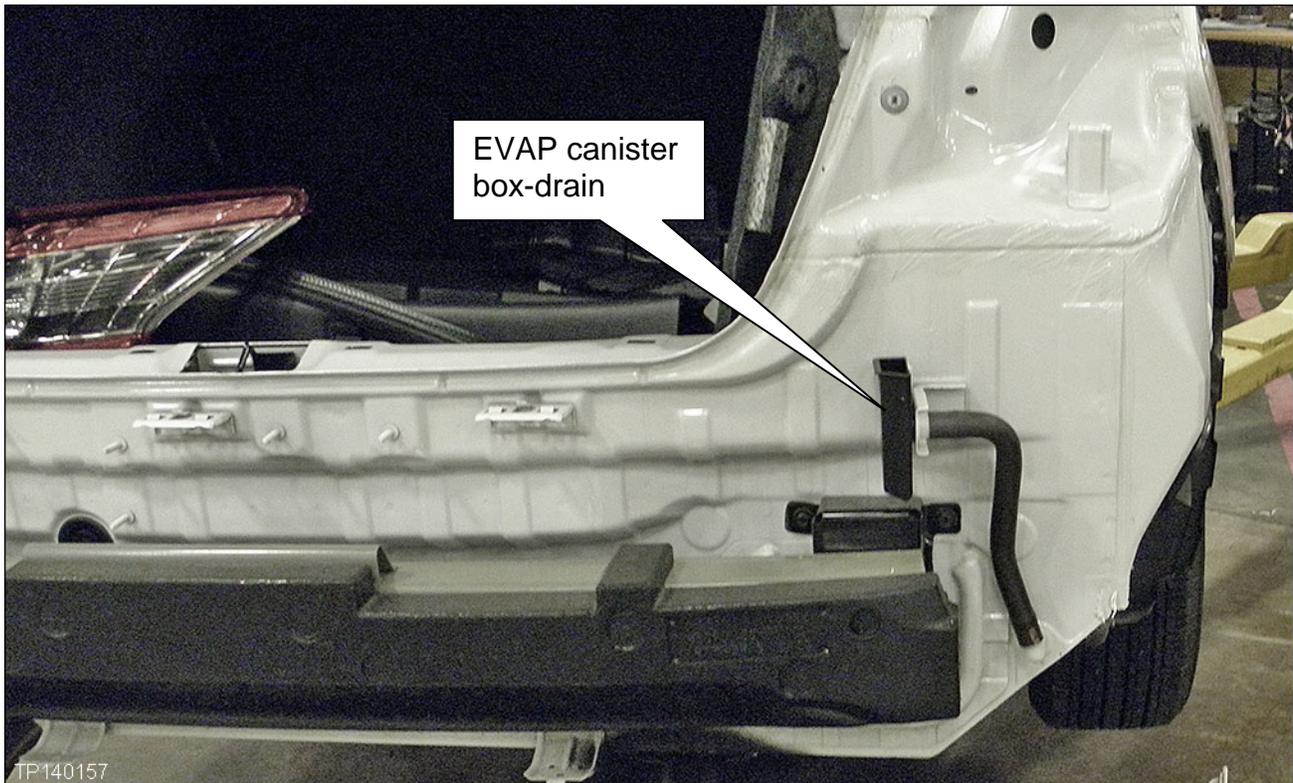
Figure 1

1. Remove the rear bumper fascia.
 - Refer to the Electronic Service Manual (ESM), section EXT-Exterior, for removal information.
2. Locate the EVAP canister box-drain.
 - The EVAP canister box-drain is located on the passenger side just below the tail-light area.

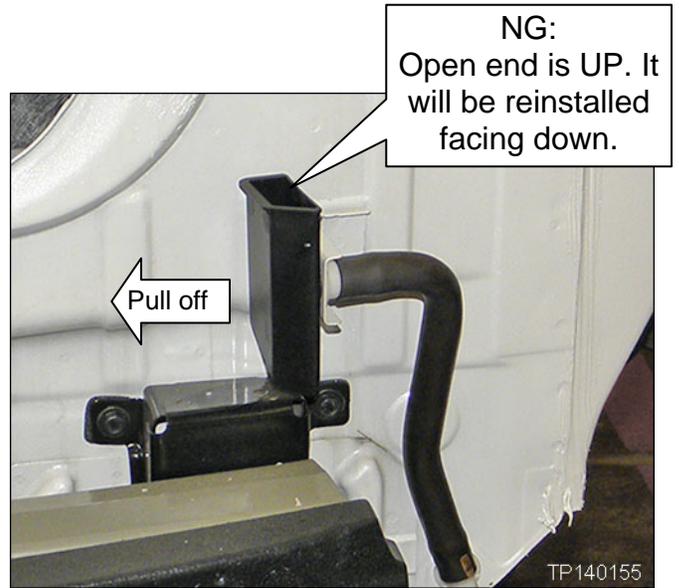
Figure 2

3. Remove the EVAP canister box-drain.
 - Pull to unsnap and remove.

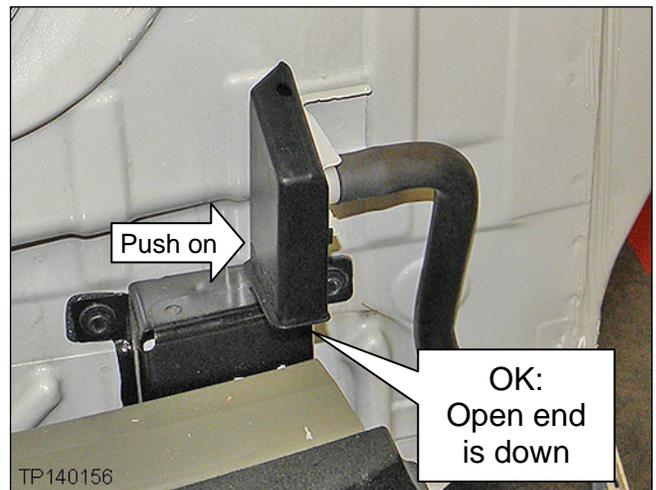
Figure 3

5. Re-install the EVAP canister box-drain with the **open end down** as shown in Figure 3.

4. Clean any dirt, ice, or debris from inside the box-drain.

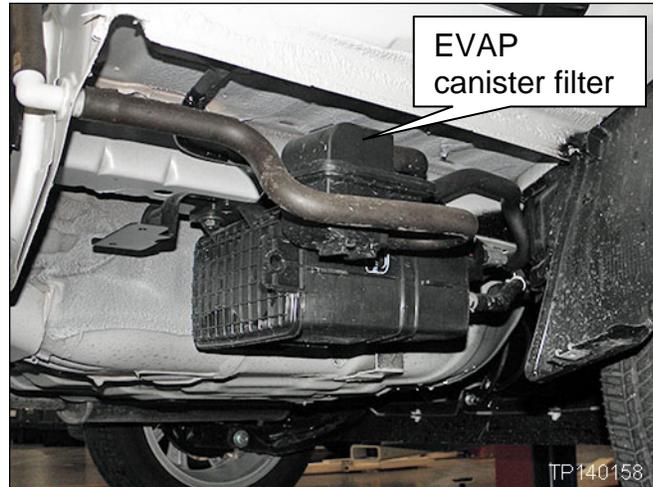
- EVAP canister filter for 2014 Sentra is shown in Figure 4, 2013 Sentra is similar.
- Figure 4 shows the canister with the bumper fascia removed.

6. Remove the EVAP canister filter:

- Refer to Figure 4, and Figures 5 and 6 on the following pages.

7. Empty water from the EVAP canister filter.

8. Re-install the EVAP canister filter.

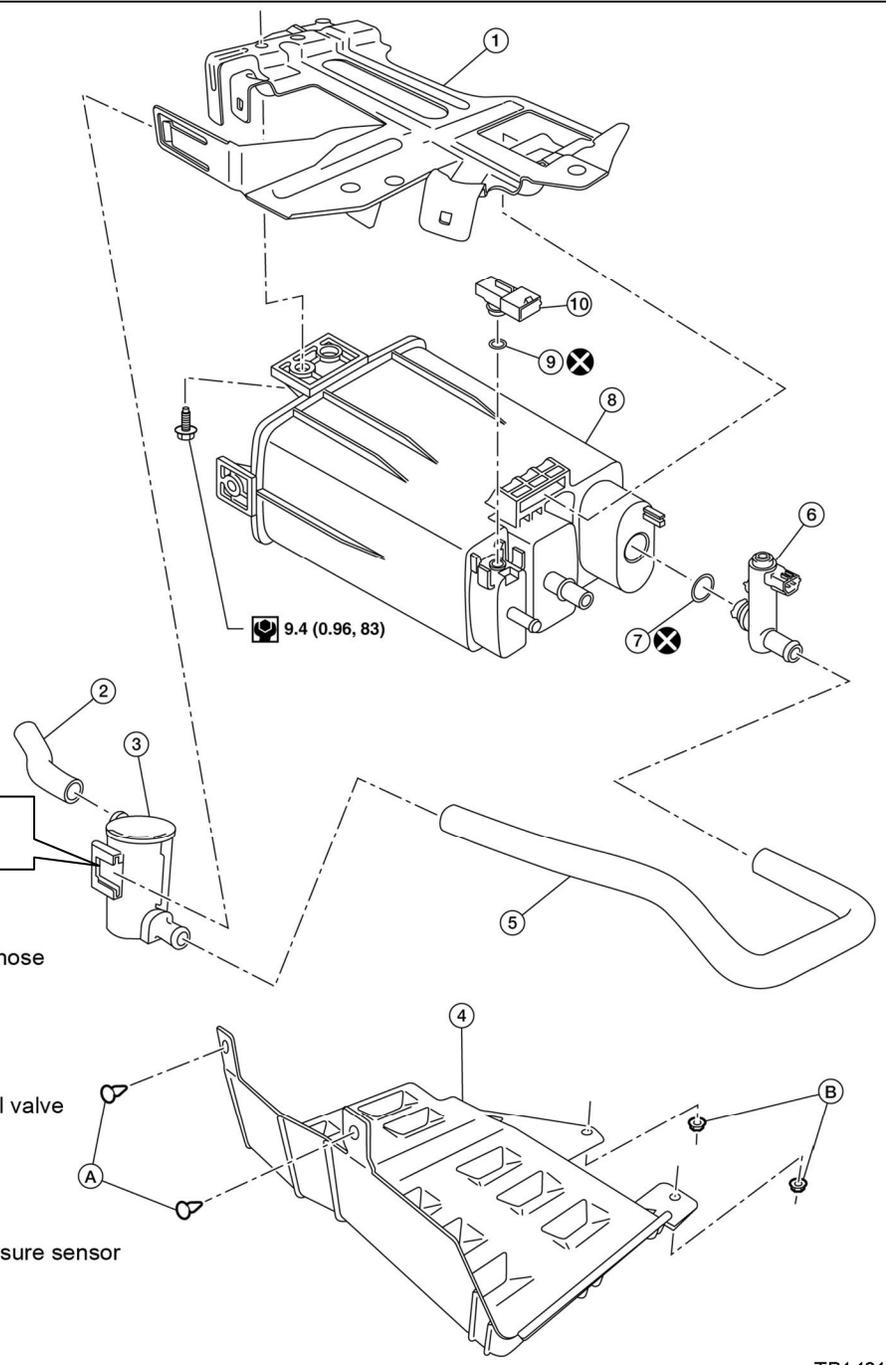
Figure 5

2013 Sentra

EVAP canister Filter

- 1. EVAP canister bracket
- 2. EVAP canister filter drain hose
- 3. EVAP canister filter
- 4. EVAP canister protector
- 5. EVAP hose
- 6. EVAP canister vent control valve
- 7. O-ring
- 8. EVAP canister
- 9. O-ring
- 10. EVAP canister control pressure sensor
- A. Clip
- B. Nut

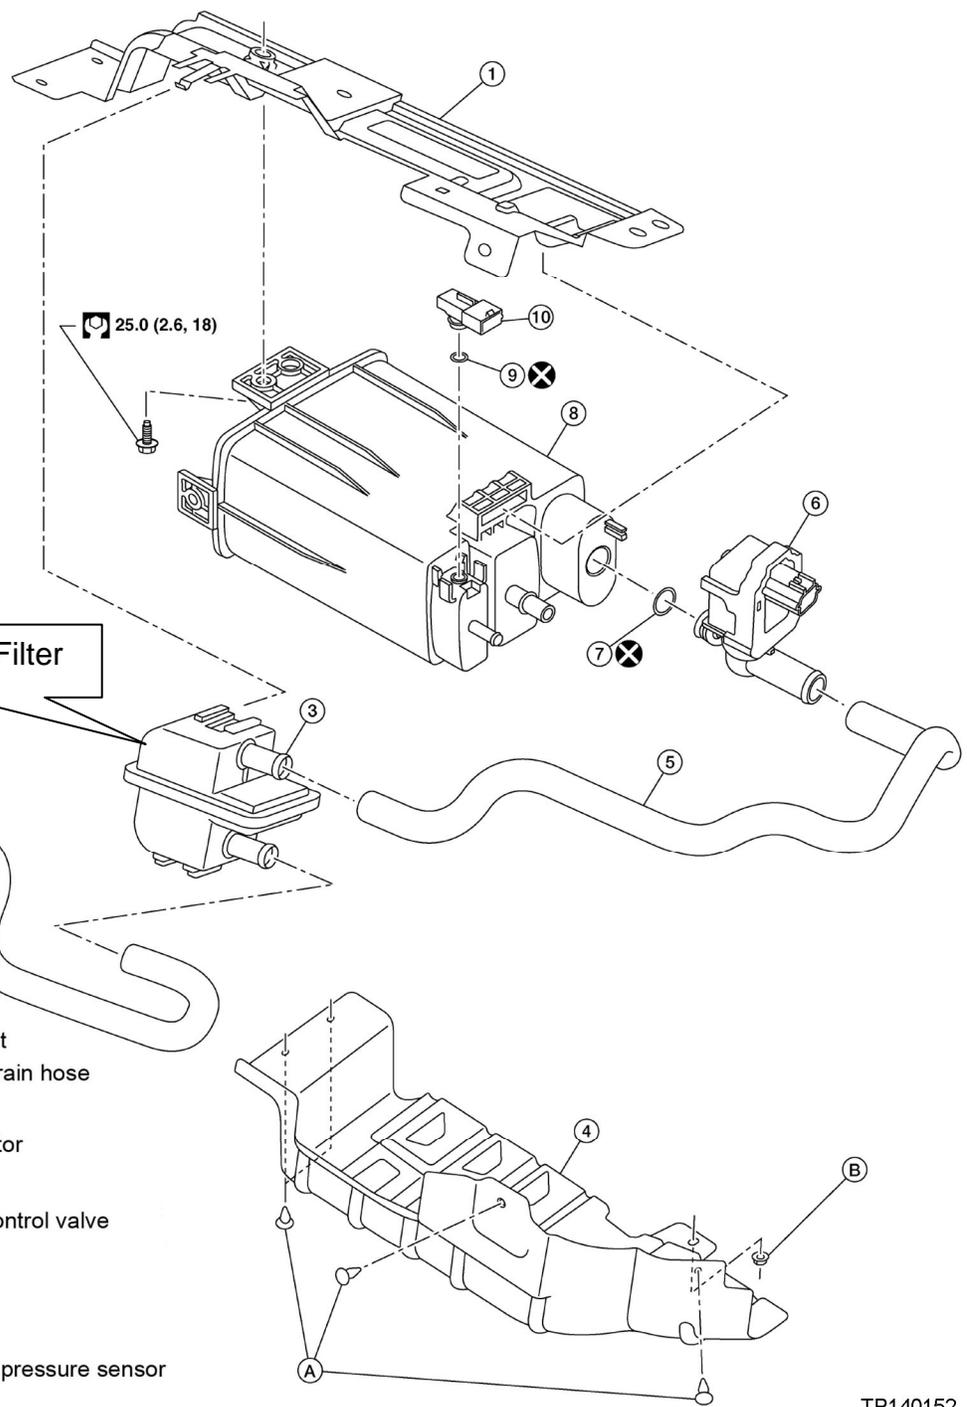
Figure 6

2014 Sentra

EVAP canister Filter

- A. Clip
- B. Nut
- 1. EVAP canister bracket
- 2. EVAP canister filter drain hose
- 3. EVAP canister filter
- 4. EVAP canister protector
- 5. EVAP hose
- 6. EVAP canister vent control valve
- 7. O-ring
- 8. EVAP canister
- 9. O-ring
- 10. EVAP canister control pressure sensor
