# SERVICE BULLETIN

Classification: EC15-003	Reference: NTB15-029	Date: April 9, 2015
-----------------------------	-------------------------	------------------------

## 2013-2015 VERSA SEDAN AND VERSA NOTE; ECM REPROGRAM FOR DTC P0116

**APPLIED VEHICLES:** 2013-2015 Versa Sedan (N17)  
2014-2015 Versa Note (E12)

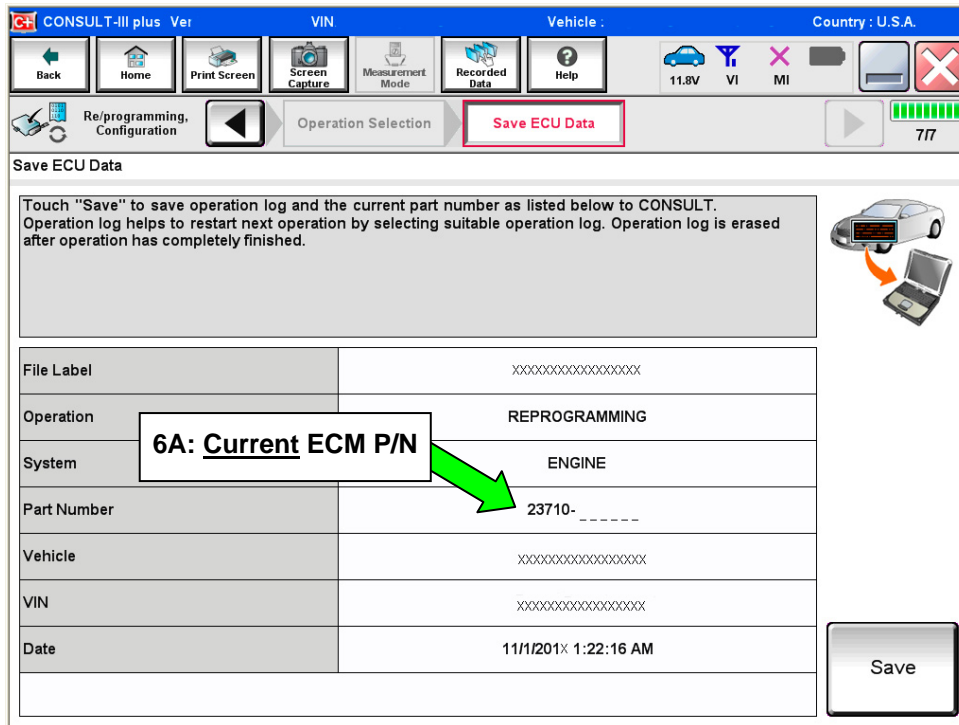
6. When you get to the screen shown in Figure 2, confirm this bulletin applies as follows.
- A. Find the ECM **Part Number** and write it on the repair order.

**NOTE:** This is the current ECM Part Number (P/N).

5. Follow the on-screen instructions and navigate the C-III plus to the screen shown in Figure 2 on the next page.

- B. Compare the P/N you wrote down to the numbers in the **Current ECM Part Number** column in **Table A** on next page.
- If there is a match, this bulletin applies. Continue with the reprogramming procedure.
  - If there is not a match, this bulletin does not apply. Close C-III plus and refer to ASIST for further diagnostic information.

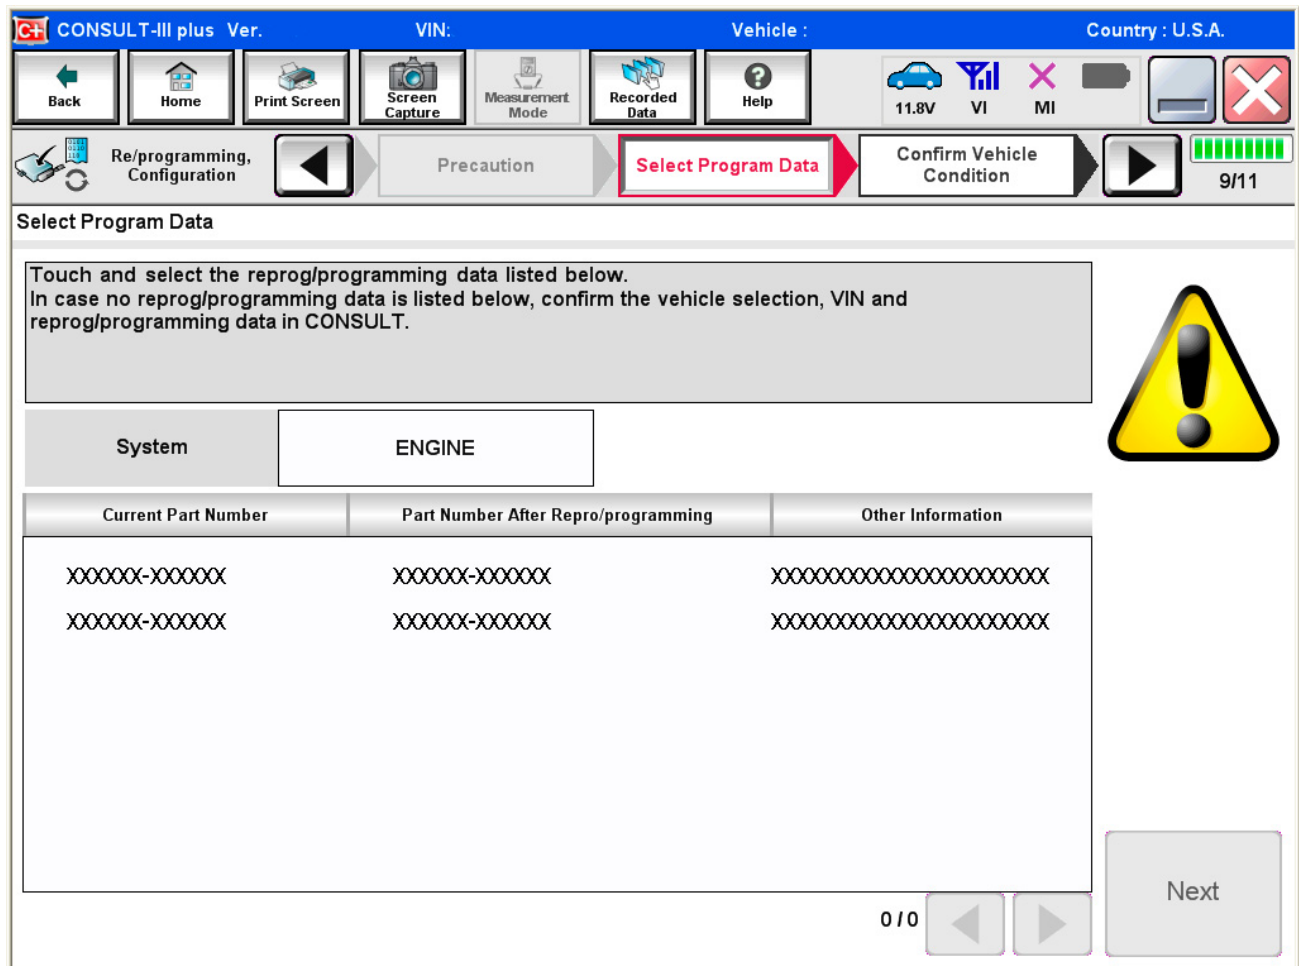
- In some cases, more than one new P/N for reprogramming is available.
  - In this case, the screen in Figure 3 displays.
  - Select and use the reprogramming option that **does not** have the message “Caution! Use ONLY with NTBXX-XXX”.
- If you get this screen and it is blank (no reprogramming listed), it means there is no reprogramming available for this vehicle. Close C-III plus and refer back to ASIST for further diagnosis.

**IMPORTANT:** If C-III plus locks up or freezes at this point or displays “cannot complete reprogramming, CONSULT PC is set up with User Rights. Reprogramming can be completed with Administrator log in”, the TOUGHBOOK settings need to be changed so that Users have full access rights. See your Dealership’s IT System Administrator for details.

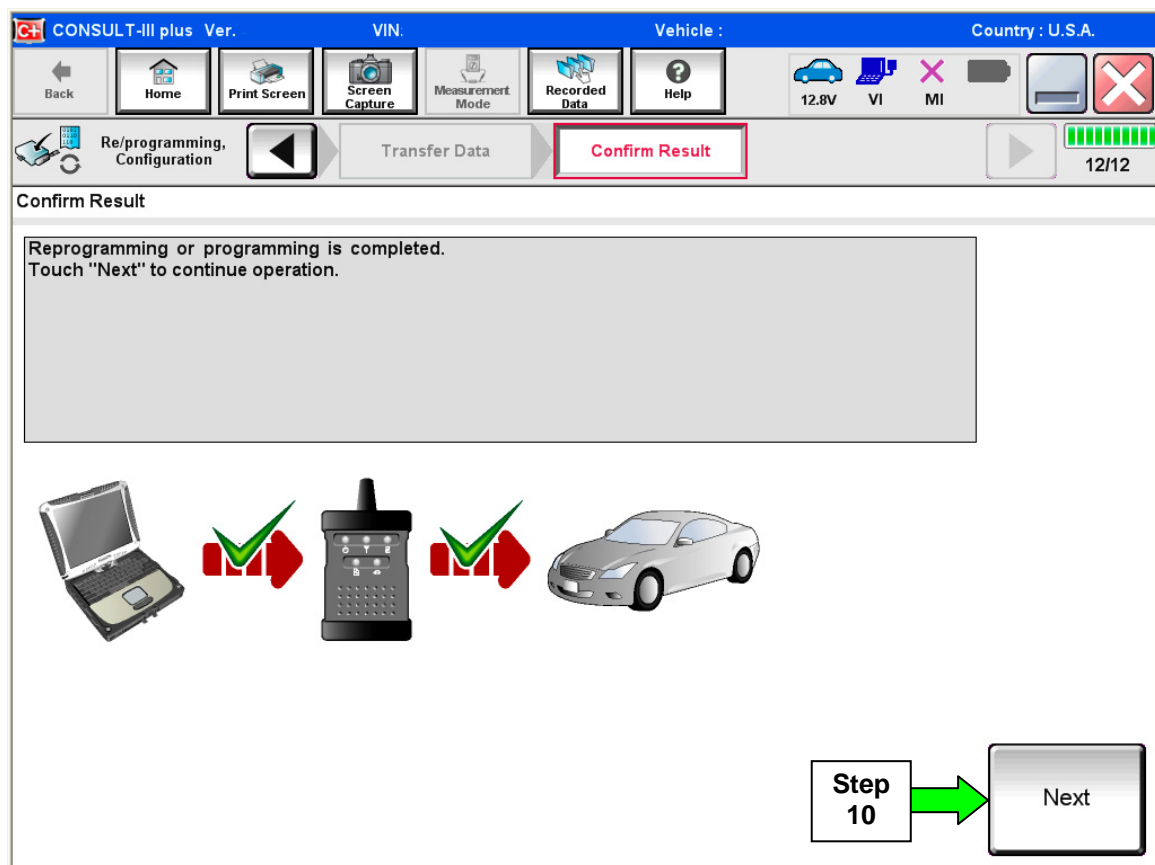
8. When the screen in Figure 4 displays, reprogramming is complete.

**NOTE:** If the screen in Figure 4 does not display (reprogramming does not complete), refer to the information on page 8.

9. Disconnect the battery charger from the vehicle.

10. Select **Next**.

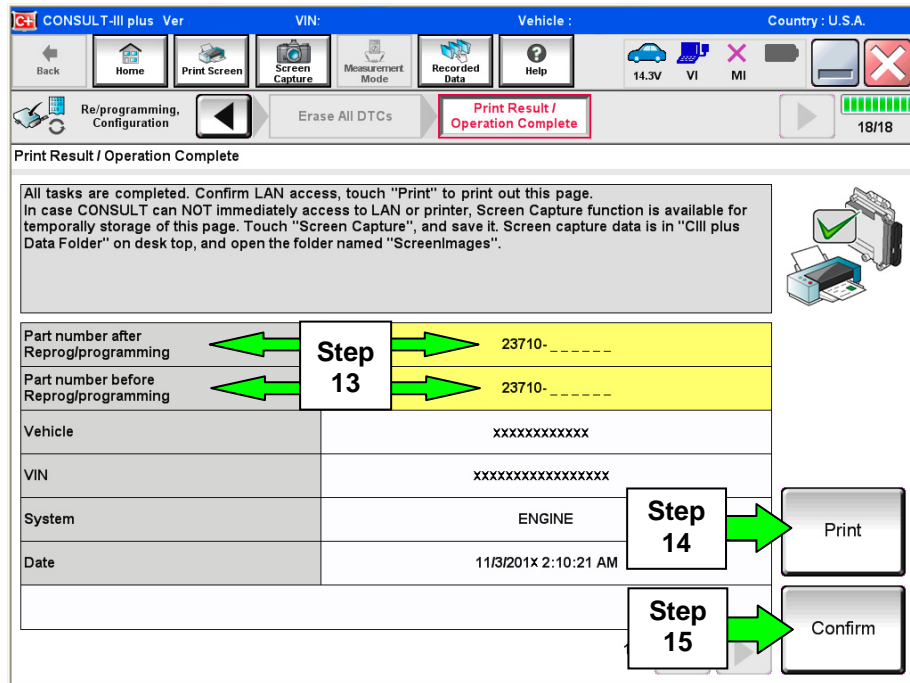
12. When the entire reprogramming process is complete, the screen in Figure 7 will display.
13. Verify the before and after part numbers are different.
14. Print a copy of this screen (Figure 7) and attach it to the repair order for warranty documentation.
15. Select **Confirm**.

16. Close C-III plus.
17. Turn the ignition OFF.
18. Disconnect the plus VI from the vehicle.
