EM14-005a

INFINITI; FLUID LEAK REPAIR SERVICE INFORMATION

APPLIED VEHICLES: All Infiniti vehicles

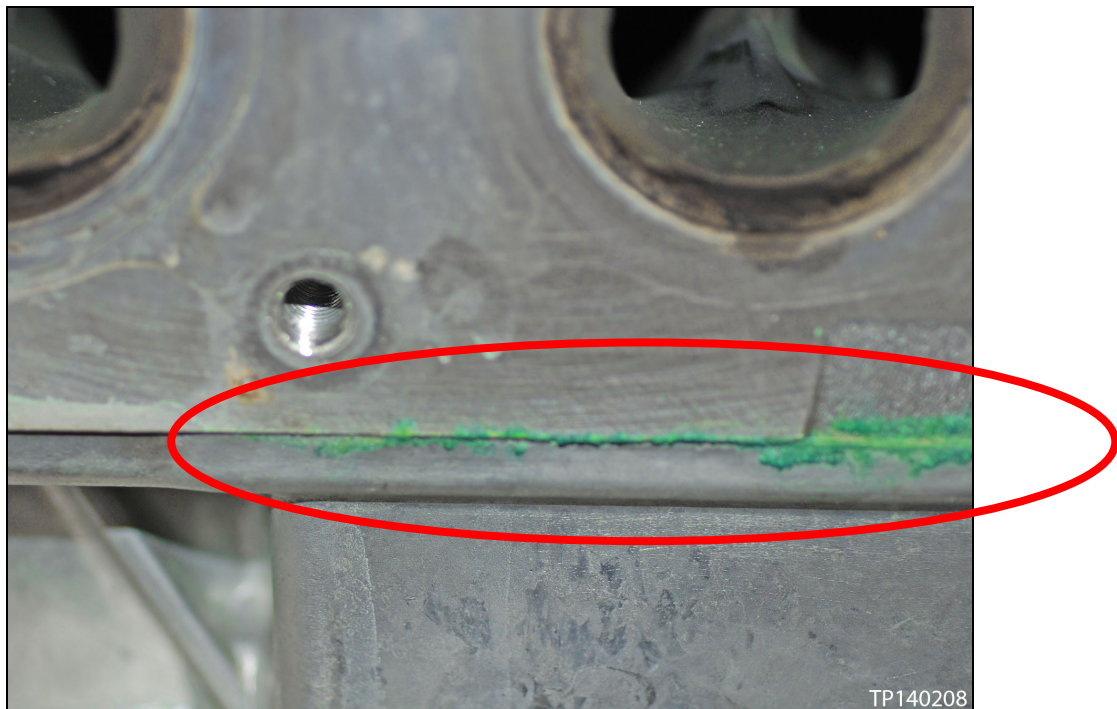
Head gasket area
