SERVICE BULLETIN

EL16-013

2015 MURANO; BUZZ NOISE FROM SEAT WITH SEAT CLIMATE CONTROL HEATER TURNED ON

APPLIED VEHICLE: 2015 Murano (Z52)

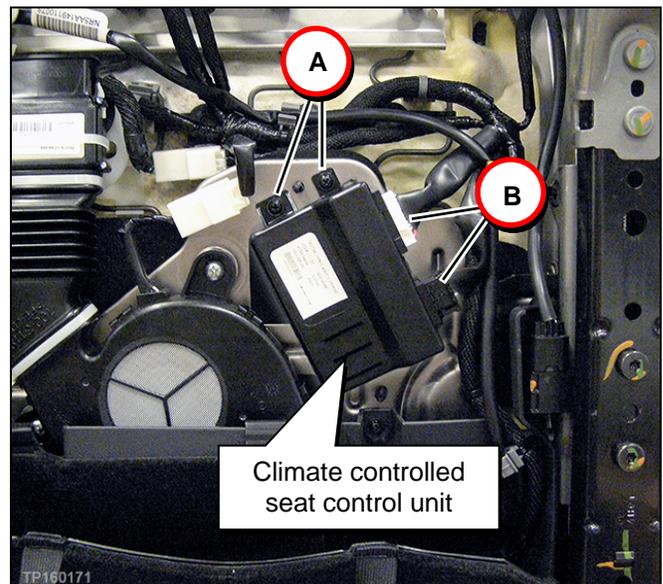
Figure 1

A = Screws

B = Harness Connectors

Replace the climate controlled seat control unit.

- Replace the control unit only for the seat that is making the buzz noise.
- Refer to the Electronic Service Manual (ESM), section SE-Seat, for replacement information.
