Technical Service Bulletin

63 Paint peeling from the rear bumper cover

63 21 07 2064279/1 August 25, 2021.

Model(s)	Year	VIN Range	Vehicle-Specific Equipment
Q5, SQ5	2020 - 2021	All	Not Applicable

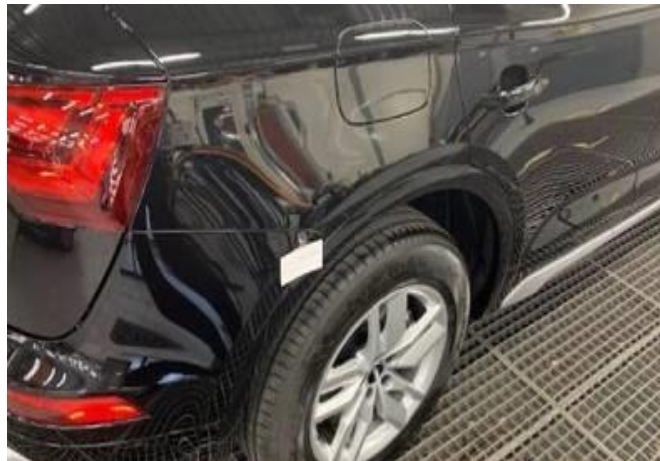
The rear bumper paint appears to have lost its adhesion. The paint peel is located on the right, left, or both sides of the cover specifically where the bumper cover meets the rear side panel.

An inconsistency in the production process of the rear bumper cover specifically at the edges that meet the rear side panel caused a weakness making the painted surfaces on these edges prone to paint peel over time. Either the right side, left side or both sides of the bumper cover are affected.

1. Figure 1 shows the area of the bumper cover affected.

Figure 1. Bumper cover edge affected.

Should the condition described in this TSB occur the rear bumper cover is to be replaced. Do not attempt to refinish the original bumper cover. Due to the technical nature of the root cause refinishing the original bumper cover will only reintroduce a subsequent paint peel in these areas of the rear bumper cover over time.

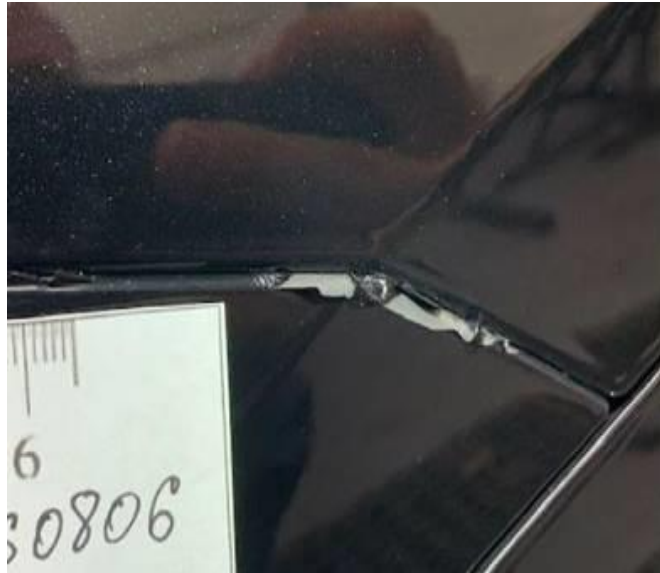
2. Figure 2 shows a close-up view of the paint peel.

Figure 2. Paint peel on bumper cover edge.

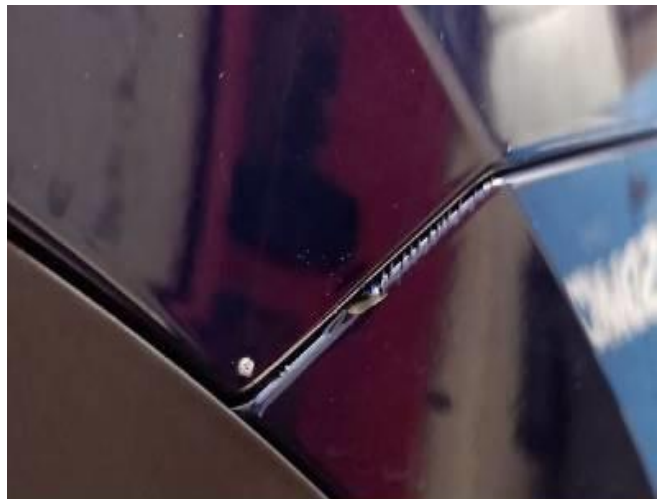
3. Figure 3 shows the condition in its early stages that may evade notice.

Figure 3. Early stages of peel.

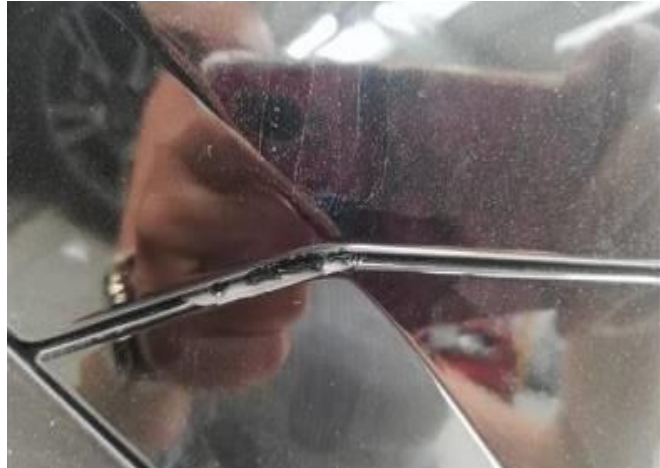
4. Figure 4 shows an intermediate loss of paint in this area.

Figure 4. Moderate loss of adhesion.

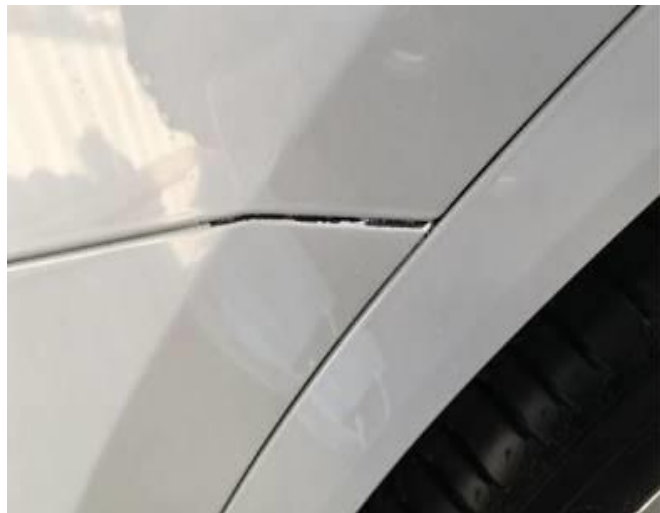
5. Figure 5 shows severe advancement of paint loss on the rear bumper cover.

Figure 5. Advanced paint peel.
