Section Function Group 214

Introduction

Volvo has received reports of valve springs on some D11 and D13 engines exhibiting early life failures. Through further examination it was found some suspect valve springs do not meet Volvo's stringent quality requirements. To ensure product reliability, Volvo Trucks will be requiring replacement of all the affected valve springs on certain engines. The removed valve springs will need to be returned for inspection.

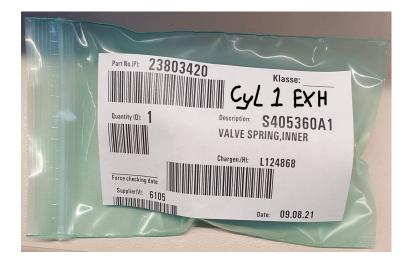
- As previously mentioned, place the used valve springs in the individual packaging from which the new valve springs arrived in.
- Write on the individual bag which position the used valve spring came from (i.e. CLY 1 EHX, as seen in the image below).
- Box all individually bagged springs in one container for shipping.

Sample of return packaging
