Sunroof leaks

Topic number	LI77.20-P-056351
Version	1
Design group	77.20 Electric sliding roof
Date	05-13-2013
Validity	463
Reason for change	
Reason for block

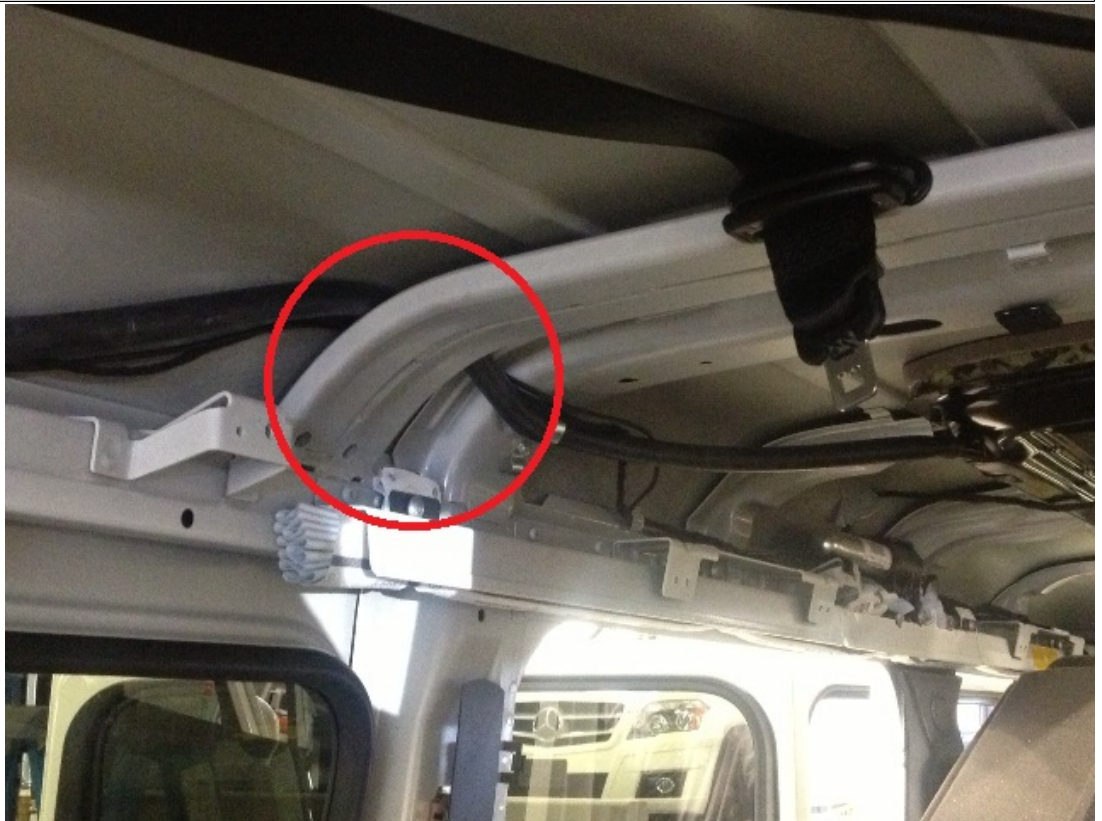
Picture 1.jpg:

Rear drain tube mounting location within roof panel. The rear drain tube may have an upward bend that allows water to collect in the drain tube (Picture 1)

Attachments	
File	Designation
Picture 1.jpg	Upward bend in rear drain tube

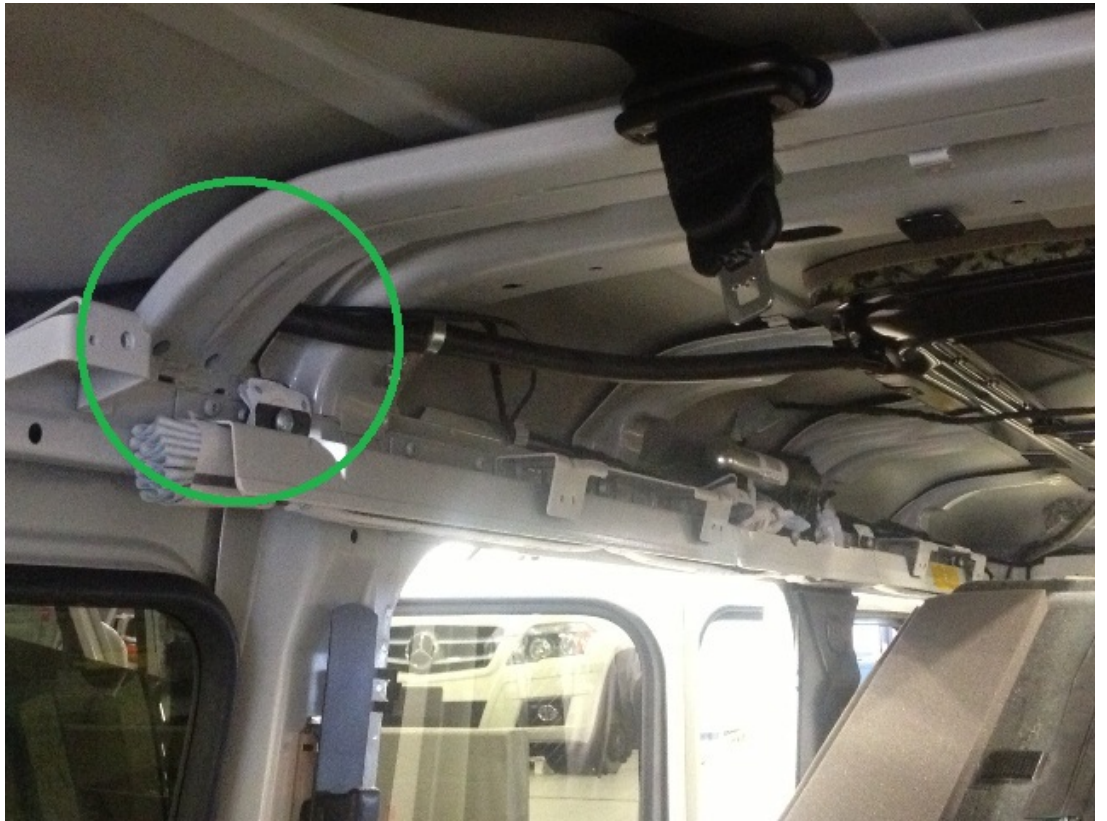
Picture 2.jpg:

Attachments	
File	Designation
Picture 2.jpg	Re-routed rear drain tube

If upward bend is present, route rear drain tubes to eliminate upward bend to allow constant downward flow if water is present in drain tube (Picture 2)
