Mack Chassis - Equipped With A Cummins 9 Liter Engine - Serpentine Belt Excessively Worn Or Damaged; Fan Belt Shredding Or Fraying Repeatedly

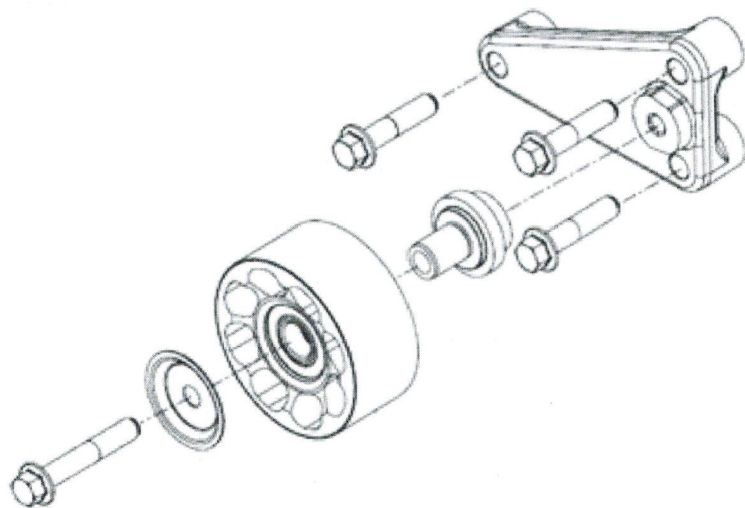
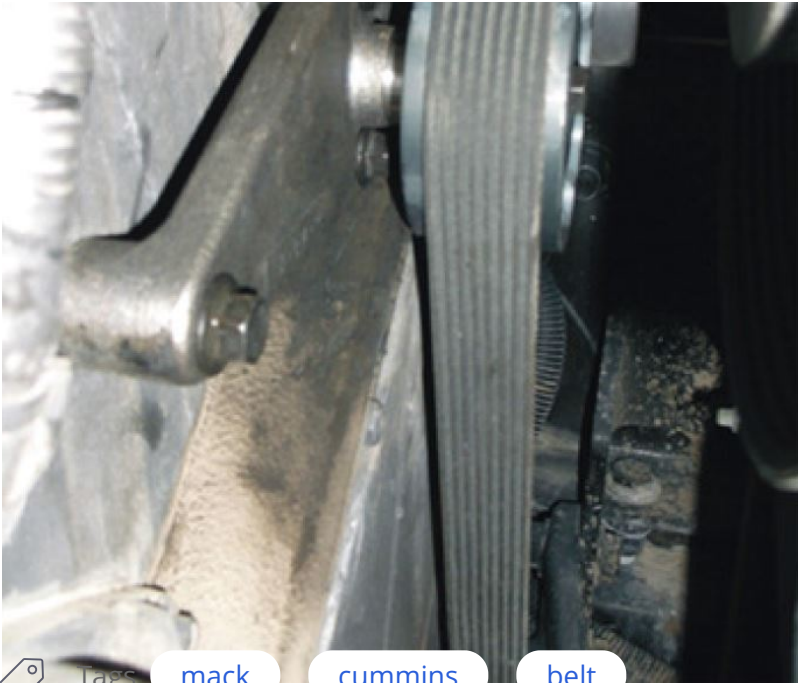
For a customer complaint regarding premature belt wear (fraying or shredding):

1. Replace the belt tensioner arm.

Note: Cummins also offers an additional, optional idler pulley kit to further minimize belt fatigue and noise. It is recommended that this kit be installed on vehicles used in time-critical applications. See part number below.

- Idler Kit, Cummins Part Number 5335096
- Belt - Refer to IMPACT
