Technical product information

Topic	Infotainment home screen - Loading messages visible on start up in multiple tiles
Market area	Russische Föderation (5RU),Australia E04 Bentley rest Asia and Australia (6E04),China 796 VW Import Comp. Ltd (Vico), Beijing (6796),Germany E02 Bentley rest Europe (6E02),Japan E03 Bentley Japan (6E03),Korea, (South) E08 Bentley South Korea (6E08),United Arab Emirates E06 Bentley Middle East and Africa (6E06),United Kingdom E01 Bentley UK (6E01),United States E05 Bentley USA and rest America (6E05)
Brand	Bentley
Transaction No.	2061537/4
Level	EH
Status	Approval
Release date

New Continental GT - GTC and New Flying Spur

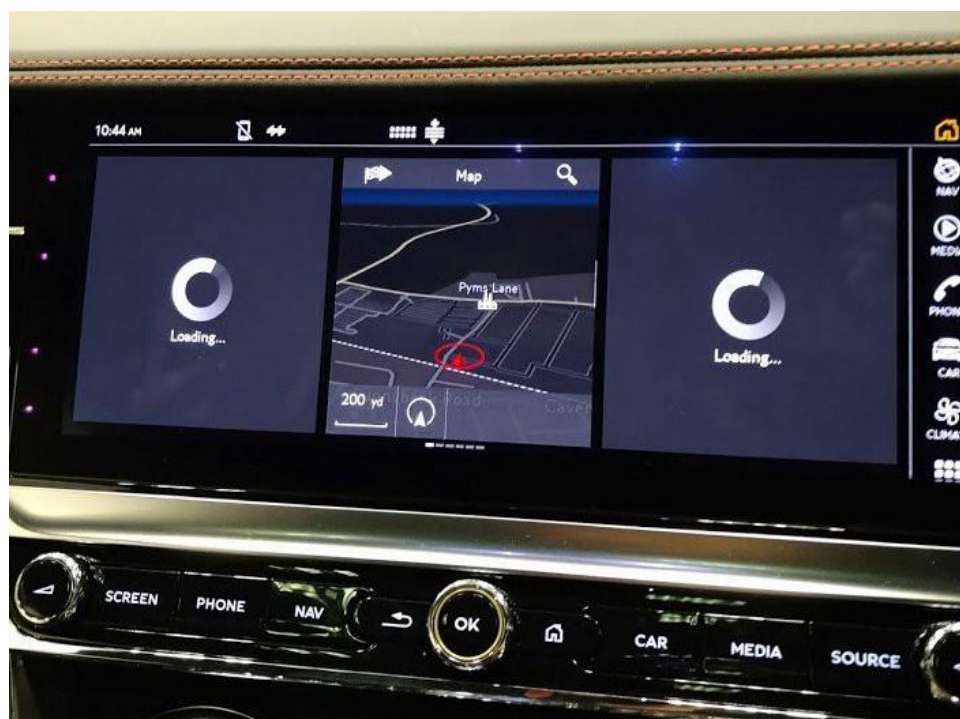
Figure 1

Upon start-up of the "Home" screen, loading messages can be seen in some or all of the tiles (Figure 1)

A delay when loading tiles is normal, this is due to the amount of external data that is required to load each individual tile, including multiple pages of external data that can be associated with each individual tile.

Some tiles will naturally take longer to load than others. For example, APPS, NAVIGATION and MEDIA are likely to have a greater delay in loading than other tiles this is due to the amount of external data required to display the relevant information.

TIP: If required, the delay can be reduced by only selecting tiles that do not communicate with external data sources, for example CAR or CLIMATE functions
