Campaign No. 2021110005 December, 2021

SUBJECT: **Model 447 Metris, Model Year 2021**  
**Replace Certain Seat Belts**

Mercedes-Benz AG ("MBAG"), the manufacturer of Mercedes-Benz vans, has been informed by its supplier, Autoliv, that it might have been supplied with certain seat belt assemblies manufactured by certain Autoliv Group companies between February 02, 2021 and June 02, 2021, which might not fulfill certain requirements of FMVSS 208. The Automatic Locking Retractor (ALR) function automatically retracts and tightens the seat belt when using a child restraint system. According to the supplier, due to a geometric deviation on the sensor lever, the child seat protection function could be deactivated earlier than intended. When the issue occurs, the customer might notice the error acoustically and haptically, since the typical "rattling" and blocking of the rear seat belt would not be present. A seat belt retractor that does not function as intended can increase the risk of injury during a crash.

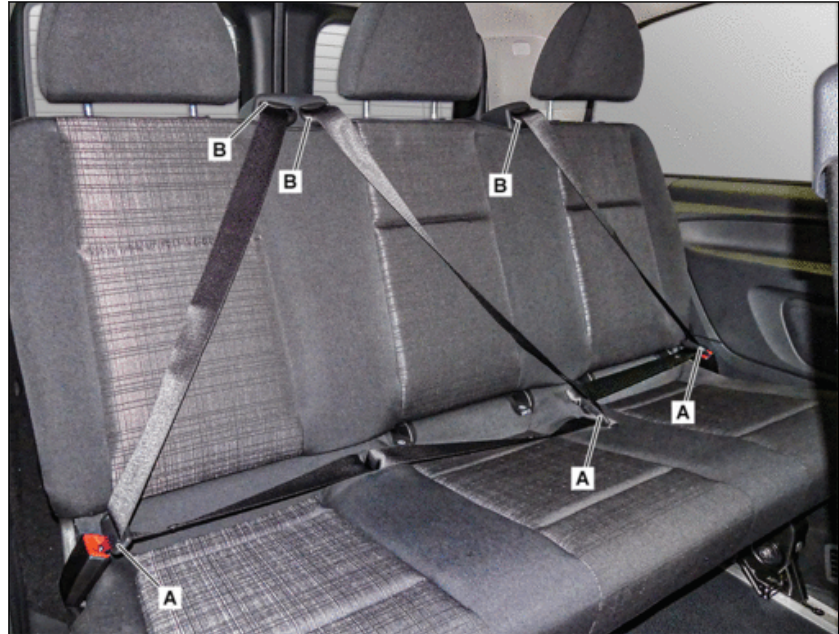
S91.40-A023-76

Shown on model 447.703 with code U63 (Passenger compartment seats, 3-passenger bench seat, 2nd row)

- A Seat belt tongue
- B Belt sash guide

<b>Check</b>		
2	Insert seat belt tongue (A) into respective seat belt buckle in passenger compartment.		
3	Pull seat belt completely out of belt sash guide (B) to end stop.

<b>The seat belt must be fully pulled out all the way to the end stop.</b>

4	Allow seat belt to slowly roll in again automatically up to the end.	<p>Clip: Check child seat safety feature of seat belts in passenger compartment (code: VS2KISIGUR)</p> <p><b>i</b> Seat belt tongue (A) remains engaged.</p> <p><b>i</b> <b>A significant rattling noise can be heard from the area of the seat belt retractor when the seat belt is rolling in.</b></p> <p>The rattling noise indicates that the child safety lock is activated.</p>	GB91.40-S-0000-01A
5	Slowly and carefully attempt to pull seat belt out of belt sash guide (B).	<p><b>i</b> Do not perform any sudden pulling movements.</p> <p><b>i</b> <b>It must not be possible to pull out the seat belt; it must remain engaged.</b></p>	
6	Open seat belt buckle and allow seat belt to completely retract.		
7	Repeat operation steps 2 to 6 a total of 5 times per seat belt in passenger compartment.	<p>If function of seat belts is OK for 5 repetitions (see operation steps 2 to 6),</p> <p style="text-align: center;">↓</p> <p>child safety locks of seat belts are OK, vehicle can be handed over to customer.</p> <p>If function of seat belts is not OK for one repetition (see operation steps 2 to 6),</p> <p style="text-align: center;">↓</p> <p>replace respective seat belt. Remove/install seat belts for passenger bench seat Model 447</p>	AR91.40-S-1206EE
