TECHNICAL SERVICE BULLETIN INSTRUCTIONS

TSB #: SB-62

Models Involved: 2022 Allegro Open Roads, 32FA

Purpose: To provide instructions on how to reverse the hydraulic lines on the bed slide of the 32FA so the slide override will work properly.

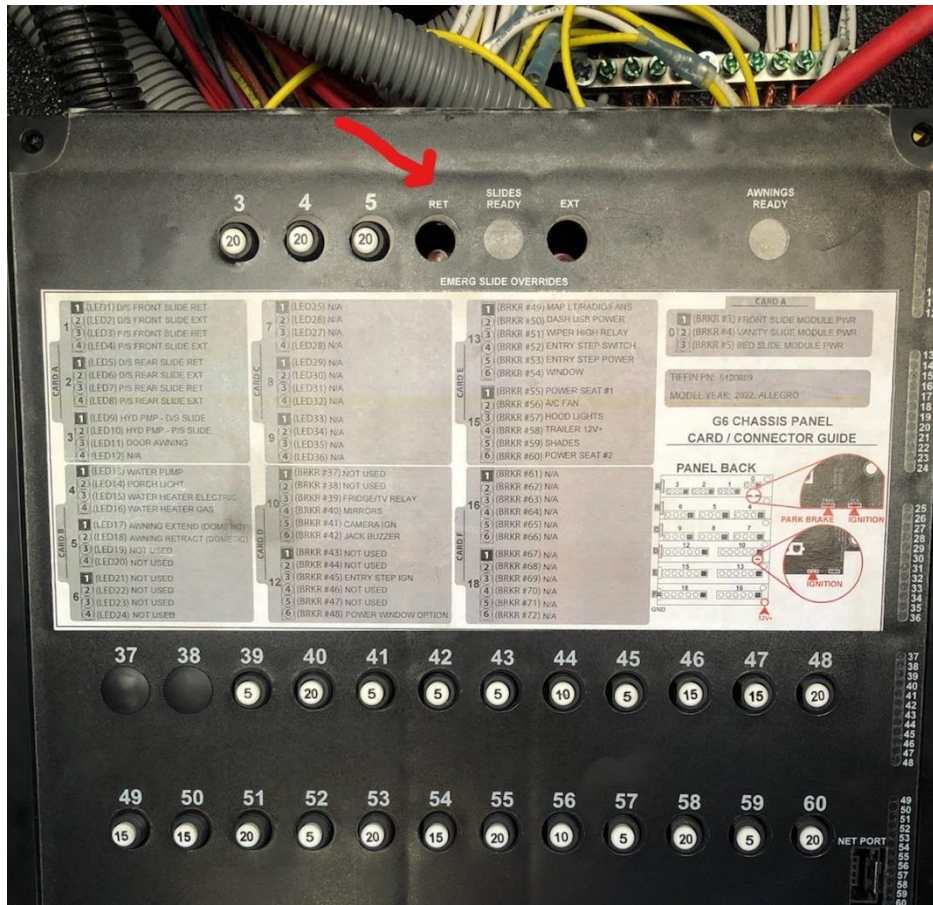
1. All slides must be fully extended to test the hydraulic lines.
2. Go to the slide override location at the G6 chassis panel. (The G6 chassis panel is located on the driver side of the coach and is the third cargo door back.)

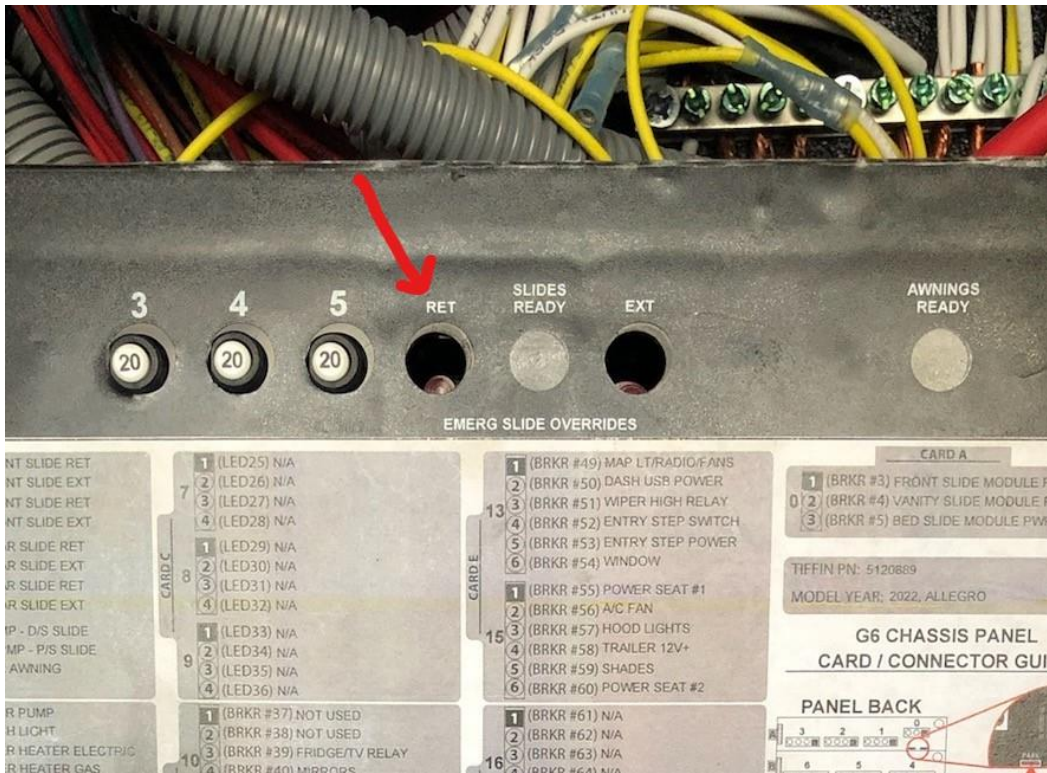
- Place an ink pen in the “EMERG SLIDE OVERRIDES” “RET” hole. If all slides retract together, the unit is already correct and needs no further action.

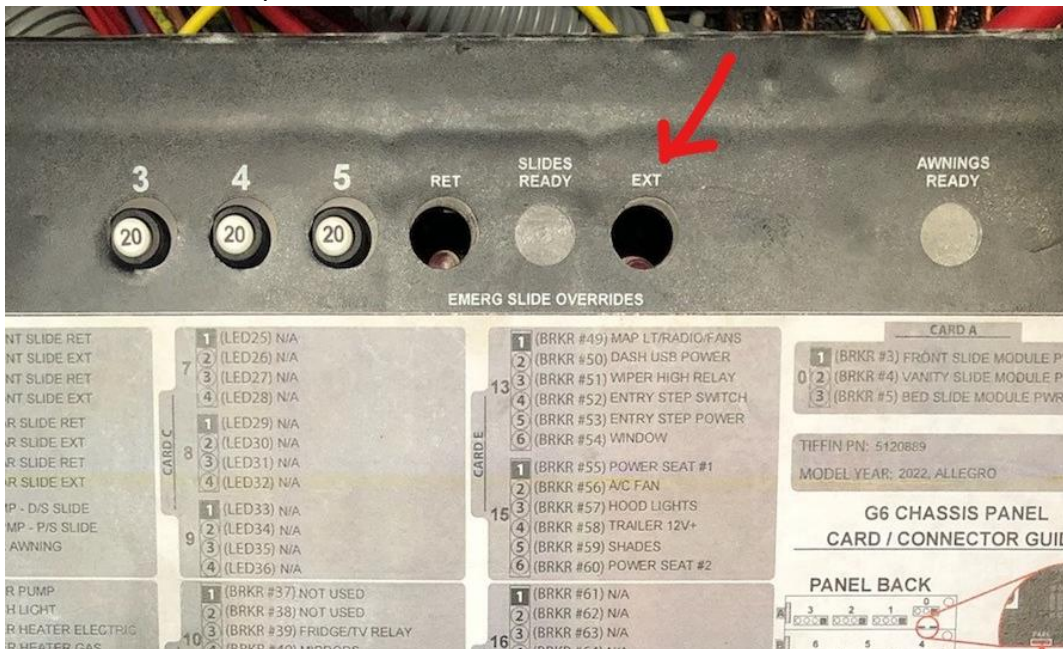
- If all boxes retract with the exception of the bed slide, place the ink pen in the “EXT” hole at the “EMERG SLIDE OVERRIDES” location. If the bed slide then retracts, continue with the correction procedure.
