## Volvo Chassis - Bendix Lane Departure Warning System ( LDWS ) Audible Alarm Does Not Deactivate When The Turn Signal Is Switched On - US16; Model Year ( MY ) 2017

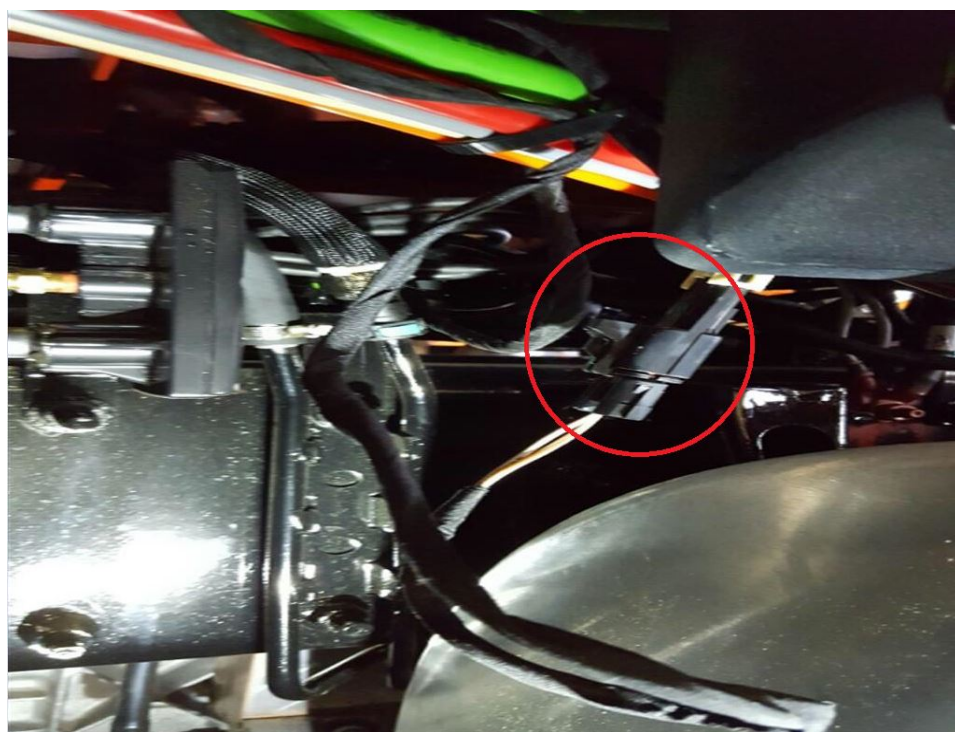
On a Volvo Chassis - US16 - with the Bendix Lane Departure Warning System ( LDW ) the alarm would not cancel once the turn signals were activated. After diagnosing it was found that the harness connector under the cab floor on the driver side as shown below was not connected.
