PIP5520A Noise From The Park Brake Or Park Brake Is Locked Up

Product Investigation Review Required

Brand:	Model:	Model Years:	VIN:		Engine:	Transmissions:
			from	to		
Chevrolet	LCF	2016 - 2022	All	All	All	All

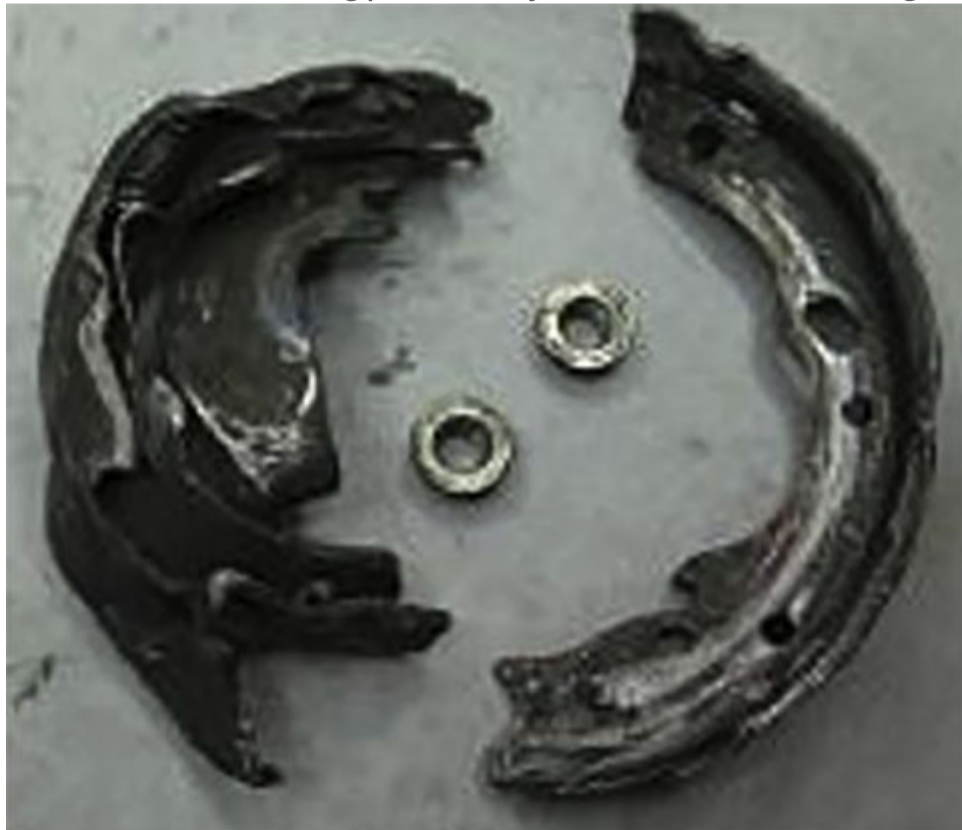
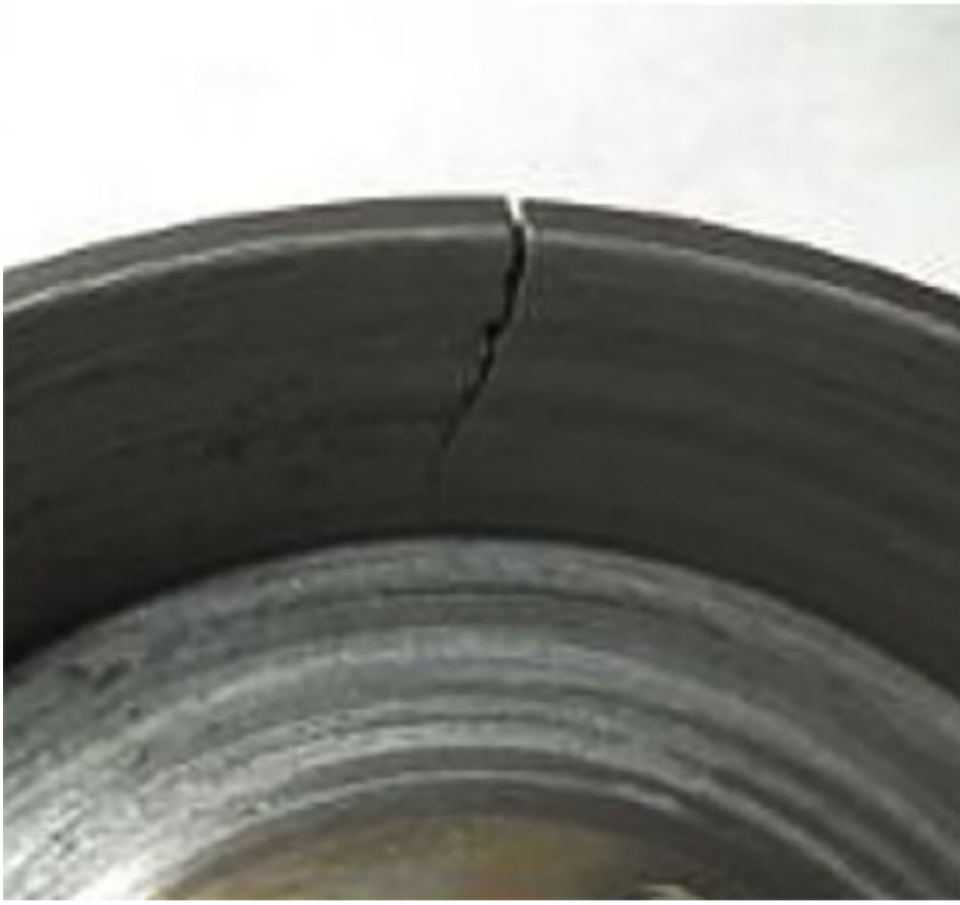
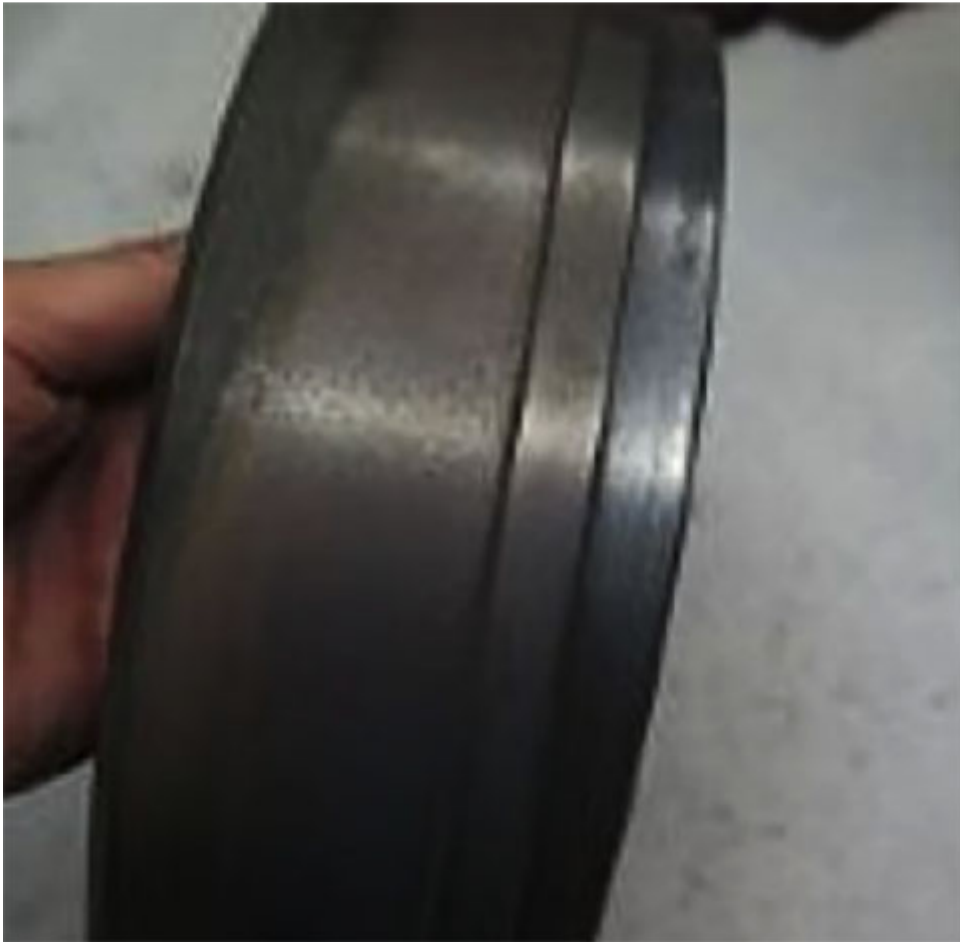
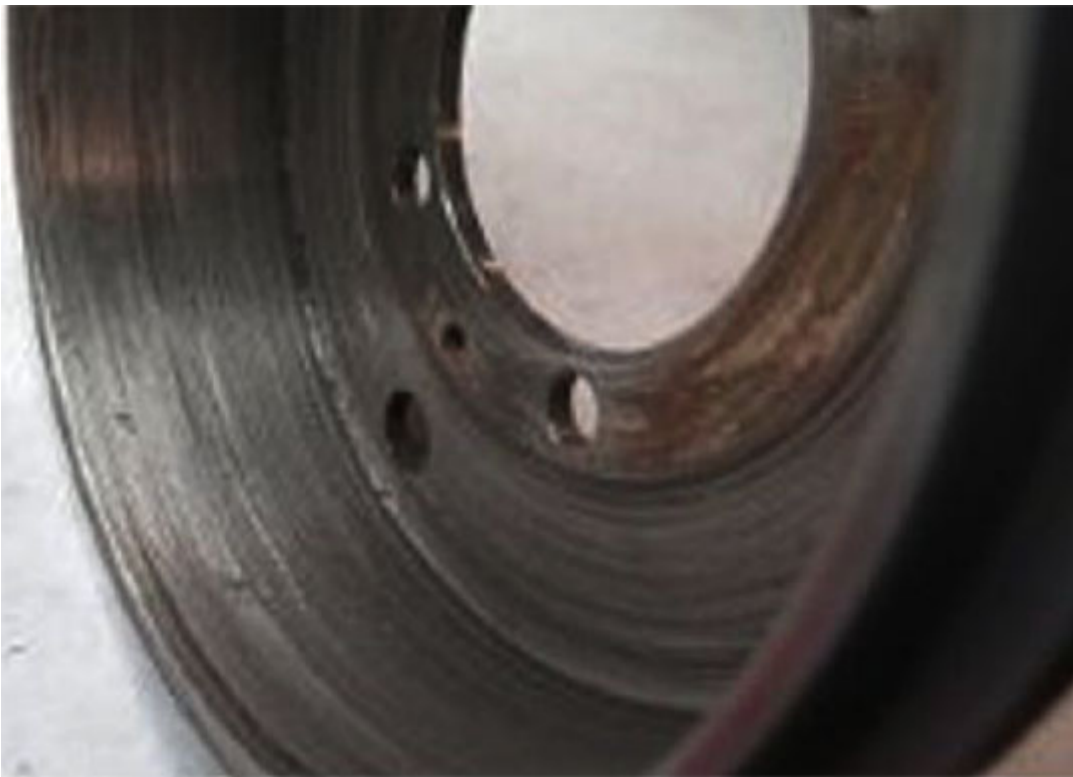
Involved Region or Country	North America
Condition	There may be a concern with a rattle or scraping noise from the park brake drum, or a concern of the park brake being locked up.
Cause	The vehicle may have been driven with the park brake engaged.

Please review the following pictures, they all indicate the vehicle being driven with the park brake being engaged.

If this is encountered check the operation of the park brake indicator by lifting up on the park brake lever.

The lamp should be on before the first click. If park brake lamp is not working diagnosis and repair as need.

For the damaged park brake review the bulletin below due to the labor operation is restricted.
