## Volvo Chassis - FSB 761-002, Shock Absorber, Inspection

## FSB 761-002, Shock Absorber, Inspection

(October 2017)

VOLVO VN, VAH, VHD, and VT trucks require a visual shock absorber inspection during regular maintenance schedules. The visual inspection will include checking the shock absorber for leakage, any irregularities, or worn shock bushings. During regular maintenance schedules, use this bulletin to determine if the shock absorber meets or does not meet the inspection criteria for warranty replacement of the shock absorber if needed.

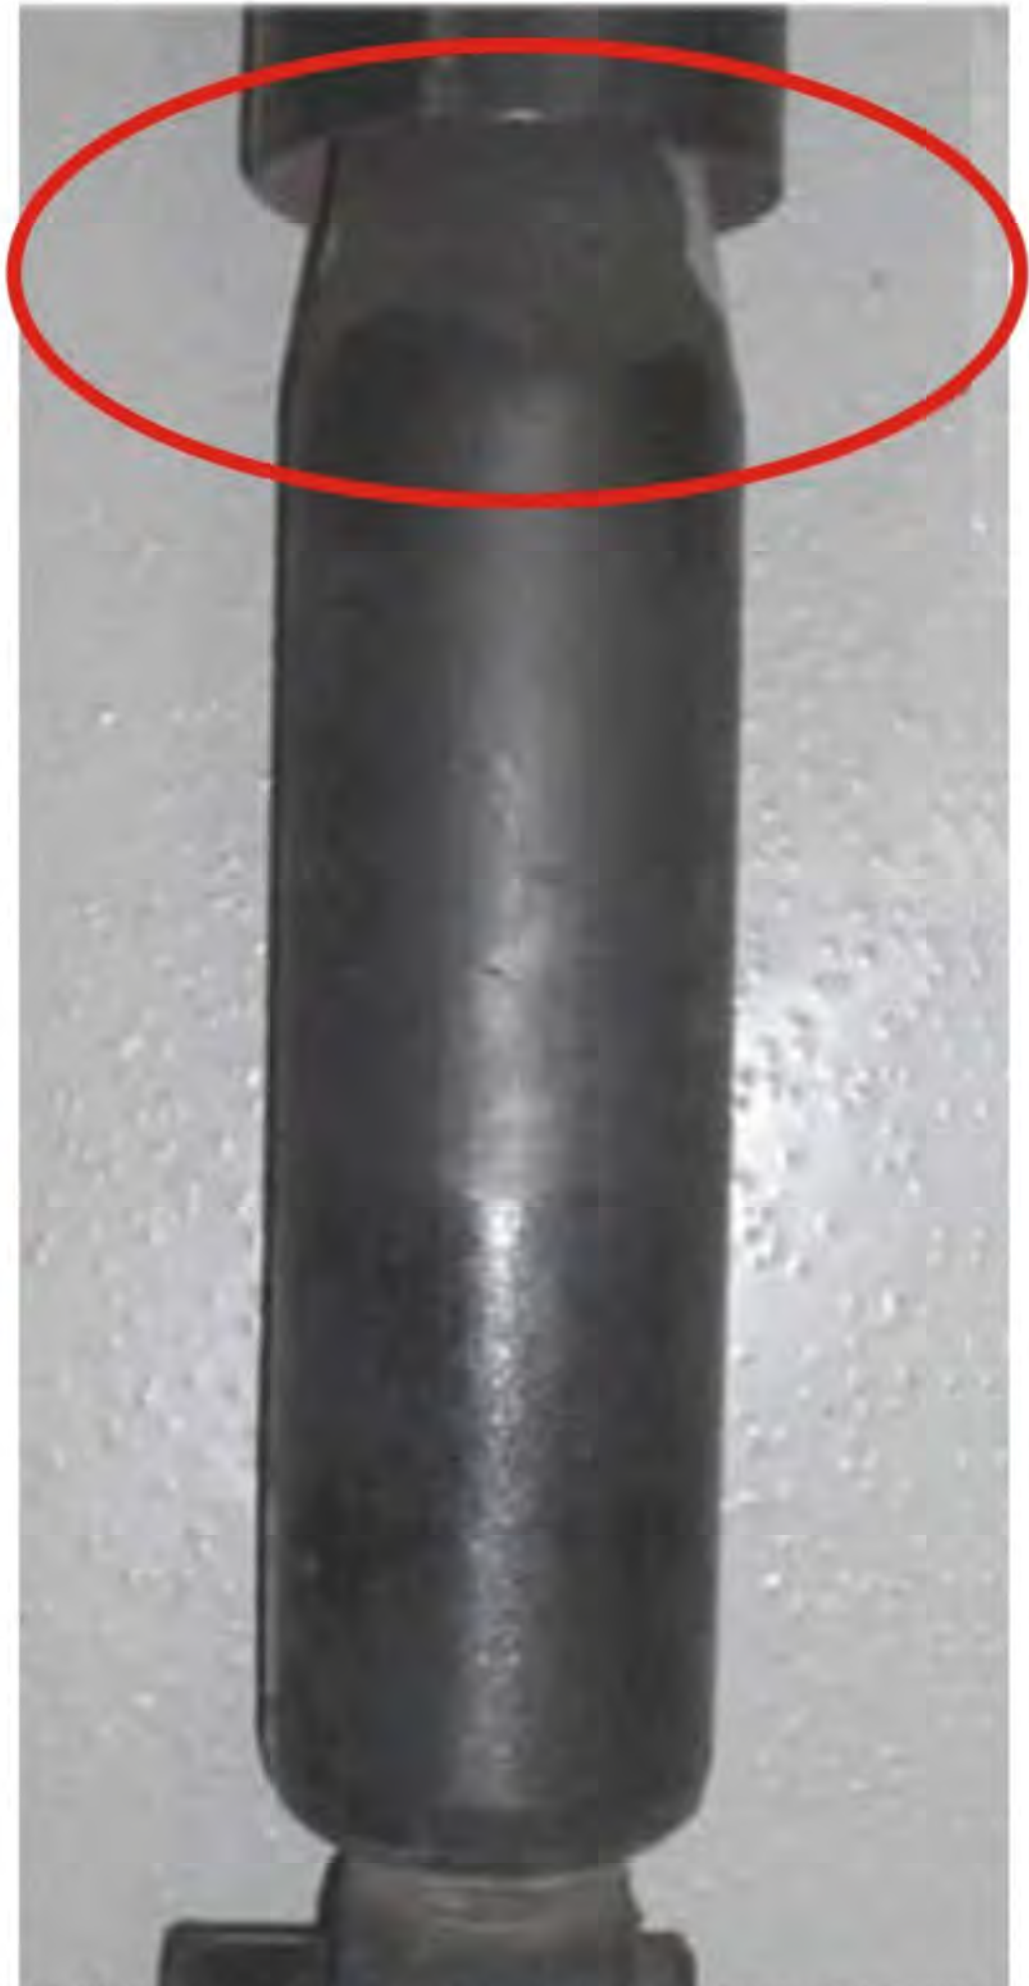
SYMPTOM:	Light Misting	
Misting  Precipitation of oil mist on the outside of the shock is visible. Appearance may be deceptive.	Light Oil Film on the Upper Shock Body NO Action Required Do Not Remove	
Cause:		
High operating temperatures results in oil mist and

precipitation. A certain degree of vapor is therefore normal and actually a necessity for the lubrication of the rod seal.

Finger Test

After the complete extension of

the shock, touch the upper area of the reservoir tube (smaller diameter) with a dry finger. If the finger remains dry, the shock is not leaking. If in doubt, wipe the shock clean and check again after a few days of operation. If oil is only visible around the bottom it likely comes from an outside source.

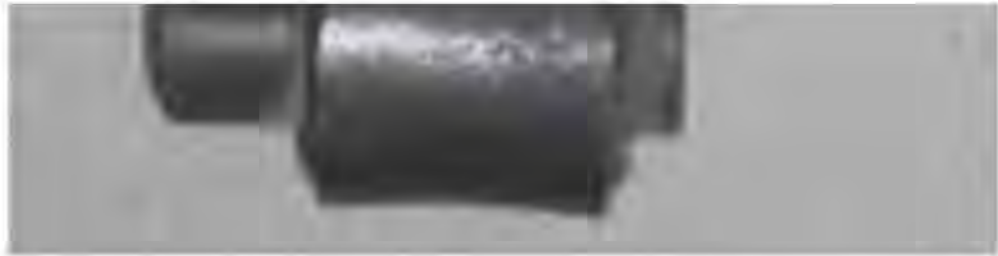
Accepted as Warranty Failure

**SYMPTOM:**  
Leakage

Leaking

Symptoms of leakage include loss of oil, loss of the damping function or loss of ride control of the vehicle. The reservoir tube (smaller diameter) is predominantly covered with oil.

Oil Leak Path Lines Visible on the Shock Body  
Action Required  
Replace Shock Absorber

**Cause:**

Damaged or overheated seal.

The shock is considered as a leaker if a dry finger gets wet of oil when touching the shock at the upper area of the reservoir tube (as in previous "Finger Test").

After the finger test, the shock can exhibit a glossy film of oil / dirt, or an oil droplet formation on the reservoir tube.

### ACTION:

Replace leaking shock.
