Technical Service Bulletin

91 USB Interface: USB socket lose, missing, pushed in
91 22 87 2066315/1 March 7, 2022.

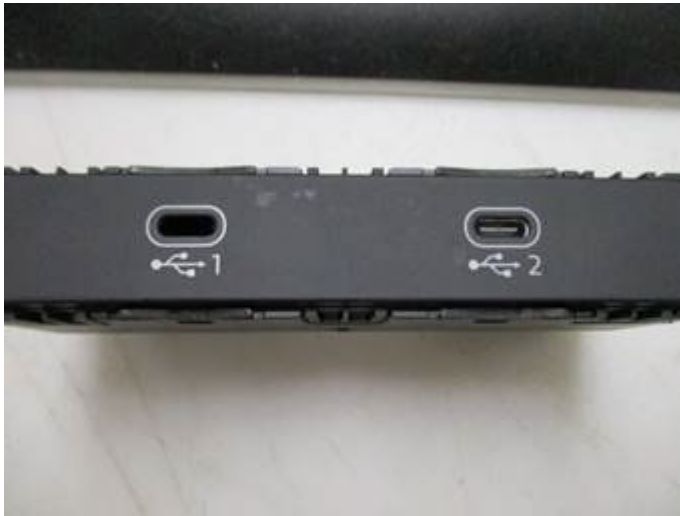
- One or both of the USB sockets in the USB interface assembly is either loose or pushed back into the housing.
- One or both of the USB sockets in the USB interface assembly is sheared off the Printed Circuit Board (PCB) (Figure 1).

Figure 1: USB socket sheared off the PCB and loose in the housing.

The USB sockets can shear off the PCB:

- If the USB connector is improperly inserted into the USB socket (for example, at an angle).
- If excessive force is applied when inserting the USB connector into the socket.
- If a non-USB-standard compliant USB connector or cable is used (e.g. low quality cables that are available online might not be USB-standard compliant in regards to connector size and damage the USB socket).
- Certain “prank” (USB-killer) devices can destroy the internal electronics of the USB interface.

The USB interface will need to be replaced to restore function.
