AN20-041B
 NTB20-079B
 February 3, 2022

AV CONTROL UNIT REPLACEMENT PROCESS

APPLIED VEHICLES: 2021-2022 Rogue (T33)

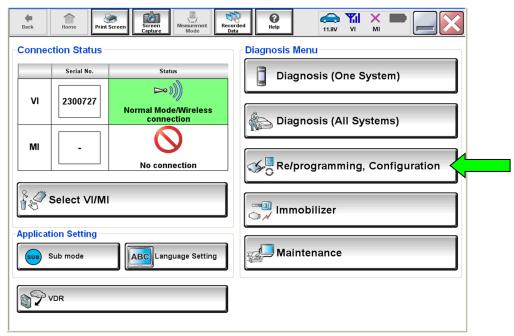
Figure 1

2. Select Re/programming, Configuration.

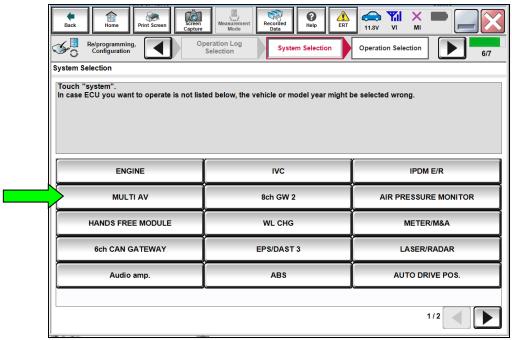
Figure 2

8. Select MULTI AV.

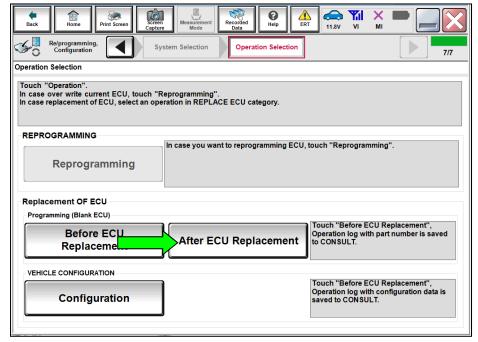
Figure 3

9. Select After ECU Replacement from the Programming (Blank ECU) menu.

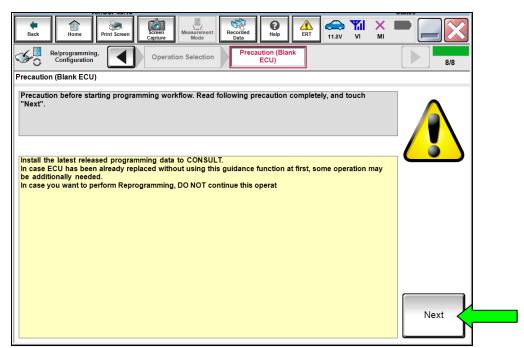
Figure 4

10. Select **Next** after reading the precaution.

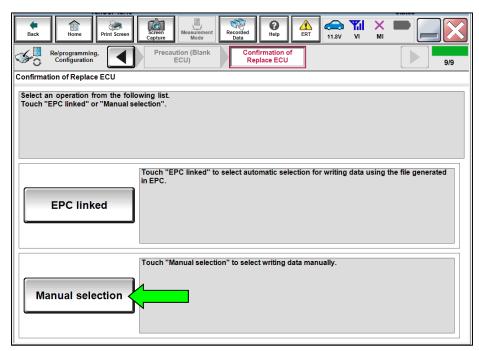
Figure 5

11. Select Manual selection.

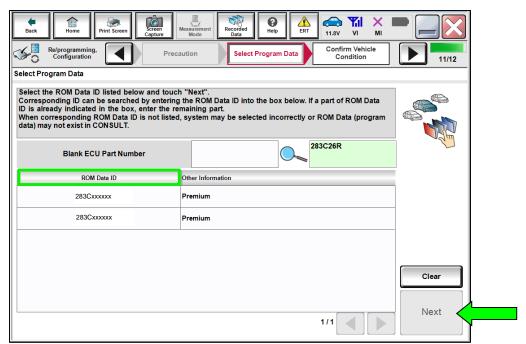
Figure 6

15. Select the applicable **ROM Data ID**, and then select **Next**.

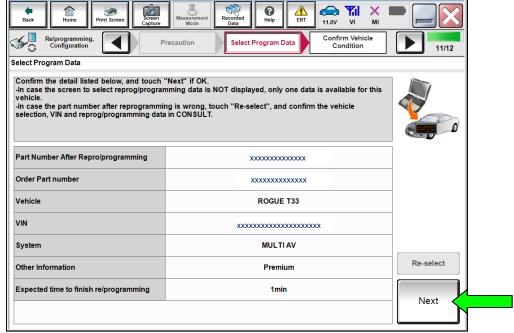
Figure 7

Confirm the information matches the vehicle you are working on, and then select Next.

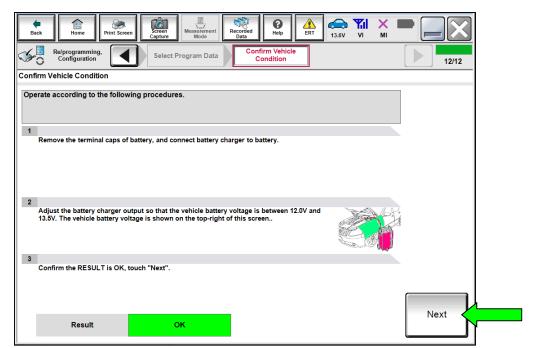
Figure 8

17. Follow the on-screen instructions, and then select **Next**.

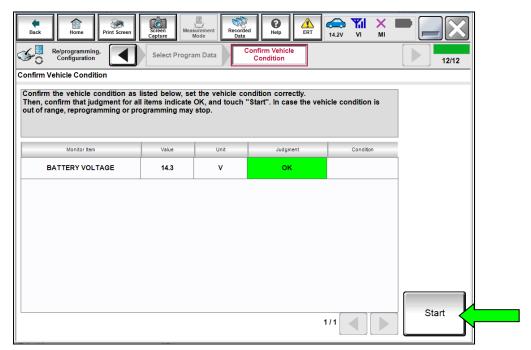
Figure 9

18. Confirm the battery voltage is within acceptable limits, and then select Start.

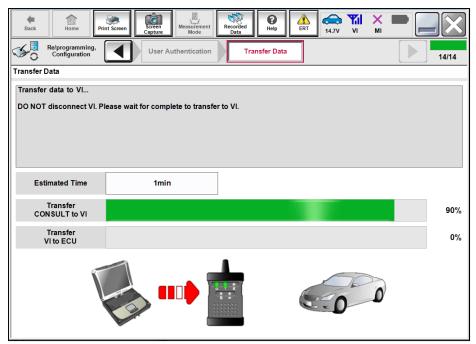
Figure 12

21. Wait for the data transfer to complete.

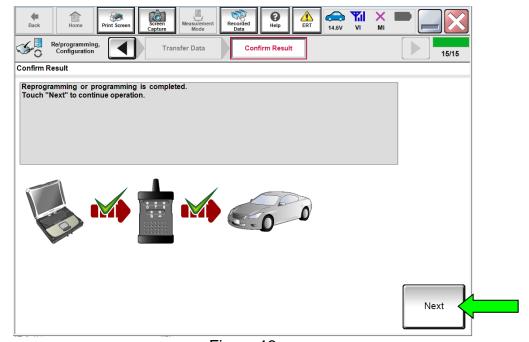
Figure 13

22. Once the data transfer is complete, select Next.

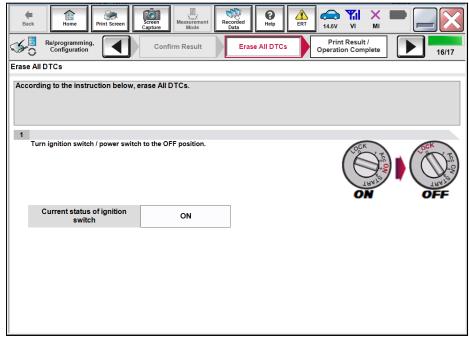
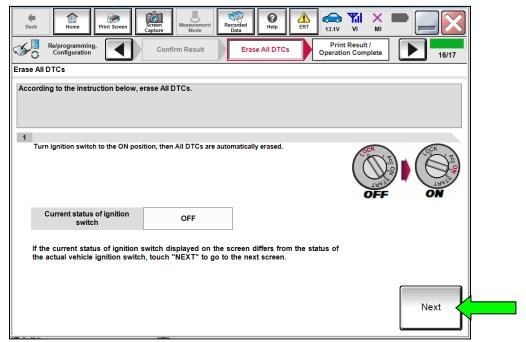
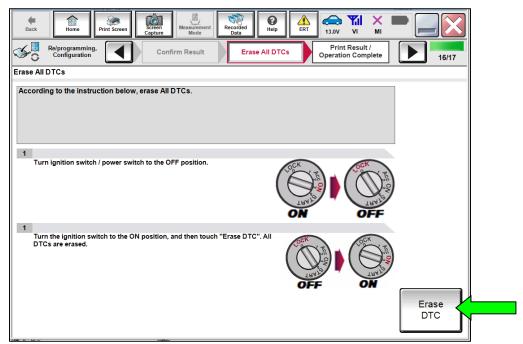
23. Perform Erase All DTCs.

• Follow the on-screen instructions as shown in Figure 14, Figure 15 and Figure 16.

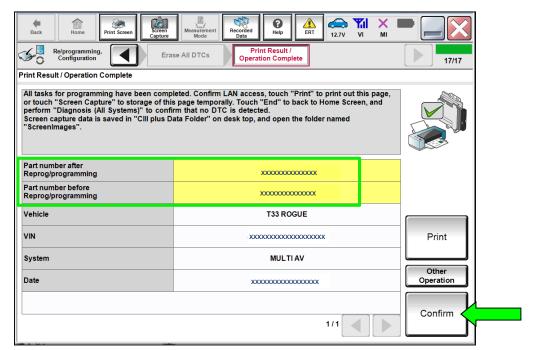
Figure 17

24. Verify the before and after part numbers are different, follow the screen prompts to print the results, then select **Confirm**.

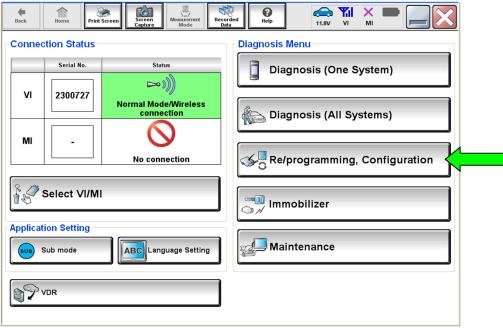
Figure 19

26. Select Re/programming, Configuration.

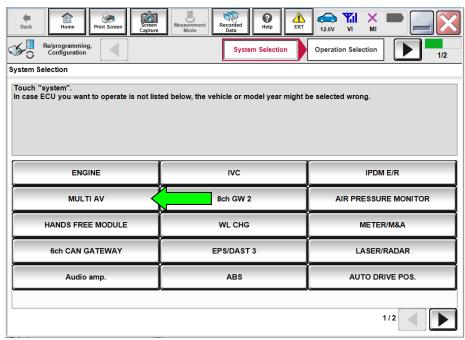
Figure 20

32. Select MULTI AV.

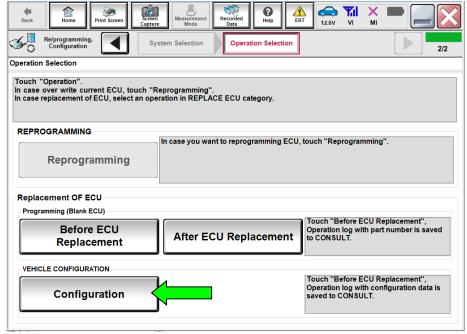
Figure 21

33. Select Configuration under VEHICLE CONFIGURATION.

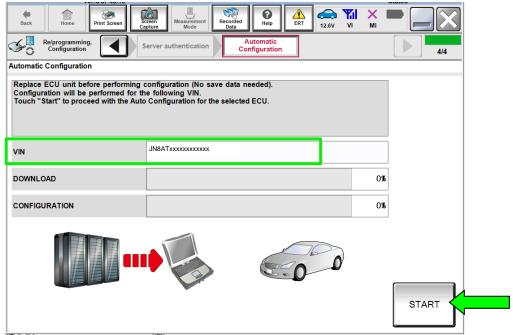
Figure 22

34. On the **Automatic Configuration** screen, ensure the VIN is correct and then select **START**.

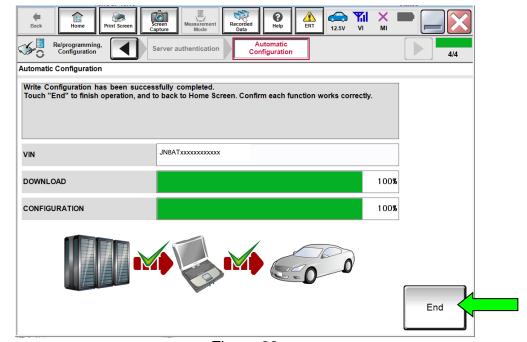
Figure 23

35. Once automatic configuration has completed, select End.

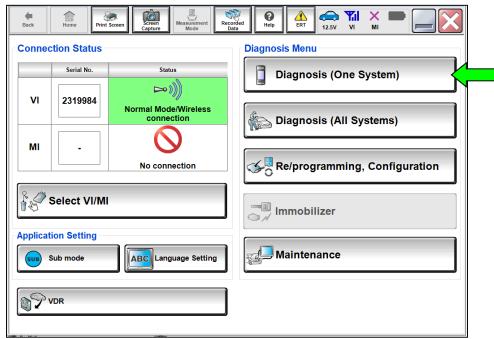
Figure 24

36. Select Diagnosis (One System).

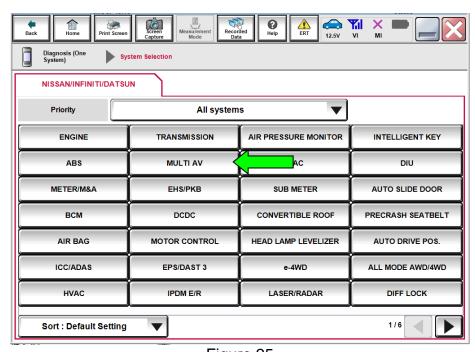
Figure 25

37. Select MULTI AV.

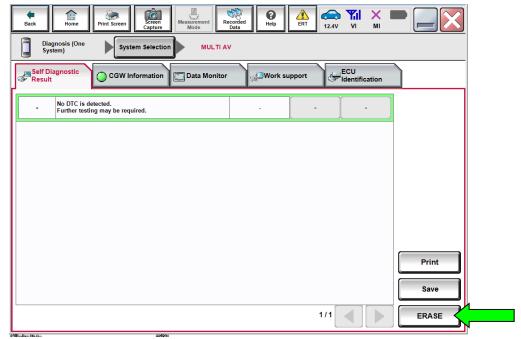
Figure 26

38. Select **ERASE** if any DTCs exist.

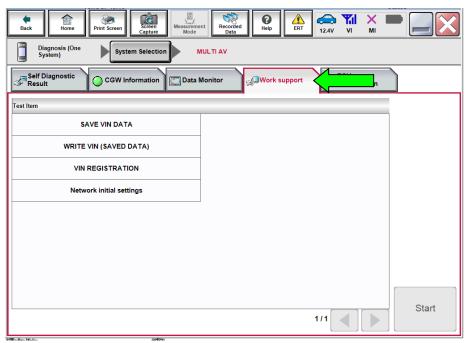
Figure 27

39. Select the Work support tab.

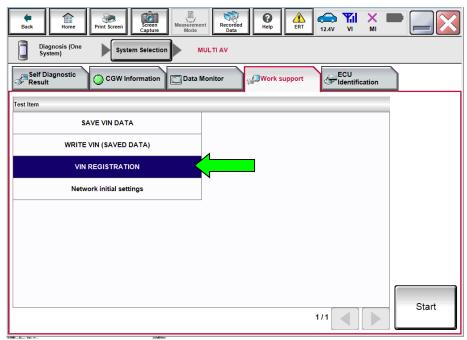
Figure 28

40. Select VIN REGISTRATION.

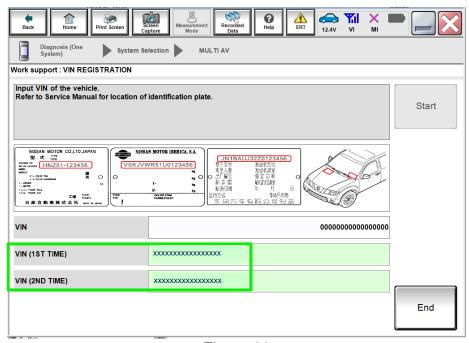
Figure 29

- 41. Type the VIN into the fields shown below.
 - The VIN must be entered two times.

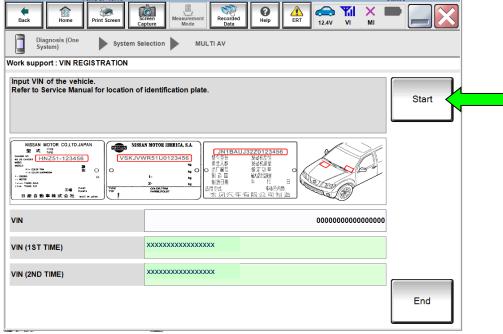
Figure 30

42. Select Start.

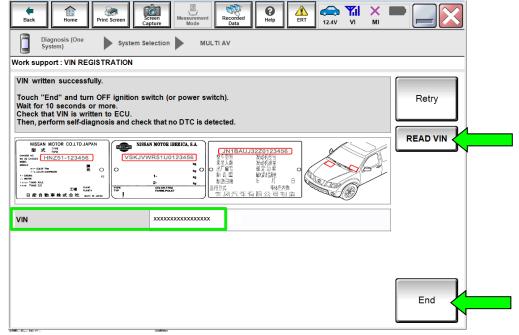
Figure 31

- 43. Select **READ VIN** to verify the VIN was written successfully.
 - The VIN should now populate in the field shown below.

44. Select End.
