Technical Service Bulletin

PSS 91 MIB3: MMI display turns blue

91 22 90 2063702/4 March 23, 2022. Supersedes Technical Service Bulletin Group 91 number 21-46 dated October 26, 2021, for reasons listed below.

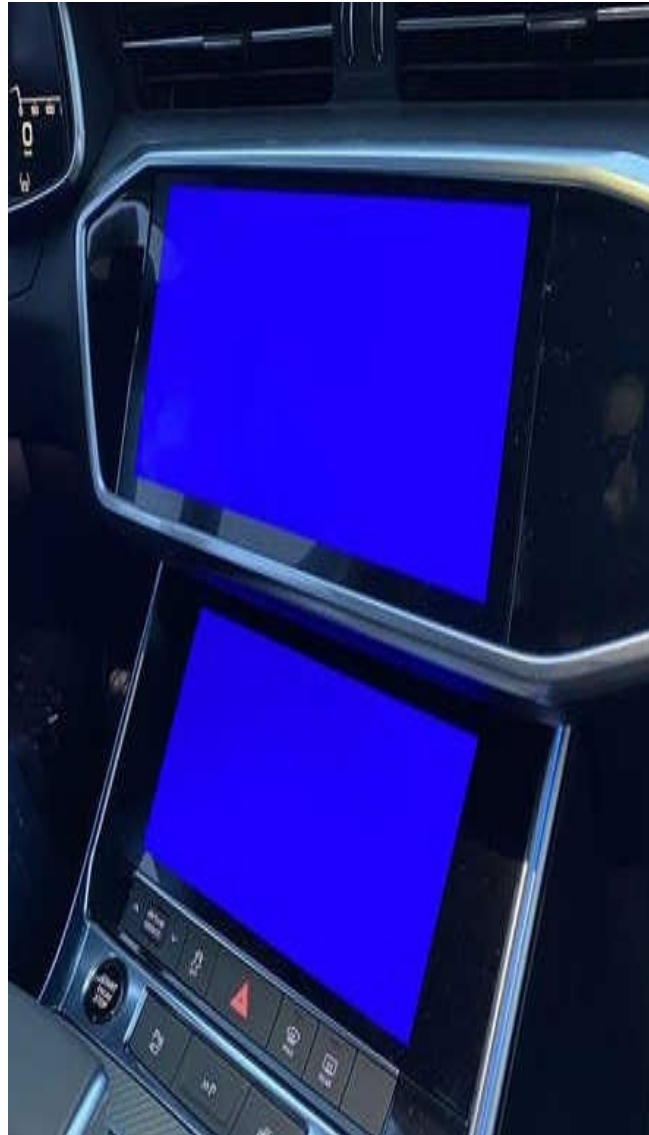
Figure 1. Dual screen vehicle.

- The MMI display turns completely blue (Figures 1 - 2).

An issue in the display driver can cause the displays to turn blue.

1. **Workaround:** Reset the MMI by pushing the On/Off/Volume button for 10 seconds or more. The MMI will reboot and should work normally afterward.
2. Explain to the customer that a permanent solution is expected in the 1st quarter of 2023 (subject to change) and that no repairs are necessary at this point. Do not replace any components for this condition since this will not resolve the customer's concern.
3. Create a PSS record in the PSS application through the Pending Service Solutions (PSS) link in AccessAudi (under *Related Links* >> *Service*), or through the Technical Assistance page in Elsa.
