Thor Motor Coach Technical Service Bulletin

TSB #	TSB 22-05		
Description/Title:	Gemini/Compass rearview monitor splitter.		
Affected Product Line(s):	2022		
Service Campaign # :	RC000261	Released Date:	
Codes:	Inspect Only: Inspect with Repair:	Document Date:	4/12/2022
Time Allowed:	Inspect Only: 0.1 TMCTS80248Y Inspect with Repair: 0.3 TMCTS80248W	Document Revision:	A

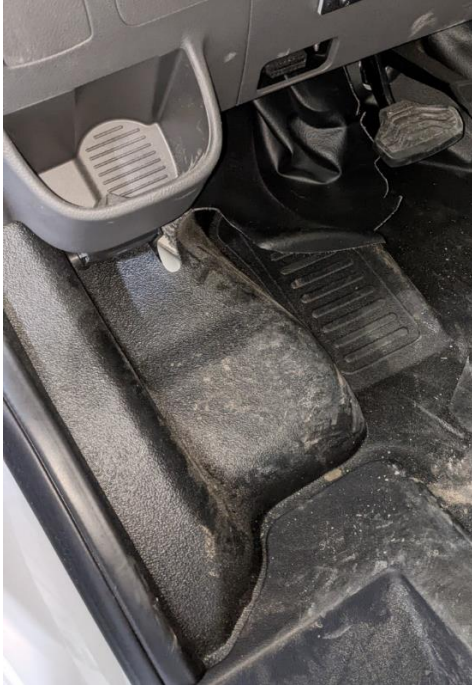
2. Area shown below is where connection is made.

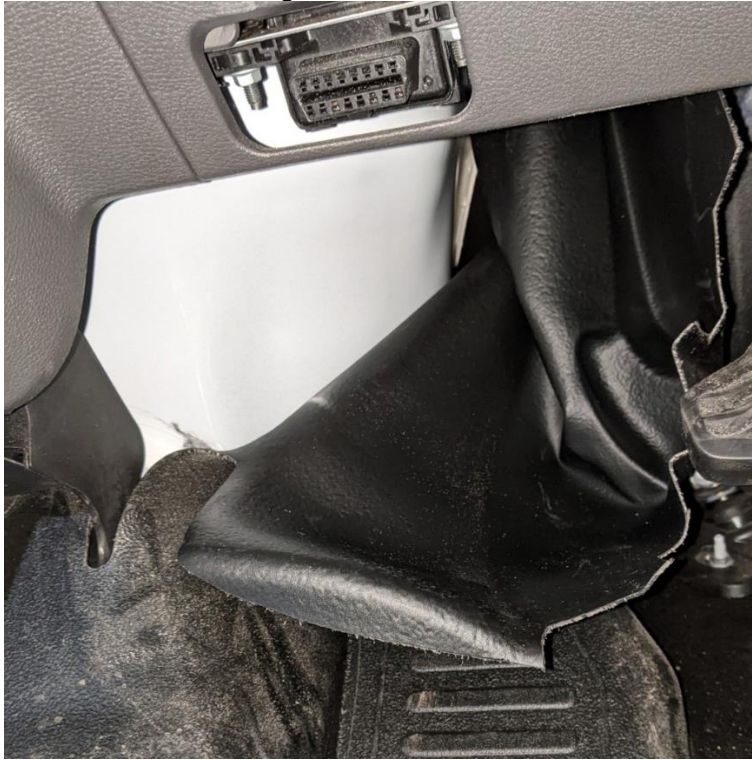
3. Pull the plastic cover away from the top of the driver's side wheel well. The connection should be in a bundle right above the wheel well.

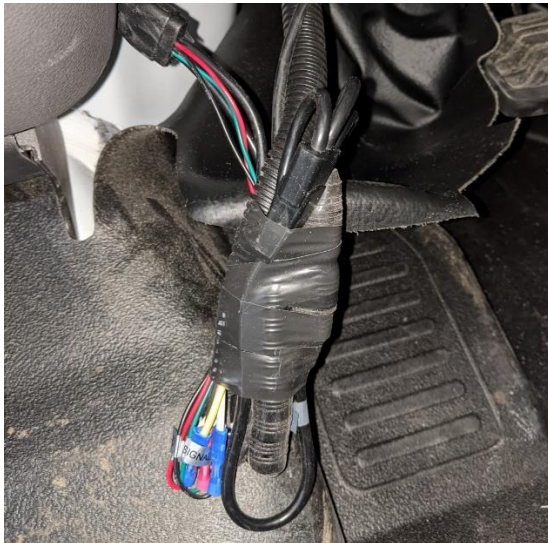
4. Pull the bundle down for better access. Remove electrical tape from bundle and install splitter

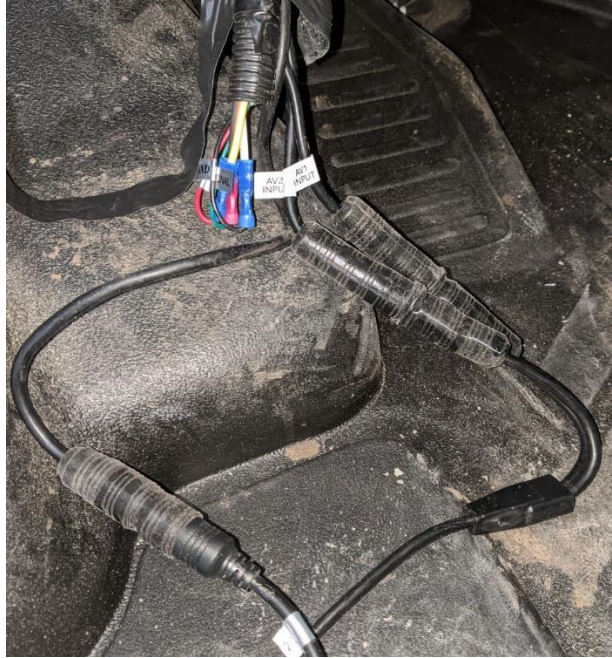
5. The picture below is how the connections look when the splitter is installed correctly. Once installation is complete re-tape the wires into a bundle and put bundle back up behind the plastic and reinstall plastic cover.

6. Test for correct function by turning on the ignition and then hitting the button on the monitor. It should turn on and display the camera image if installed correctly. Also test by putting the coach into reverse and ensuring camera is operational.
