SERVICE BULLETIN

APPLICABILITY: 2022MY BRZ NUMBER: 12-235-22

SUBJECT: Rear License Plate Mounting

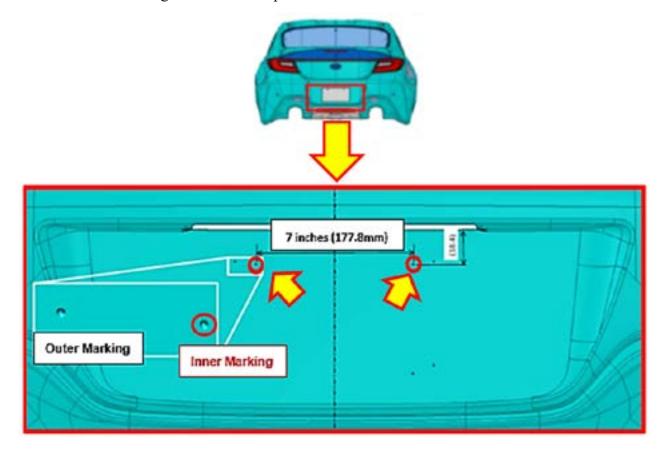
This bulletin announces the procedure for rear license plate mounting. The 2022MY BRZ requires the rear license plate to be mounted to the rear bumper face. There are alignment marks located on the bumper that are to be used for mounting positioning. Use the procedure information outlined in this bulletin when installing the rear license plate.

STEP 1: Locate the inner alignment markings outlined with **RED** in the image above. The marks have a distance of 7 inches (177.8mm) between them.
