## Technical product information

<b>Topic</b>	Tweed interior trim - Cleaning advice
<b>Market area</b>	Russische Föderation (5RU),Australia E04 Bentley rest Asia and Australia (6E04),China 796 VW Import Comp. Ltd (Vico), Beijing (6796),Germany E02 Bentley rest Europe (6E02),Japan E03 Bentley Japan (6E03),Korea, (South) E08 Bentley South Korea (6E08),United Arab Emirates E06 Bentley Middle East and Africa (6E06),United Kingdom E01 Bentley UK (6E01),United States E05 Bentley USA and rest America (6E05)
<b>Brand</b>	Bentley
<b>Transaction No.</b>	2066611/1
<b>Level</b>	EH
<b>Status</b>	Approval
<b>Release date</b>

### All models with Tweed interior trim

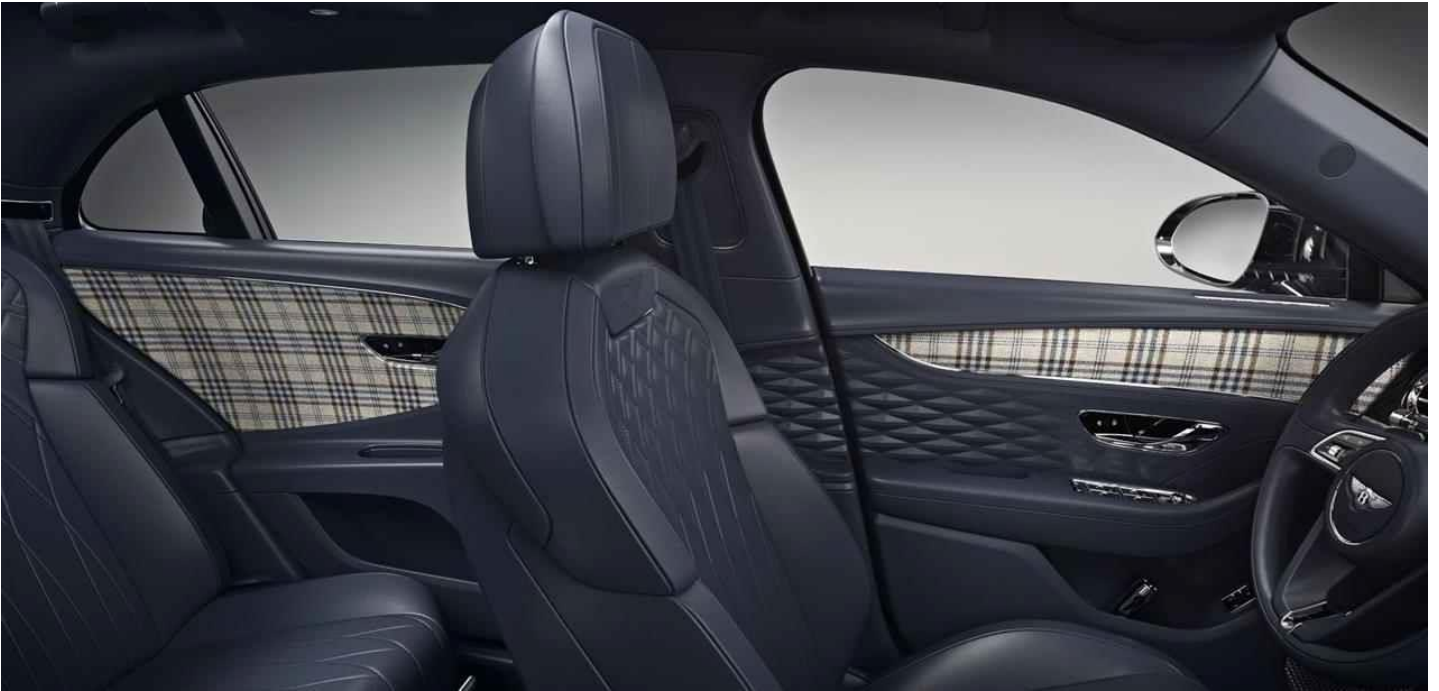
The instructions within this TPI must be strictly observed when cleaning the interior of a vehicle which has been specified with Tweed interior trim  
Figure 1 shows an example of the Tweed interior trim

- Regularly vacuum the Tweed trim to extract dust and dirt. Use a soft brush and gentle movement to minimise abrasion
- Light marks or stains should be promptly wiped with a damp cloth and left to dry
- For a deeper cleanse, a fabric-friendly cleaning product particularly appropriate for wool should be used. If the addition of a small amount of water is necessary, the cloth should be left to dry naturally before further use
- Do not under any circumstances over-wet the upholstery
- A fabric shaver can be used on Tweed if there is any piling evident after cleaning

If any soiling is evident on the tips of the natural loose fibres, a fabric shave may be used to remove the soiling
