# TECHNICAL TOPICS

| Deployable Sidestep Erratic Operation | 22MY New Range Rover (L460) |

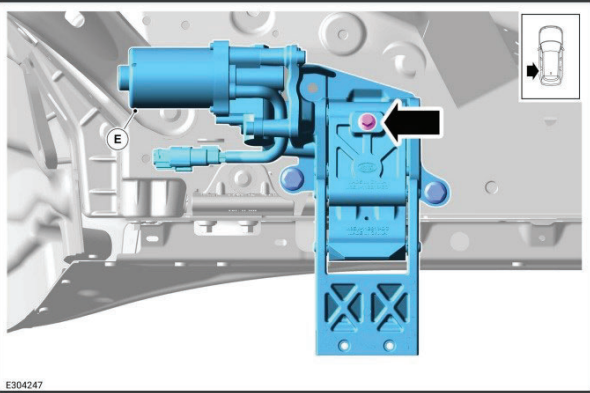
| Deployable Sidestep Erratic Operation | 22MY New Range Rover (L460) |
|---|---|
| <p><u>Customer Voice:</u></p> <ul style="list-style-type: none"><li>- A customer may report that the deployable sidesteps are operating erratically.</li></ul> <p><u>Technical Description:</u></p> <ul style="list-style-type: none"><li>- The accessory fit deployable sidesteps may operate erratically or intermittently on one or doth sides. This may be a result of a fixing that has become loose.</li></ul> <p><u>Status:</u></p> <ul style="list-style-type: none"><li>- Should a customer express a concern please refer to SSM 75721 for a list of related DTC's and repair procedures.</li></ul> | <p>E304247</p> |
