Rick March, General Manager Customer Relations Group

Neutralizing Filiform Corrosion

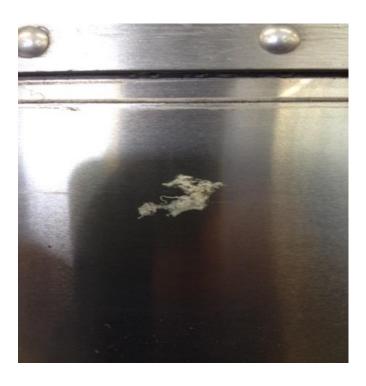
Picture of Filiform Corrosion
