Aftertreatment Hydrocarbon Injector (AHI) Troubleshooting Guide - US10+OBD13 And Newer Emissions

System Overview

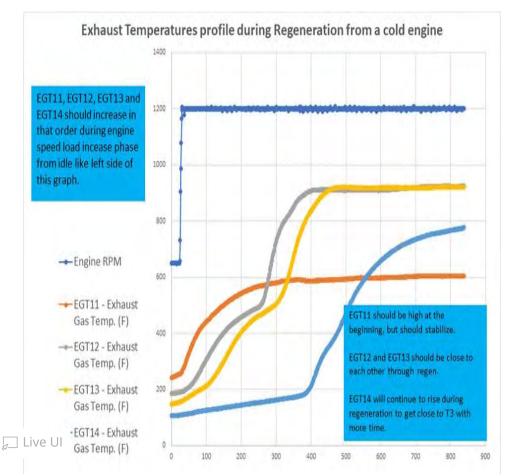
• Run a Service Regeneration. Ensure that the temperature graph looks similar to the one in the image below.

• Check the Adaptive Factor for the AHI system by using operation 2545-08-03-02 Exhaust Aftertreatment Diagnostics, Options C in Premium Tech Tool.

- If the Adaptive Factor is higher than 1.2:

- Replace the AHI Nozzle
- Reset the Adaptive Factor using the option in PTT

- If the Adaptive Factor is lower that 1.2:

• The AHI nozzle is NOT the likely cause of the failed regeneration. Symptom Based Diagnostics in PTT should be followed from this point.

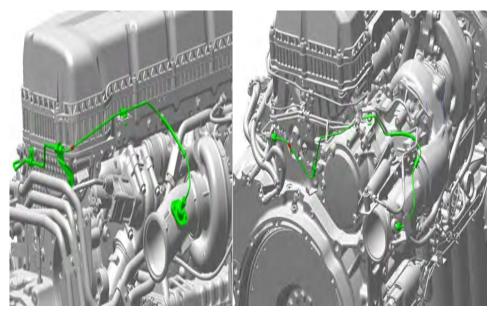
These lines run from the AHI Module to the Nozzle and are two-piece metal lines. With start of production 2017 these lines have a limited serviceability (3 times only) that are marked with plastic clips. The primary failure mode of these lines is leaking (fuel/air) at the points of connection. Because of the atomized fuel and air this leaking may not be easily noticeable.

2017 VGT Engine

2017 TC Engine

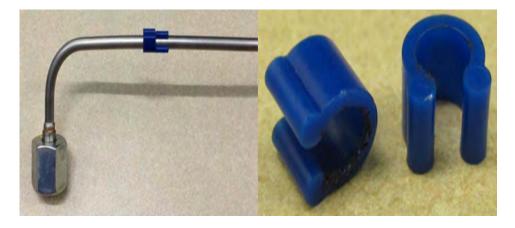
These lines are only to be tightened 3 times before they require replacement. This applies to both connection points of the Live UI ,HI Module and AHI Nozzle). When new, two plastic C-clips are

installed on each of the lines. Each time a line is removed and rehttps://volvo-trkna-prod1.pegacloud.net/prweb/PRAuth/app/VolvoKM_/iNPUIKpeinqPJi2G0hH930k43USdE1gb*/!TABTHREAD5?pyActivity=%40basec... 7/9 tightened, one of the plastic clips is to be removed. When there are no clips left on the line it should be replaced with a new one.

Lines are to be torqued in accordance with the table below.

NOTE: It is extremely important to follow proper torque to reduce premature line failure.

Torque Specifications			
US17 and newer			
Air/Fuel Line Fittings	25 ± 6 Nm (221 ± 53 in-lb)		
Connection Joint	15 ± 2 Nm (135 ± 18 in-lb)		
US13 through US16			
Air/Fuel Line Fittings	22 ± 2 Nm (195 ± 18 in-lb)		
Connection Joint	22 ± 2 Nm (195 ± 18 in-lb)
