Technical Bulletin

50 16 01 January 19, 2016 **2011761** Supersedes Technical Bulletin V501501 dated January 2, 2015 to include additional model and model year applicability.

Corrosion, Front Fenders, at Upper Wheel Opening (U.S. Only)

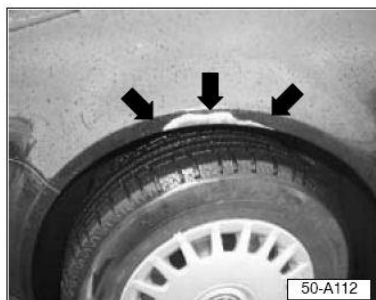
Surface corrosion or corrosion perforation can occur on various locations around the front wheel arch.

- Corrosion at front fender -arrows-, as shown.

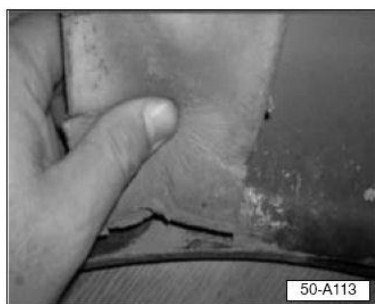
- This condition may be due to the foam pad on the inner fender pressing against the upper edge of the fender, which chafes through the paint in the affected area.
