GROUP	MODEL
Subsequent Repair Action	2010-2011MY Forte & Forte Koup (TD) w/2.4L MPI
NUMBER	DATE
PI2102Y/Z	May 2022

ENGINE REPLACEMENT INSTRUCTIONS FOR DTC P1326 (PI2102Y/Z)

This bulletin provides information related to the Technical Service Bulletin previously published in (PI2102) titled "Knock Sensor Detection System - ECU Logic Improvement" for 2010-2011MY Forte and Forte Koup (TD) vehicles equipped with Theta 2.4L MPI engine, produced from February 24, 2009 through May 31, 2011. Specifically, this bulletin provides instructions on which procedures to follow if, after installation of the KSDS, any one of the subject vehicles below return to the dealer with Diagnostic Trouble Code (DTC) P1326 (Knock Signal Range/Performance).

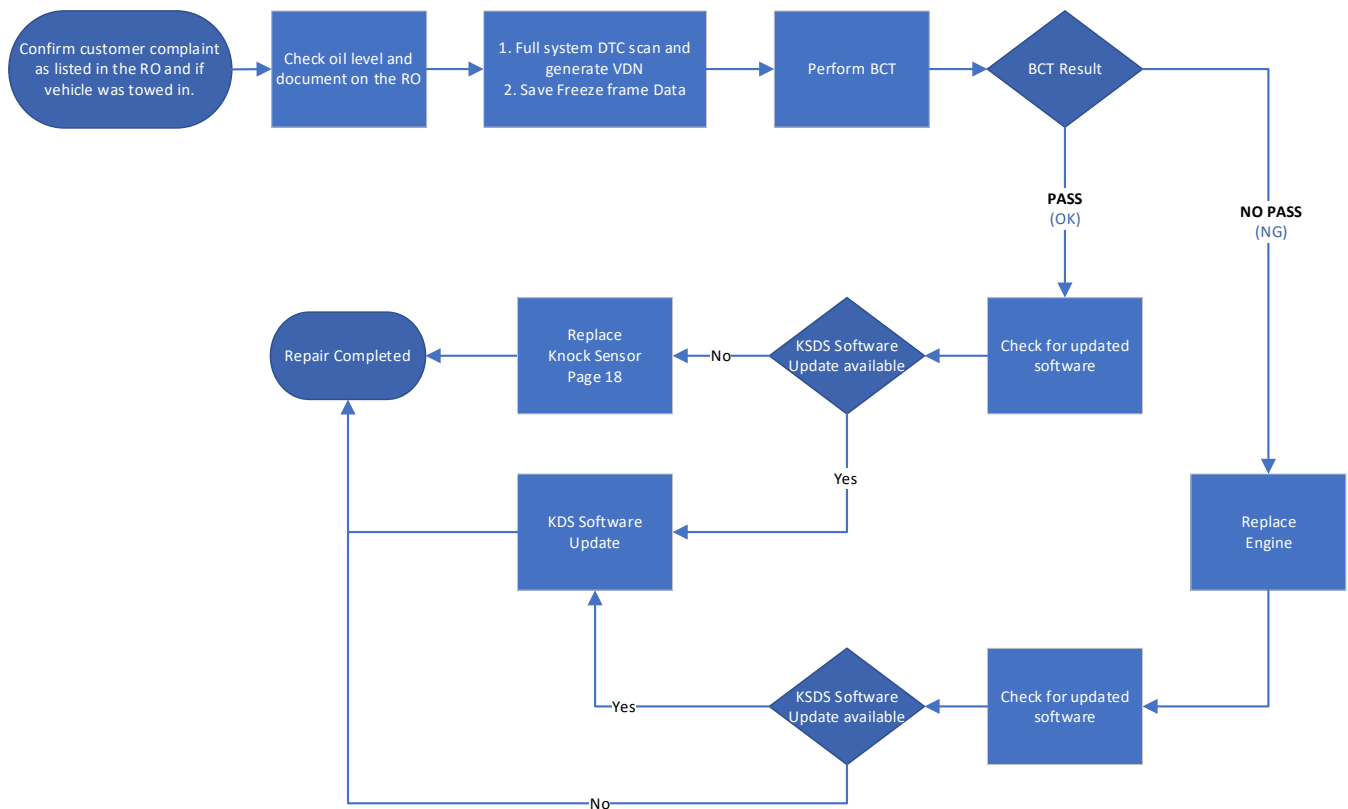
A. DTC P1326 STORED

Create PI2102Y Claim – No Techline PWA Required

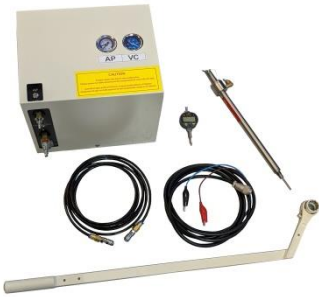
Tool Name	Tool Part No.	Figure	Comments
Click-Type or Electronic Torque Wrench	N/A	 	Locally Sourced
Bearing Clearance Tester Kit	KQ231 2T110QQK

If DTC P1326 is present, first perform the bearing clearance inspection with the Engine Bearing Clearance Tester device (SST KQ231-2T110QQK). This device checks the rod bearing clearance by placing air and vacuum into the cylinder block. Measure the bearing clearance and follow the instructions in this bulletin. Refer to the flow chart found on pages 2-4, then follow the appropriate procedure as outlined in this bulletin. Before conducting the procedure, verify the vehicle is included in the list of affected VINs.

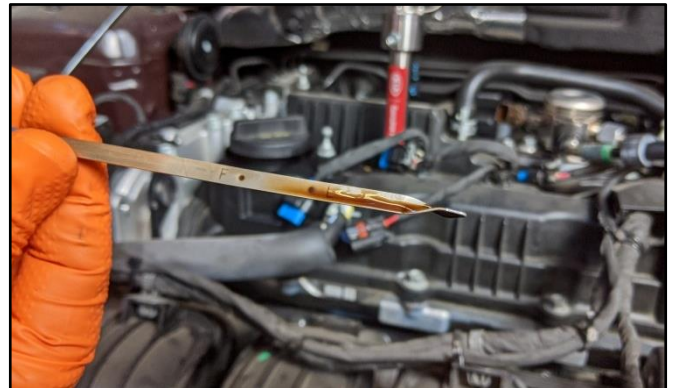
Oil Level Check: (Applies to all Flowcharts B and C)

1. Measure and record oil dip stick level.
2. Note oil dip stick reading on the RO.

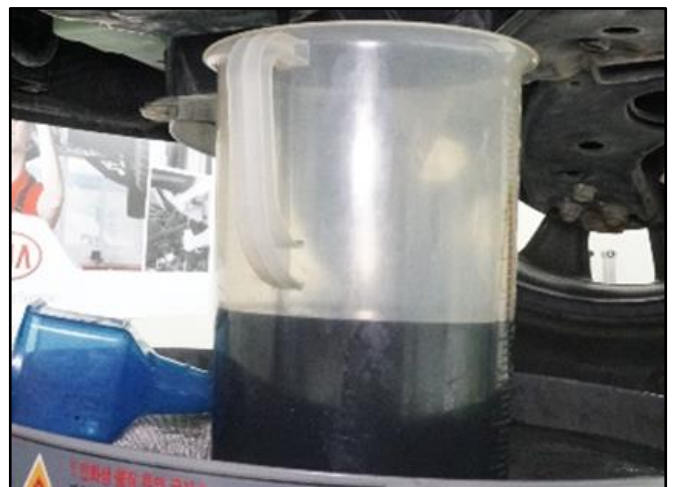
**Oil Level Measurement: (Flowchart C)**

1. Remove oil filler cap, remove oil drain plug and drain oil into the supplied measuring container SST067BUCK and check oil level.
2. Record oil level reading.
3. Take photo of the oil level using KDS.

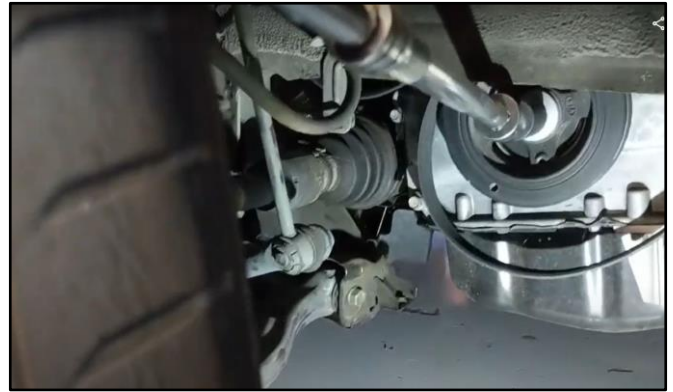
5. Show the removed drive belt and attached torque wrench to crank bolt.

Prepare the vehicle prior to the video by removing the spark plugs and drive belt as well as setting the torque wrench to 94 lb.ft.

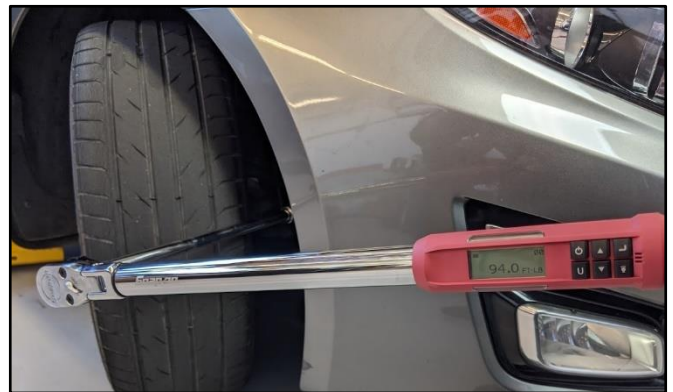
6. Show the engine being cranked and torque specification exceeding 94 lb.ft. torque.
