Technical Service Bulletin

PSS 91 MIB3: lower display is flickering or distorted

91 22 04 2066224/4 June 6, 2022. Supersedes Technical Service Bulletin Group 91 number 22-02 dated May 25, 2022, for reasons listed below.

Model(s)	Year	VIN Range	Vehicle-Specific Equipment
A6 and S6	2021 – 2022	All	Not Applicable

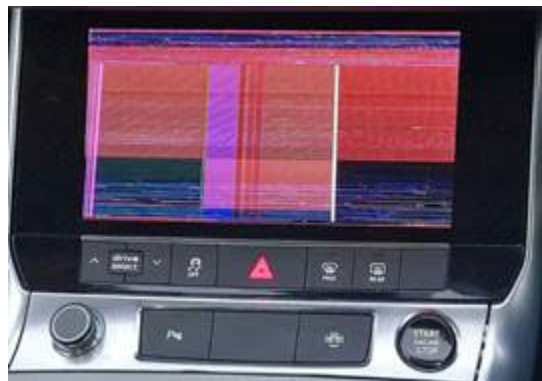
- The lower display flickers intermittently or the display seems to be distorted.

Figure 1: Display distorted

A software malfunction may cause the lower display to flicker or be distorted.

1. Explain to the customer that a solution is expected by the end of the 4th quarter of 2022 (subject to change) and that no repairs are necessary at this point. Do not replace any components for this condition since this will not resolve the customer's concern.
2. Create a PSS record in the PSS application through the Pending Service Solutions (PSS) link in AccessAudi (under *Related Links >> Service*), or through the Technical Assistance page in Elsa.

1. Reboot the MMI (refer to "Restarting the MMI" in the owner's manual)
 - a. Push and hold the volume/power button for at least ten seconds until you see the upper MMI screen boot back up.

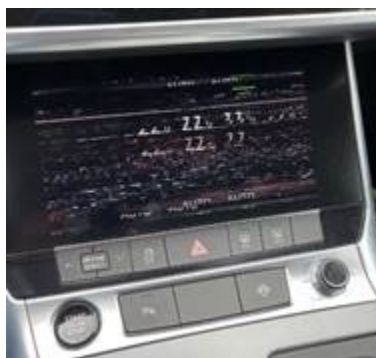
Figure 2: Display flickering
