DEF Level (UQLS) Sensor Troubleshooting Guide -US17+OBD16 Emissions and Newer

25068-9 FSB 258-040, Aftertreatment Diesel Exhaust Fluid (DEF) Tank, Level Sensor, Replacement

Frame-mounted DEF tank with Volvo engine

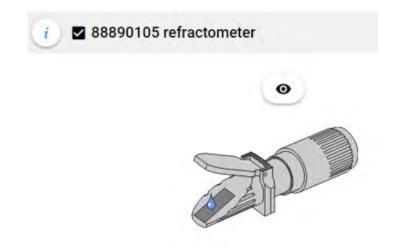
2. Verify the DEF quality is at an acceptable value.

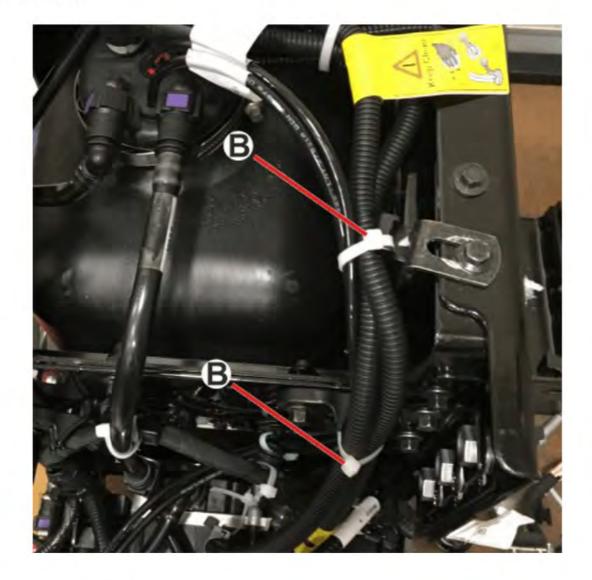
Maintain minimum 40 mm bend radius of UQLS (Urea Quality and Level Sensor) control module routing (A) at sensor head.

Note: Do not kink the UQLS control module routing.

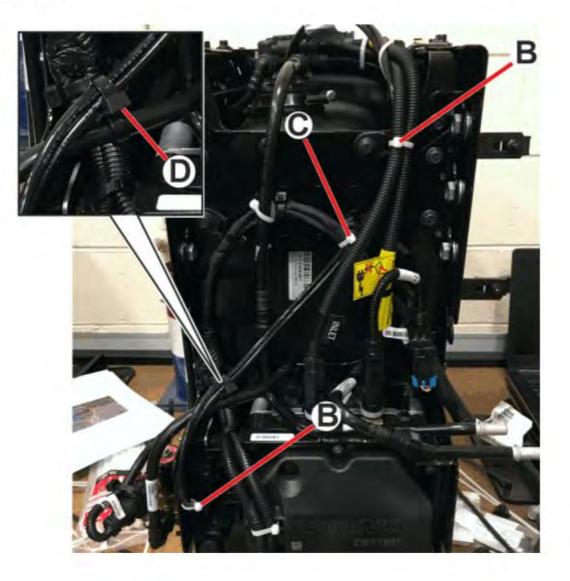
2. Route and tie the UQLS control module routing with the urea harness.

Note: Use regular cable tie (B).

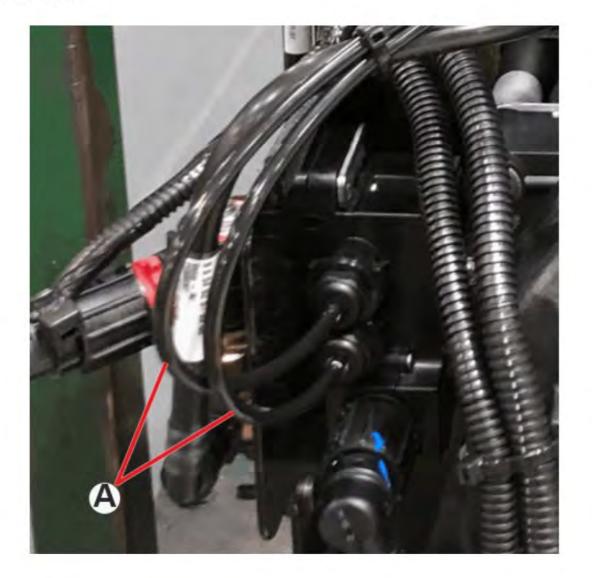
3. Route and tie the UQLS control module routing with the electrical harness.

Note: Use helicopter cable tie (C).

4. Route and tie UQLS control module routing with the coolant lines.

Note: Use double head cable tie (D).

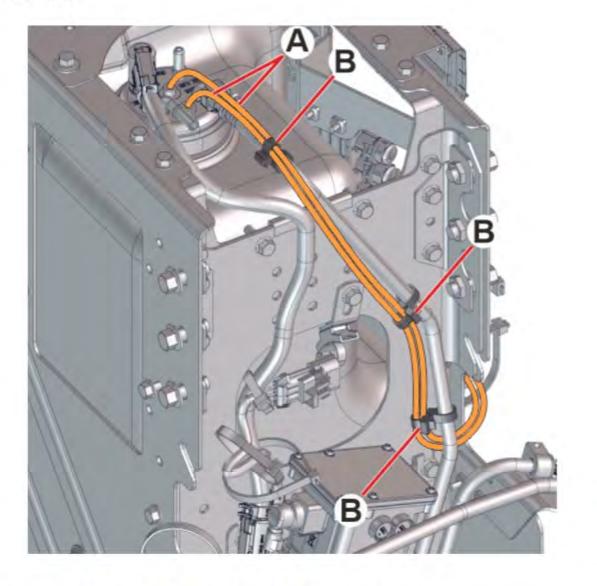
5. Maintain minimum 40 mm bend radius of UQLS control module routing(A) at electrical junction box.

Note: Do not kink the UQLS control module routing.

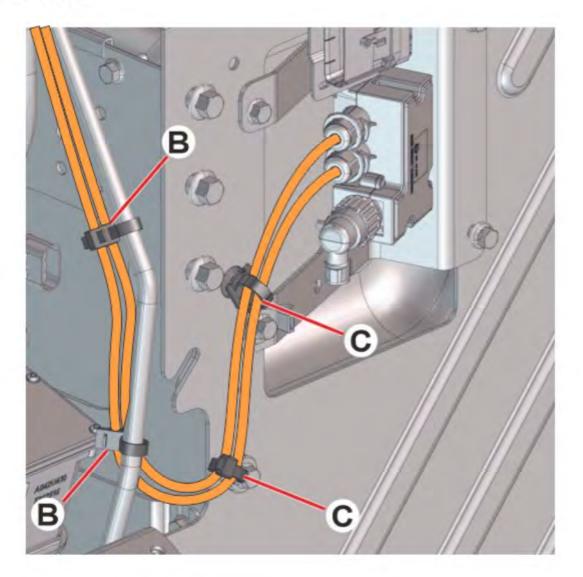
Maintain minimum 40 mm bend radius of UQLS (Urea Quality and Level Sensor) control module routing (A) at sensor head.

Note: Do not kink the UQLS control module routing.

2. Route and tie the UQLS (Urea Quality and Level Sensor) control module routing with the coolant pipe.

Note: Use double head tie (B).

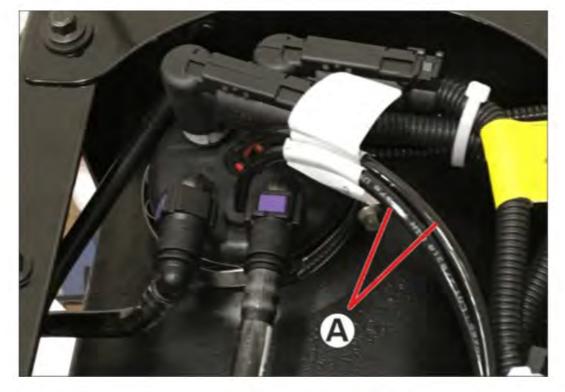
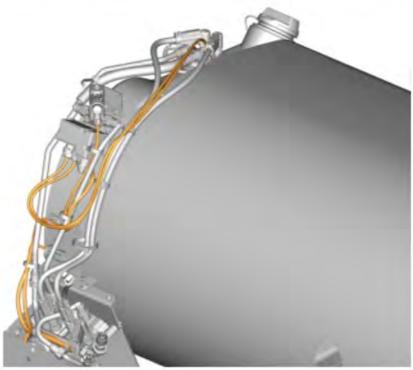
3. Route and tie the UQLS control module routing with the bracket.

Note: Use cable tie (C).
