MHEV DC/DC Converter – Squeaking noise from Cabin

20-22MY Range Rover, Range Rover Sport, RR Evoque, RR Velar, Discovery, Discovery Sport, Defender, Jaguar F-PACE

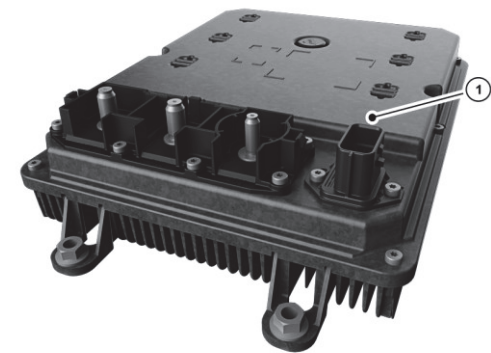
- This squeak can be heard from the MHEV Direct Current to Direct Current (DC/DC) converter, when under load.
- Internal fault within the MHEV DC/DC converter.

- Confirm the squeak is coming from the MHEV DC/DC converter. This can be done by removing the 10 pin connector.
- Turn on some vehicle electrical systems to place a load (you can turn steering wheel lock to lock) on the charging system and see if the squeak is no longer present.
- If this check confirms that the noise is coming from the MHEV DC/DC converter, then replace.

Refer to SSM 75825 / 75826
