# **Technical product information**

Topic	Door speakers (Naim) not illuminating with the door(s) closed regardless if the exterior lights are on or off
Market area	Russische Föderation (5RU), Australia E04 Bentley rest Asia and Australia (6E04), China 796 VW Import Comp. Ltd (Vico), Beijing (6796), Germany E02 Bentley rest Europe (6E02), Japan E03 Bentley Japan (6E03), Korea, (South) E08 Bentley South Korea (6E08), United Arab Emirates E06 Bentley Middle East and Africa (6E06), United Kingdom E01 Bentley UK (6E01), United States E05 Bentley USA and rest America (6E05)
Brand	Bentley
Transaction No.	2067597/2
Level	EH
Status	Released for publishing
Release date	02-Nov-2022

## Bentayga Series with Naim sound & without Mood lighting

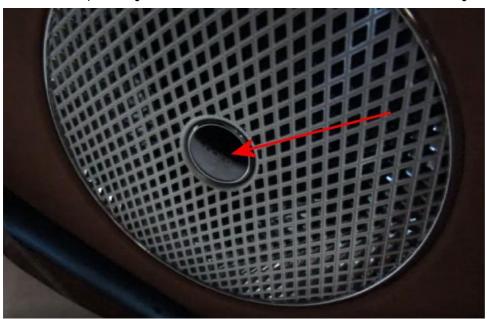
The Naim door speaker logo does not illuminate when the door is closed and the external lights are switched on

Figure 1
This phenomenon is only evident on vehicles equipped with Naim audio (8RF) and without mood lighting (QQ0)

• On receipt of a customer complaint, the operative should raise a non technical DISS query to record the phenomenon, Do not replace any parts or conduct any further diagnostic work
