Service Bulletin

Bulletin No.: 19-NA-255

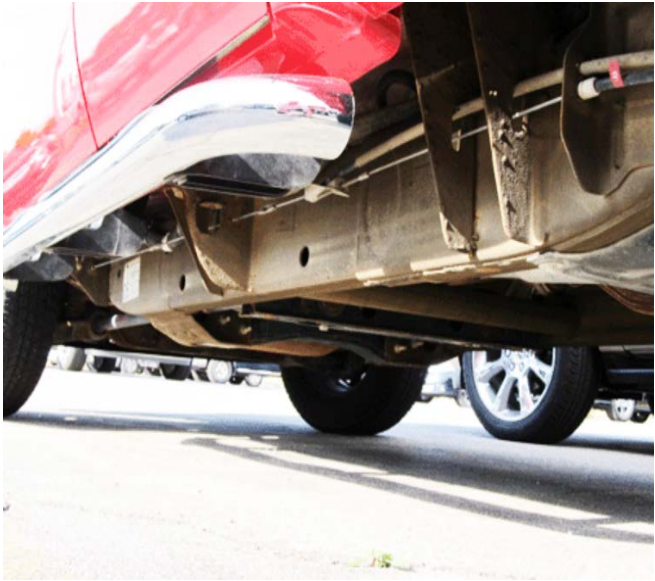
Involved Region or Country	North America, Europe, Middle East, Israel, Palestine, Chile, Columbia, Ecuador, Paraguay, Peru, Uruguay, Japan, S Korea, China, Taiwan, Thailand, Africa and Egypt, Russia, Uzbekistan, S. Africa, Australia and New Zealand.
Additional Options (RPOs)	
Condition	<p>Some customers may comment that areas of the frame wax coating are peeling off and rust/corrosion is visible on the metal in these areas. Several examples of this condition are shown in each group of graphics below.</p> <p>Truck Example Photos</p>

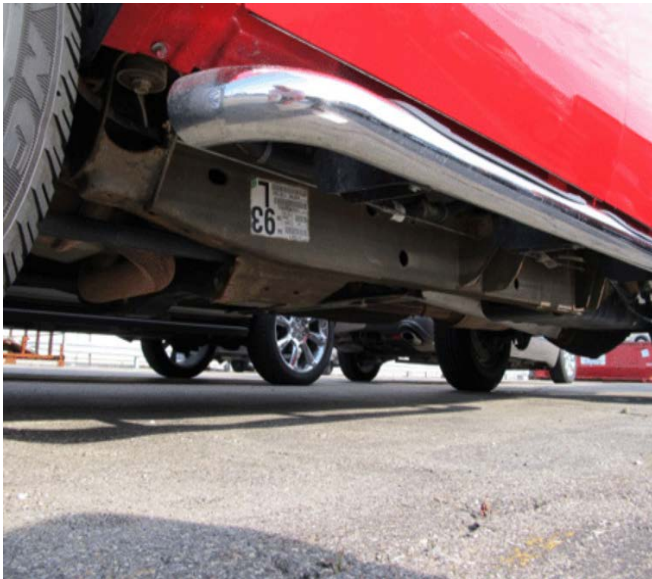
1. Raise and suitably support the vehicle. Refer to *Lifting and Jacking the Vehicle* in the Service Manual.

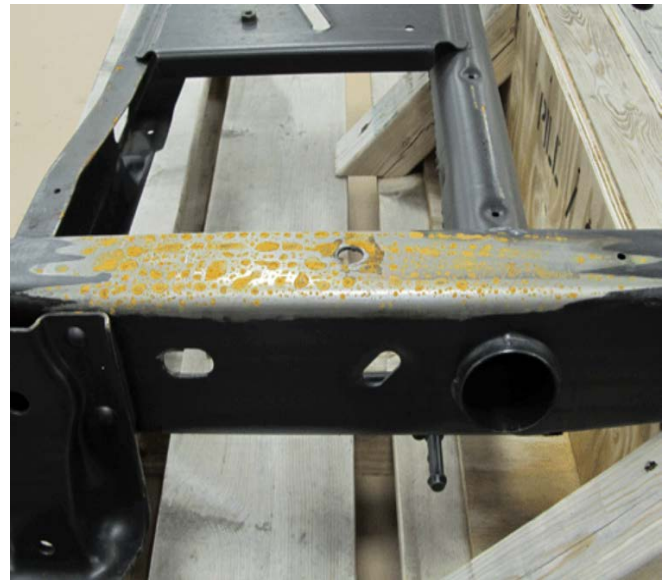
4. Determine a start and finish point on each side for the section/area of the frame to be repaired.

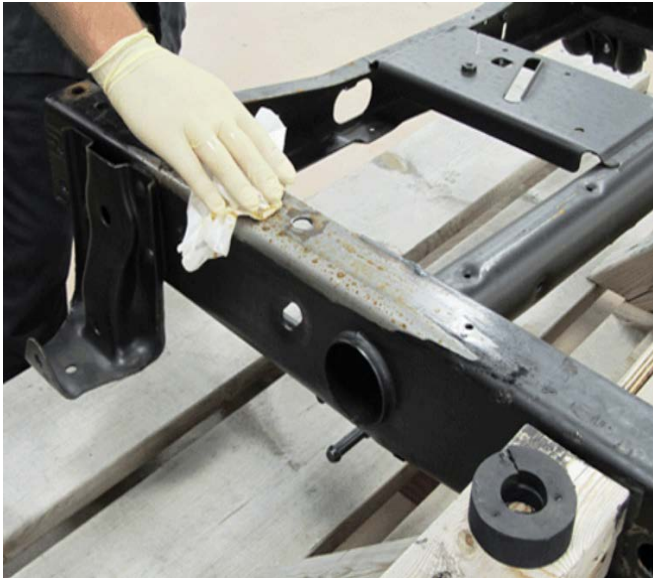
6. Any loose rust or loose flakes should be scraped, wire brushed or ground off.
7. Remove any residual wax, oil or rust by wiping the frame down with a towel or Scotch-Brite™ (3M) pad soaked with wax/grease remover.

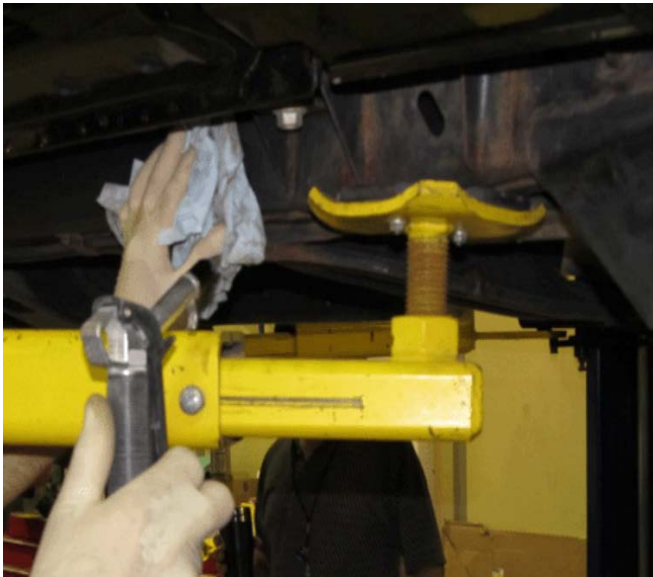
8. Using Lloyd's Pure Prep™ Metal Surface Preparation P/N 25418 (10 fluid ounce bottle), or equivalent, saturate a towel or Scotch-Brite™ (3M) pad with the pre-diluted solution and scrub the area well, rendering a foaming of the Pure Prep.™ This will greatly improve adhesion and corrosion resistance in the repair areas.

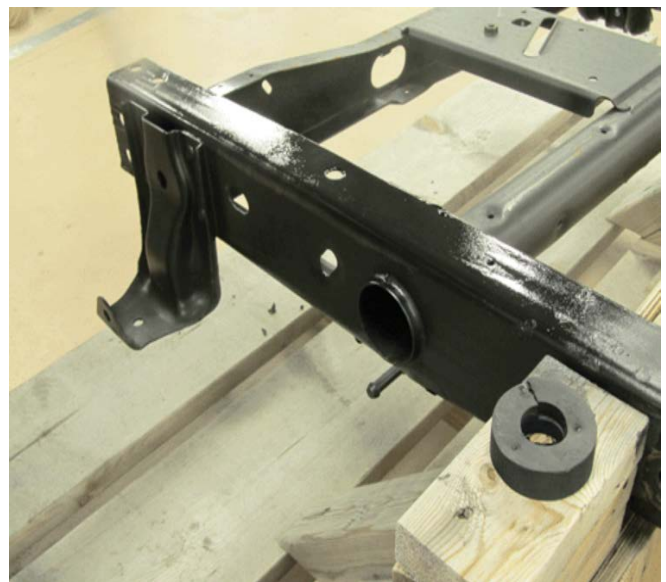
Note: Dried Lloyds Kryptonite will perform beautifully over time and actually get harder and more durable as it experiences heat.

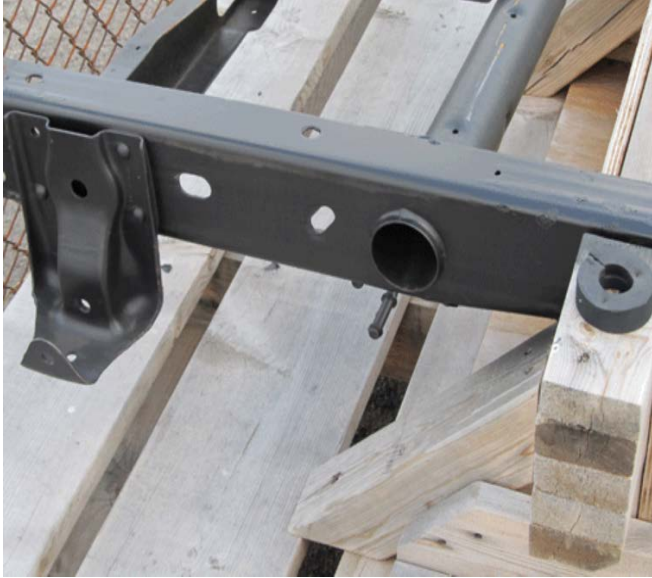
Note: As shown in the graphic below, besides adding a corrosion resistant layer, it dries to firm, wax-like film which will more closely resemble the appearance of the unrepaired areas of the frame.
