Subject: Information on the Replacement of Left Front Accelerometer

Brand:	Model:	Model Year:		VIN:		En- gine:	Transmis- sion:
		from	to	from	to		
Cadillac	Escalade Mod- els	2021	2023				
Chevro- let	Suburban						
	Tahoe Models						
GMC	Yukon Models

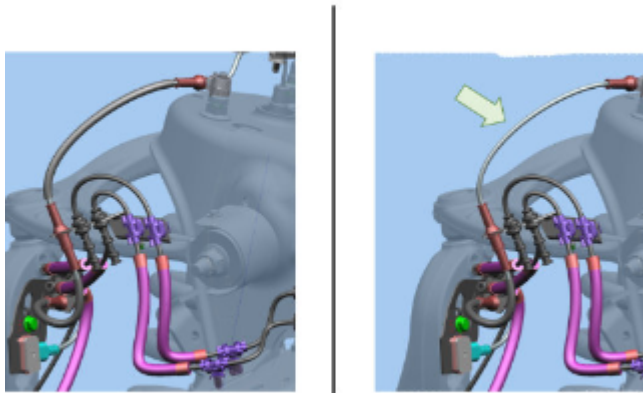
6182608

If you encounter a vehicle with a concern that leads to the replacement of the left front Electronic Suspension Wheel Front Vertical Accelerometer (Part Number 84842005), It will be necessary to remove the conduit between strut stud clip and combo bracket grommets like shown in the above illustration.

Do not replace the left front Electronic Suspension Wheel Front Vertical Accelerometer for this condition.
