WML0 – Retrofitting Loudspeaker Booster (Delivery Stop)

Revision: This bulletin replaces bulletin Group 9 155/21 WML0, dated August 26, 2022.

Model Line: **Macan (95B)**

Concerns: **Loudspeaker booster**

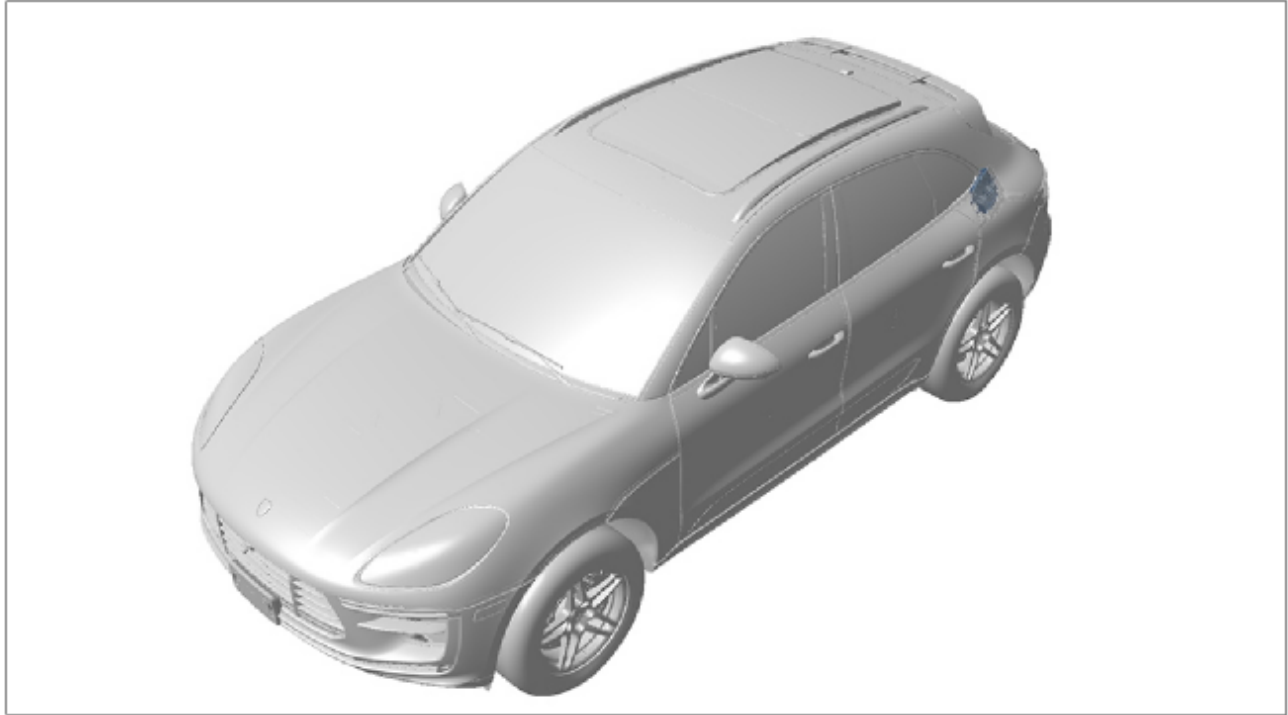
*Installation position*– Loudspeaker booster (**retrofit**)**Parts required**

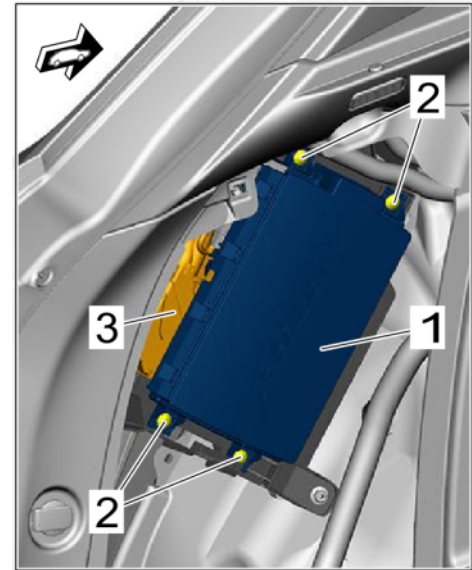
Loudspeaker booster

- 2 Position loudspeaker booster ⇒ *Loudspeaker booster -1-*, screw in fastening screws ⇒ *Loudspeaker booster -2-* and tighten to **Tightening torque 6 Nm (4.5ftlb.)** .

- 3 Plug in and lock electric plug connections ⇒ *Loudspeaker booster -3-*.
- 4 Install side trim panel for rear luggage compartment at the left. ⇒ *Workshop Manual '700319 Removing and installing side trim panel for rear luggage compartment'*

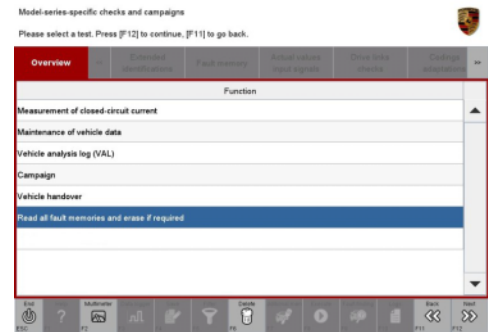
Erasing fault memories

- 19.4 Press •F8" to delete fault memory entries.
- 19.5 Press •F12" ('Yes') in response to the question asking whether you really want to delete all fault memory entries.

The faults stored in the fault memories of the various control units are deleted.

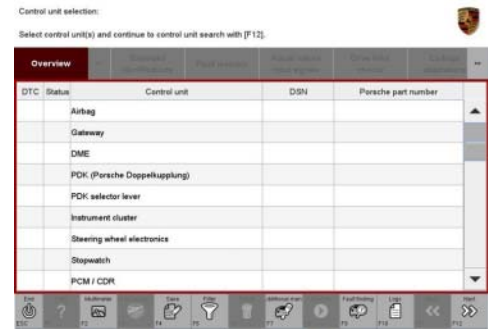
Control unit selection

- 15 Select the '**External booster**' control unit in the **overview**. Press •F12" ('Next') to continue.
- 16 Select '**Coding/adaptation**'.
- 17 Select '**Automatic coding**'. Press •F12" ('Next') to continue.
- 18 The message "Coding was completed successfully" appears. Press •F12" ('Next') to continue.
- 19 Read out and erase the fault memories of all control units.
 - 19.1 Press •F7" in the control unit selection screen ('Overview' menu) to call up the Additional menu.
